CASE SUMMARY

PSU 08 CASE NO. 191G TYPE OF ACCIDENT One Vehicle Rollover

NATIONAL ACCIDENT SAMPLING SYSTEM
CRASHWORTHINESS DATA SYSTEM

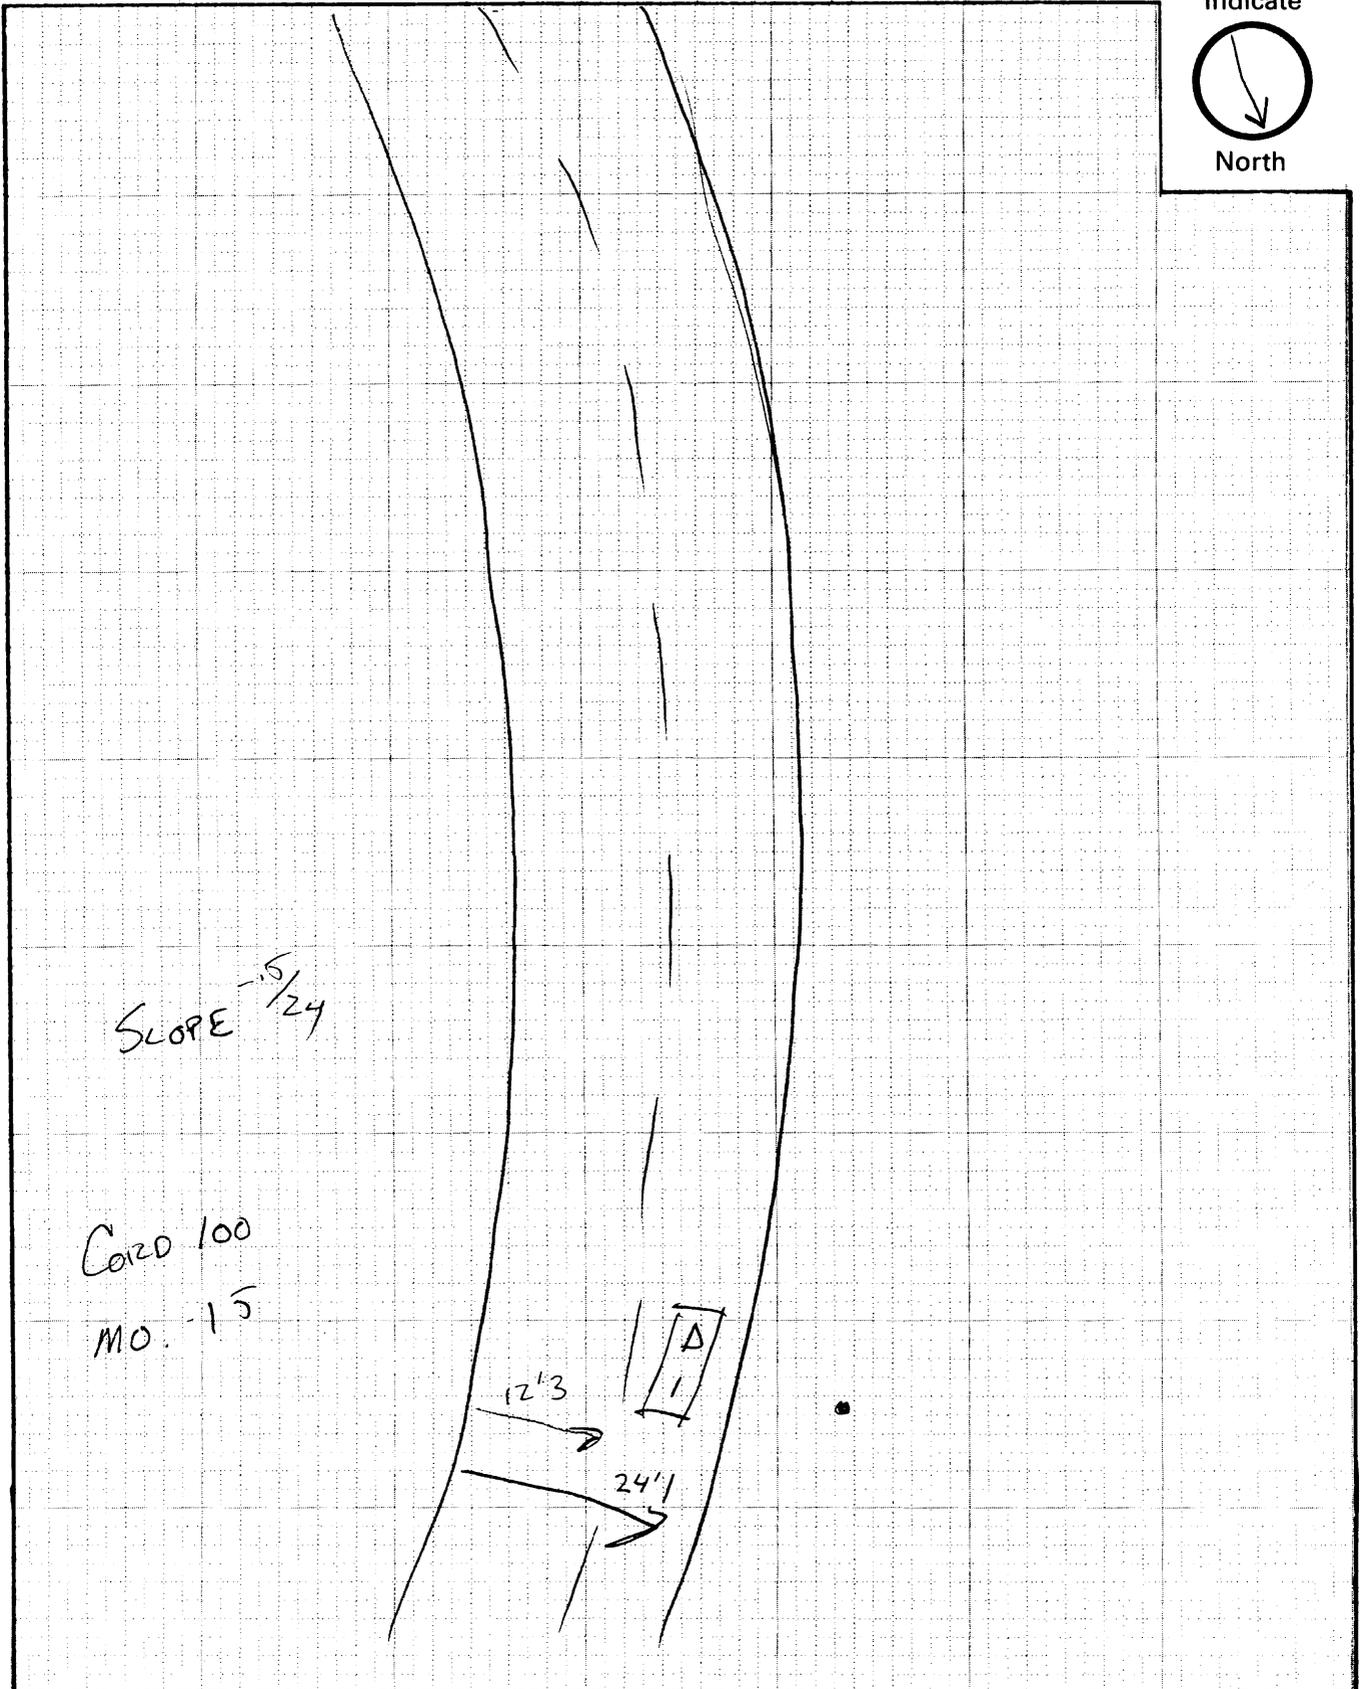
ACCIDENT COLLISION DIAGRAM

V1 was traveling south on a four lane divided concrete interstate in the right lane. As V1 negotiated a left curve in the wet roadway, V1 began to rotate counterclockwise. V1 slid off right side of roadway through a grassy berm where due to change in surfaces, V1 rolled four quarter turns coming to rest upright facing southeast.

ROAD SURFACE: CONCRETE

ROAD CONDITION: WET

ROAD GRADIENT: $-\frac{5}{24}$
 -29%

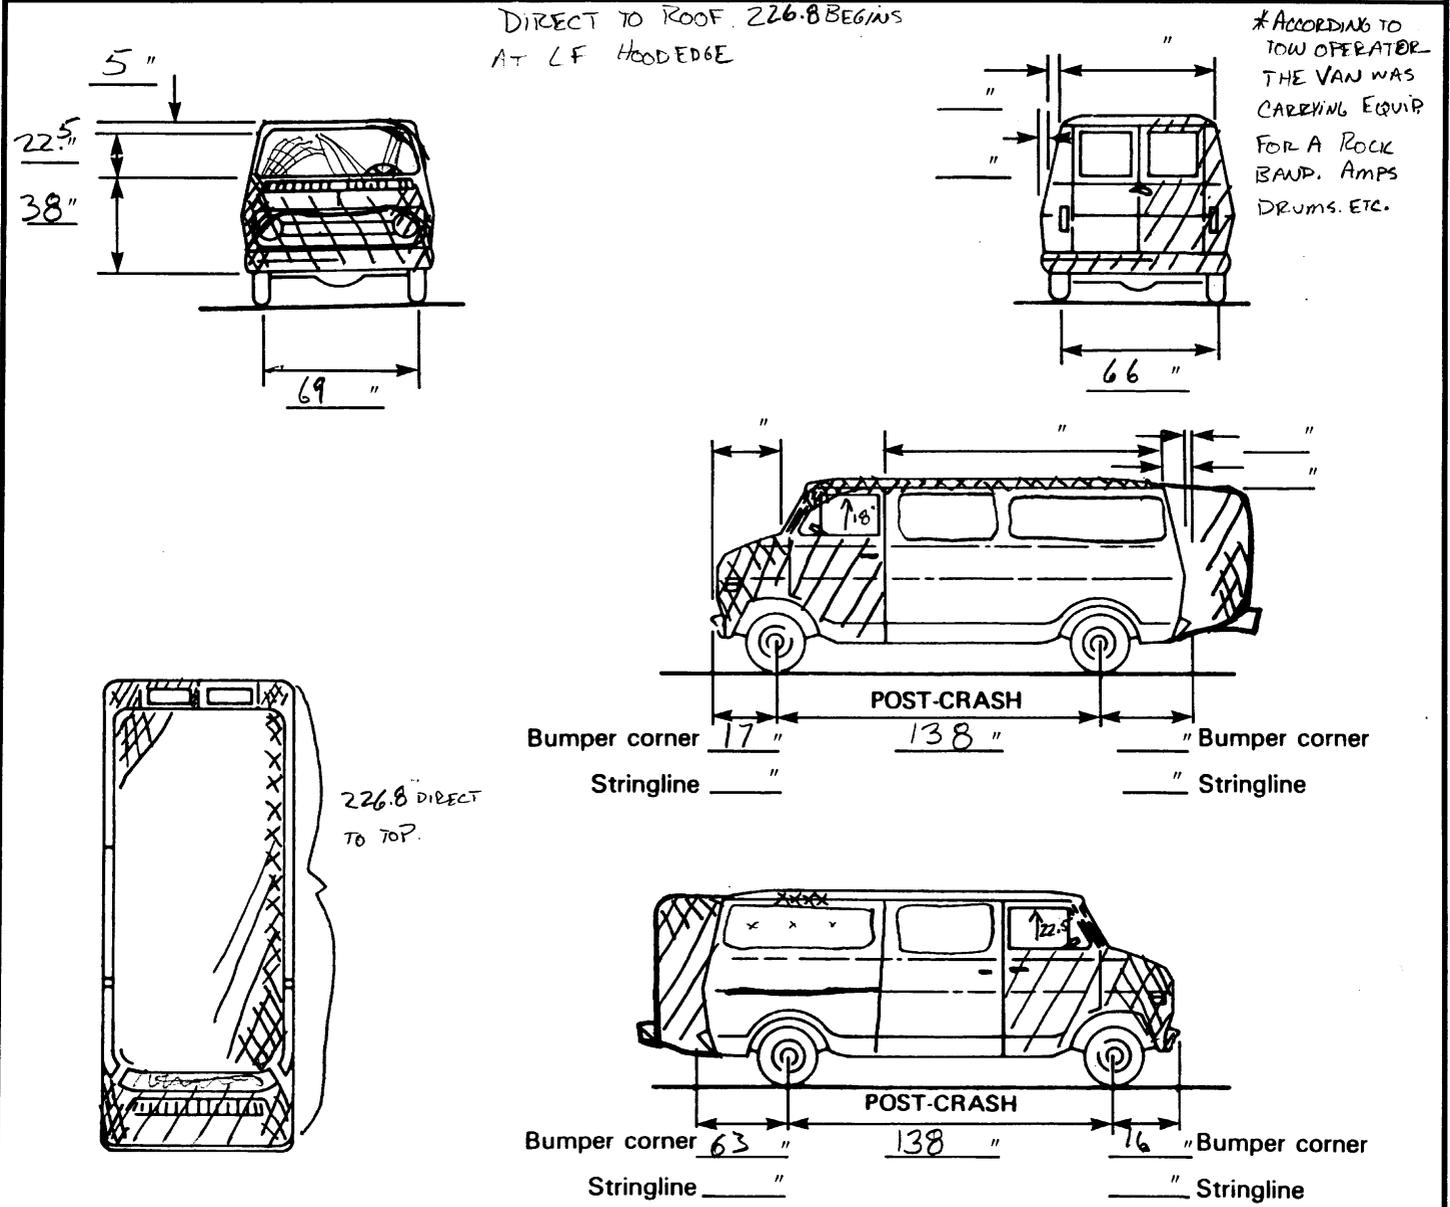
VEHICLE DAMAGE SKETCH

Vehicle No.	Class of Vehicle	Year/Make/Model	Most Severe Damage		Component Failure
			Damage Plane	Severity Description	
1	Passenger Van	88 /Ford/Club Wagon	Roof	Moderate	3rd Seat Anchor

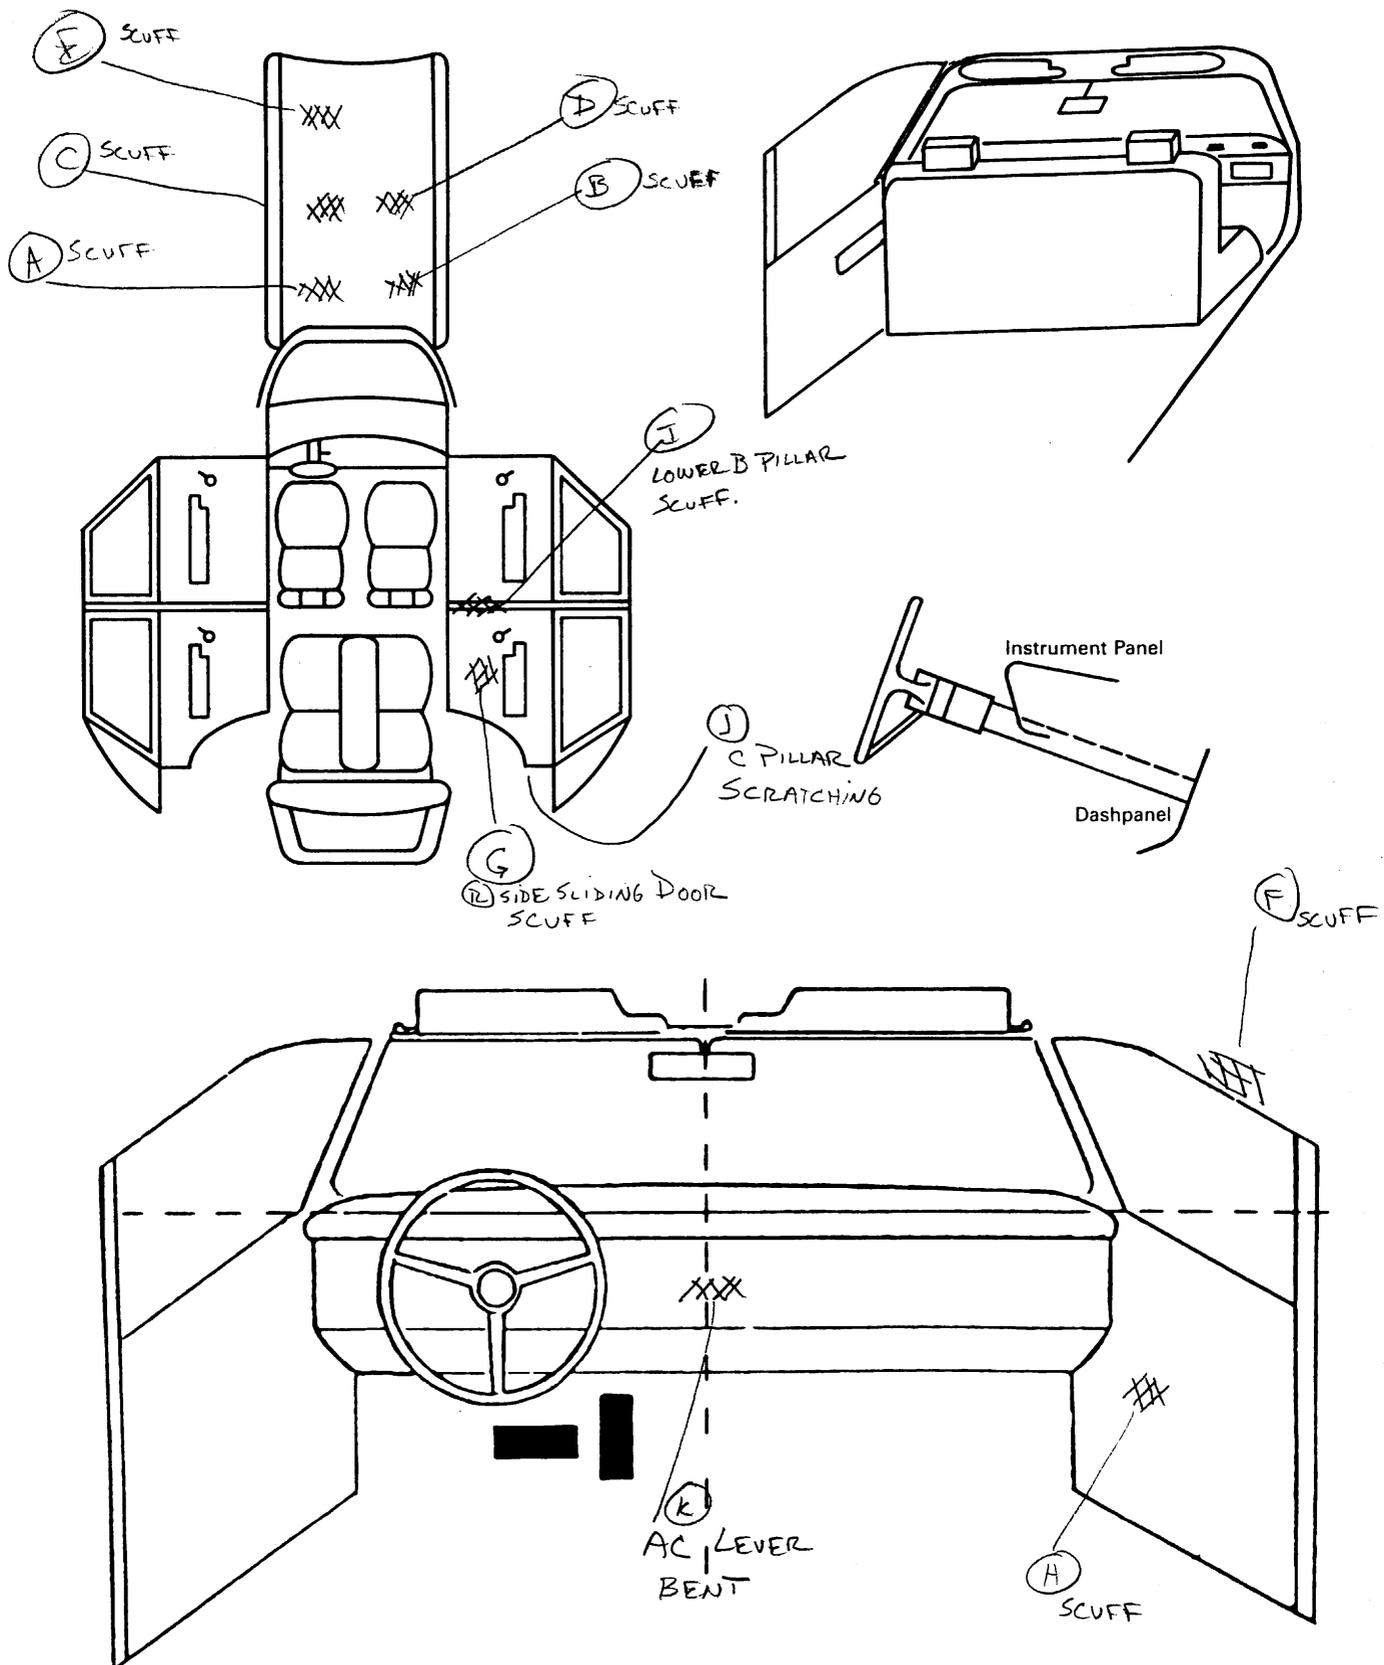
VEHICLE INTERIOR SKETCHES

Contact	Interior Component Contacted	Occupant No. If Known	Body Region If Known	Supporting Physical Evidence	Confidence Level of Contact Point
A	54	1	HEAD	SCUFF + HAIR	1
B	54	2	↓	↓	1
C	54	3	↓	↓	1
D	54	4	↓	↓	1
E	54	5	↓	↓	1
F	53	2	HEAD	SCUFF	1
G	37	4	(R) SIDE	SCUFF	1
H	30	2	(R) SIDE	SCUFF	1
I	31	4	FEET	SCUFF - DENT	1
J	34	5	(R) SIDE	SCUFF	1
K	10	1	UNKNOWN	AC VENT BROKEN	1
L					
M					
N
