**National Highway
Traffic Safety
Administration**

CASE SUMMARY

PSU 44 CASE NO. 148D TYPE OF ACCIDENT Car/Ran off road/Rollover

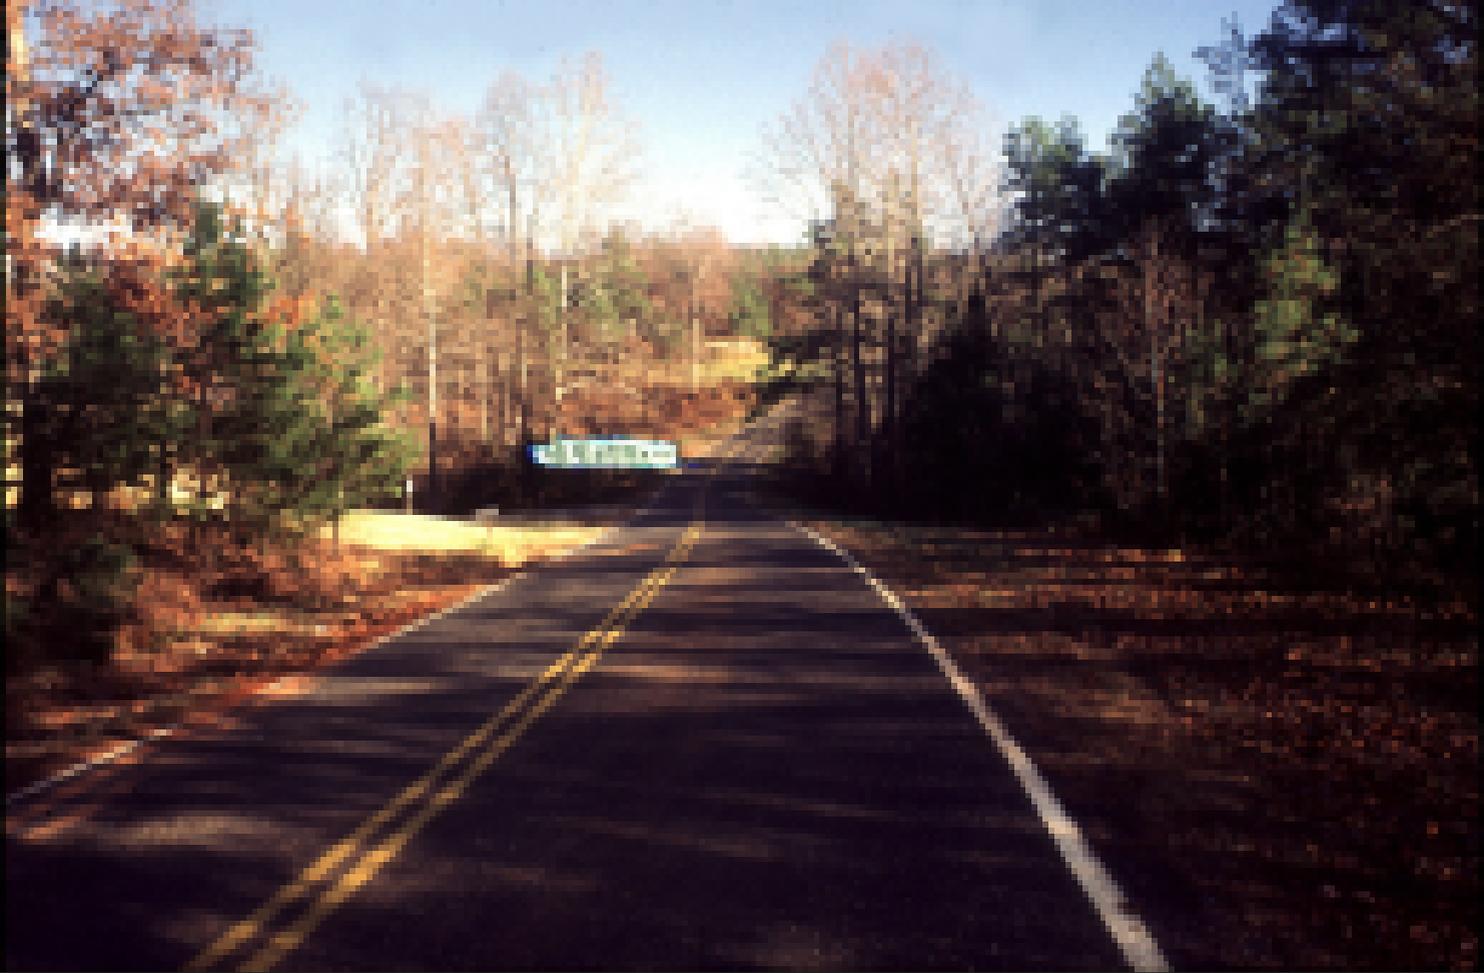
PSU 44-148D (1988) #1

Primary Sampling Unit Number <u>44</u>			Case Number--Stratum <u>148D</u>
Slide No.	Vehicle No.	Direction of Picture	Description of Slide Subject Matter
1-19	1		scene
1-2	1	East	VI approach
3	1	East	VI hits pothole (now filled in) and loses control
4-6	1	N. East	VI begins to rotate CCW off the road toward the embankment
7-10	1	N. EAST	VI ROLLS OVER AND STRIKES TREES
11-12	1	N. EAST	VI ROLLS BACK OVER ON ALL FOUR TIRES and comes to rest
13-19	1	West	lookbacks
20-38	1		exterior slides
32-38	1		stands were set up - however - later determined as rollover damage.
39-52	1		interior slides
41-42	1		door was open at the time of inspection
43	1		shows that windshield is cracked and out of place
44-45	1		shows steering wheel & column type
46-47	1		shows seat type - intrusion, damage to head restraints and restraint system
48-50	1		shows intrusions
51-52	1		shows back seat area & intrusions
