**National Highway
Traffic Safety
Administration**

CASE SUMMARY

PSU 77 CASE NO. 055C TYPE OF ACCIDENT vehicle/van^{-angle} impact; Van/rollover, Van/pedestrian

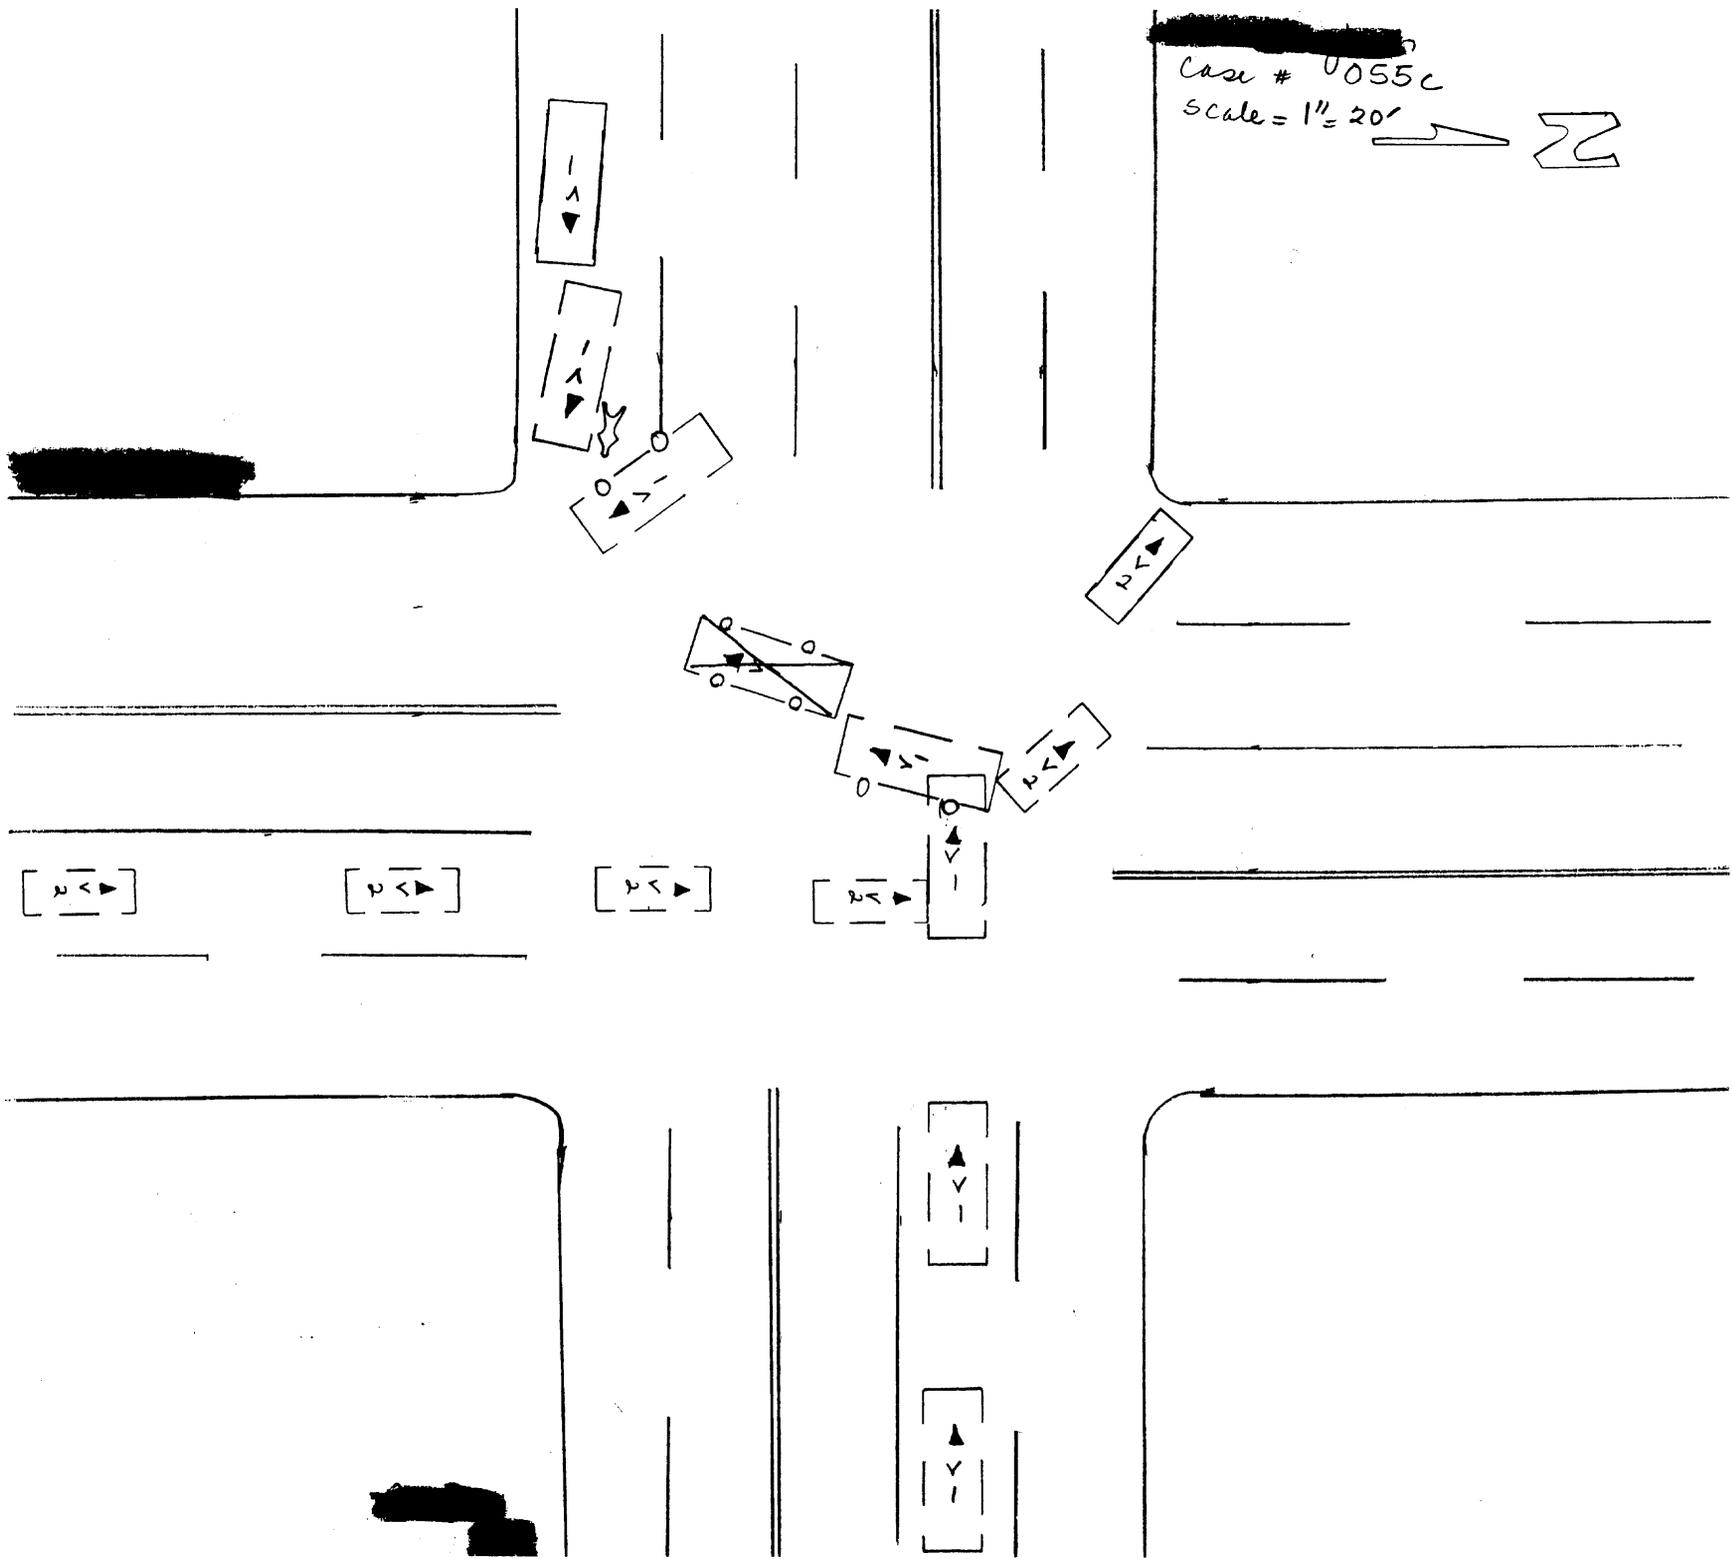
Case # 0055C

vehicle #1 was westbound on a local trafficway approaching a 4-way intersection. Vehicle #2 was northbound also approaching the intersection. Vehicle #1 & #2 entered the intersection at the same time & both vehicles collided. V#2 contacted V#1's left side causing it to start rolling. V#1 rolled 4 quarter turns then somehow slipped into reverse & started traveling westbound in reverse in the eastbound lanes of traffic -

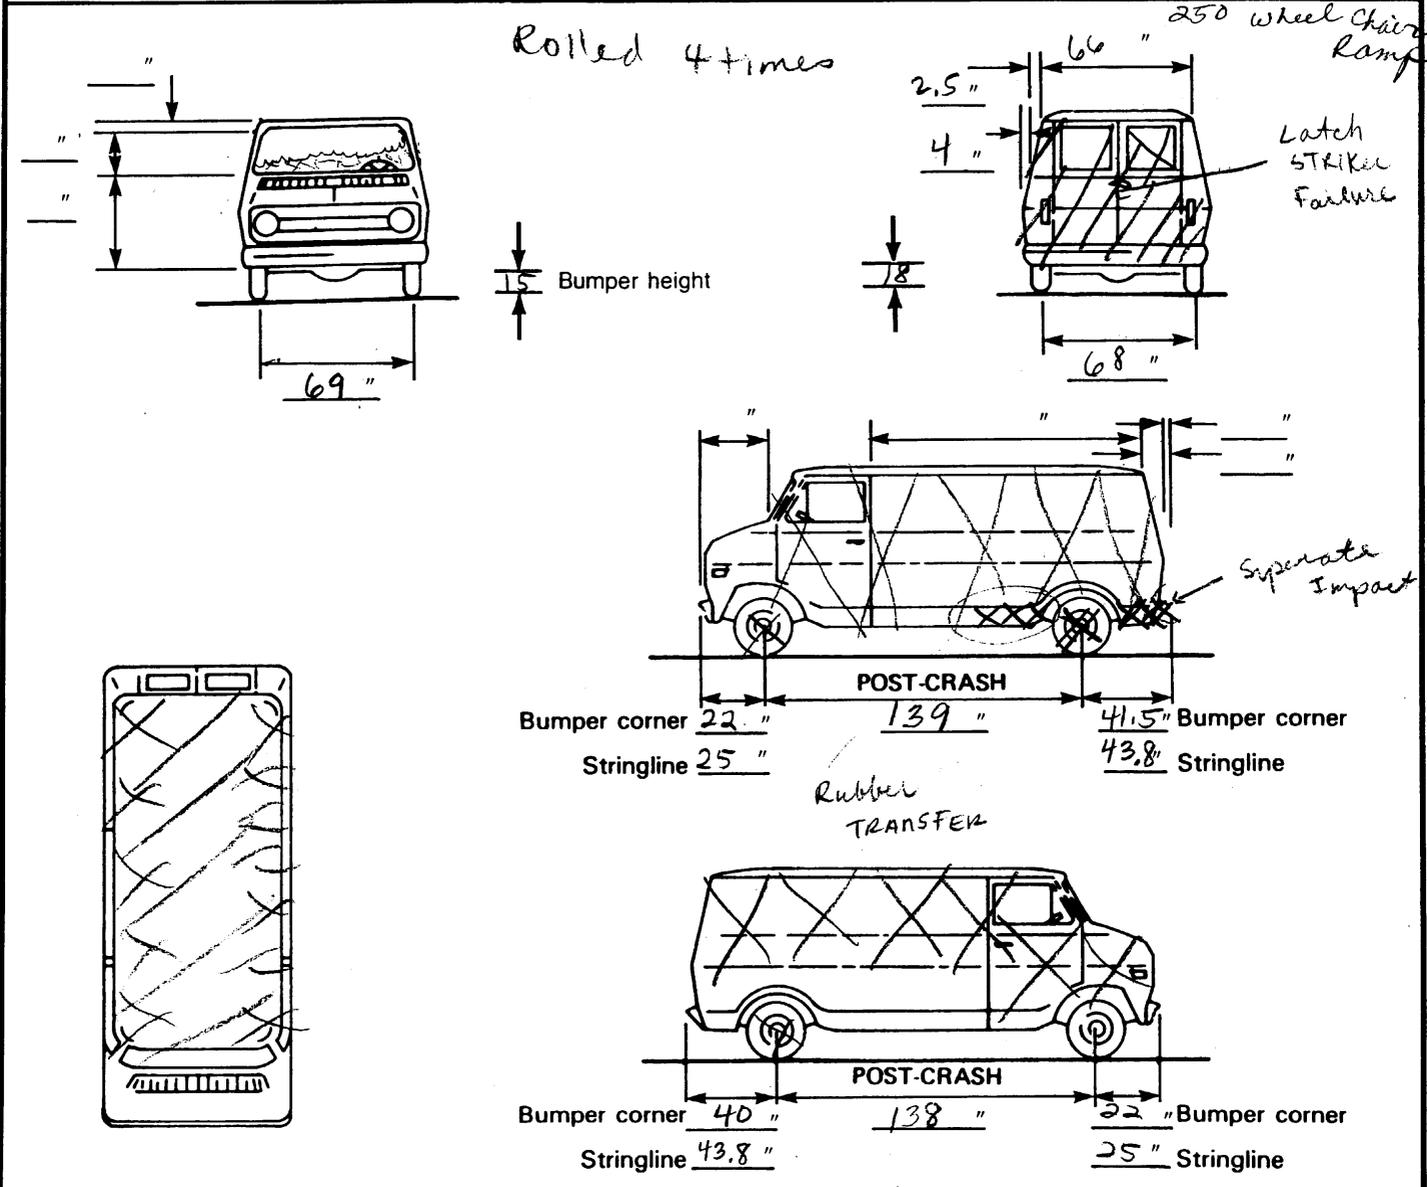
VEHICLE DAMAGE SKETCH

Specific Impact No.	Location of Direct Damage	Location of Field L
<u>01</u>	<u>Begins 52" in front of LR Axle</u>	<u>Begins LR BC</u>
<u>02</u>	<u>Rollover</u>

Specific Impact Number	Plane of C-Measurements	Direct Damage		Field L	C ₁	C ₂	C ₃	C ₄	C ₅	C ₆	±D
		Width (CDC)	Max Crush								
<u>02</u>	<u>L Side</u>	<u>12.75</u>	<u>Damaged</u>								
		<u>4.25</u>	<u>Comparison of check plate stick 14" down from front door</u>								
		<u>8.50</u>	<u>8.5" LF A-pillar area</u>								
<u>01</u>	<u>L Side</u>	<u>91"</u>	<u>C2</u>	<u>96.6</u>	<u>2.90</u>	<u>9.75</u>	<u>2.10</u>	<u>3.10</u>	<u>2.75</u>	<u>2.0</u>	<u>-62</u>
			<u>7.40</u>		<u>-2.35</u>	<u>2.35</u>	<u>-2.35</u>	<u>-2.35</u>	<u>-2.35</u>	<u>-2.35</u>	<u>-20.7</u>
	<u>Result</u>				<u>.55</u>	<u>7.40</u>	<u>0</u>	<u>.75</u>	<u>.40</u>	<u>0</u>	
	<u>Free space</u>										
	<u>Actual</u>

TIRE—WHEEL DAMAGE a. Rotation physically restricted RF <u>2</u> LF <u>2</u> RR <u>2</u> LR <u>2</u> (1) Yes (2) No (8) NA (9) Unk.		ORIGINAL SPECIFICATIONS Wheelbase <u>138</u> Overall Length <u>206.8</u> Maximum Width <u>79.8</u> Curb Weight <u>4,200</u> Average Track _____ Front Overhang <u>25</u> Rear Overhang <u>43.8</u> Engine Size: cyl./ displ. <u>8cyl/</u> Undeformed End Width <u>77</u>		WHEEL STEER ANGLES (For locked front wheels or displaced rear axles only) RF ± _____ ° LF ± _____ ° RR ± _____ ° LR ± _____ ° Within ± 5 degrees	
TYPE OF TRANSMISSION <input type="checkbox"/> Manual <input checked="" type="checkbox"/> Automatic		DRIVE WHEELS <input type="checkbox"/> FWD <input checked="" type="checkbox"/> RWD <input type="checkbox"/> 4WD		Approximate Cargo Weight _____

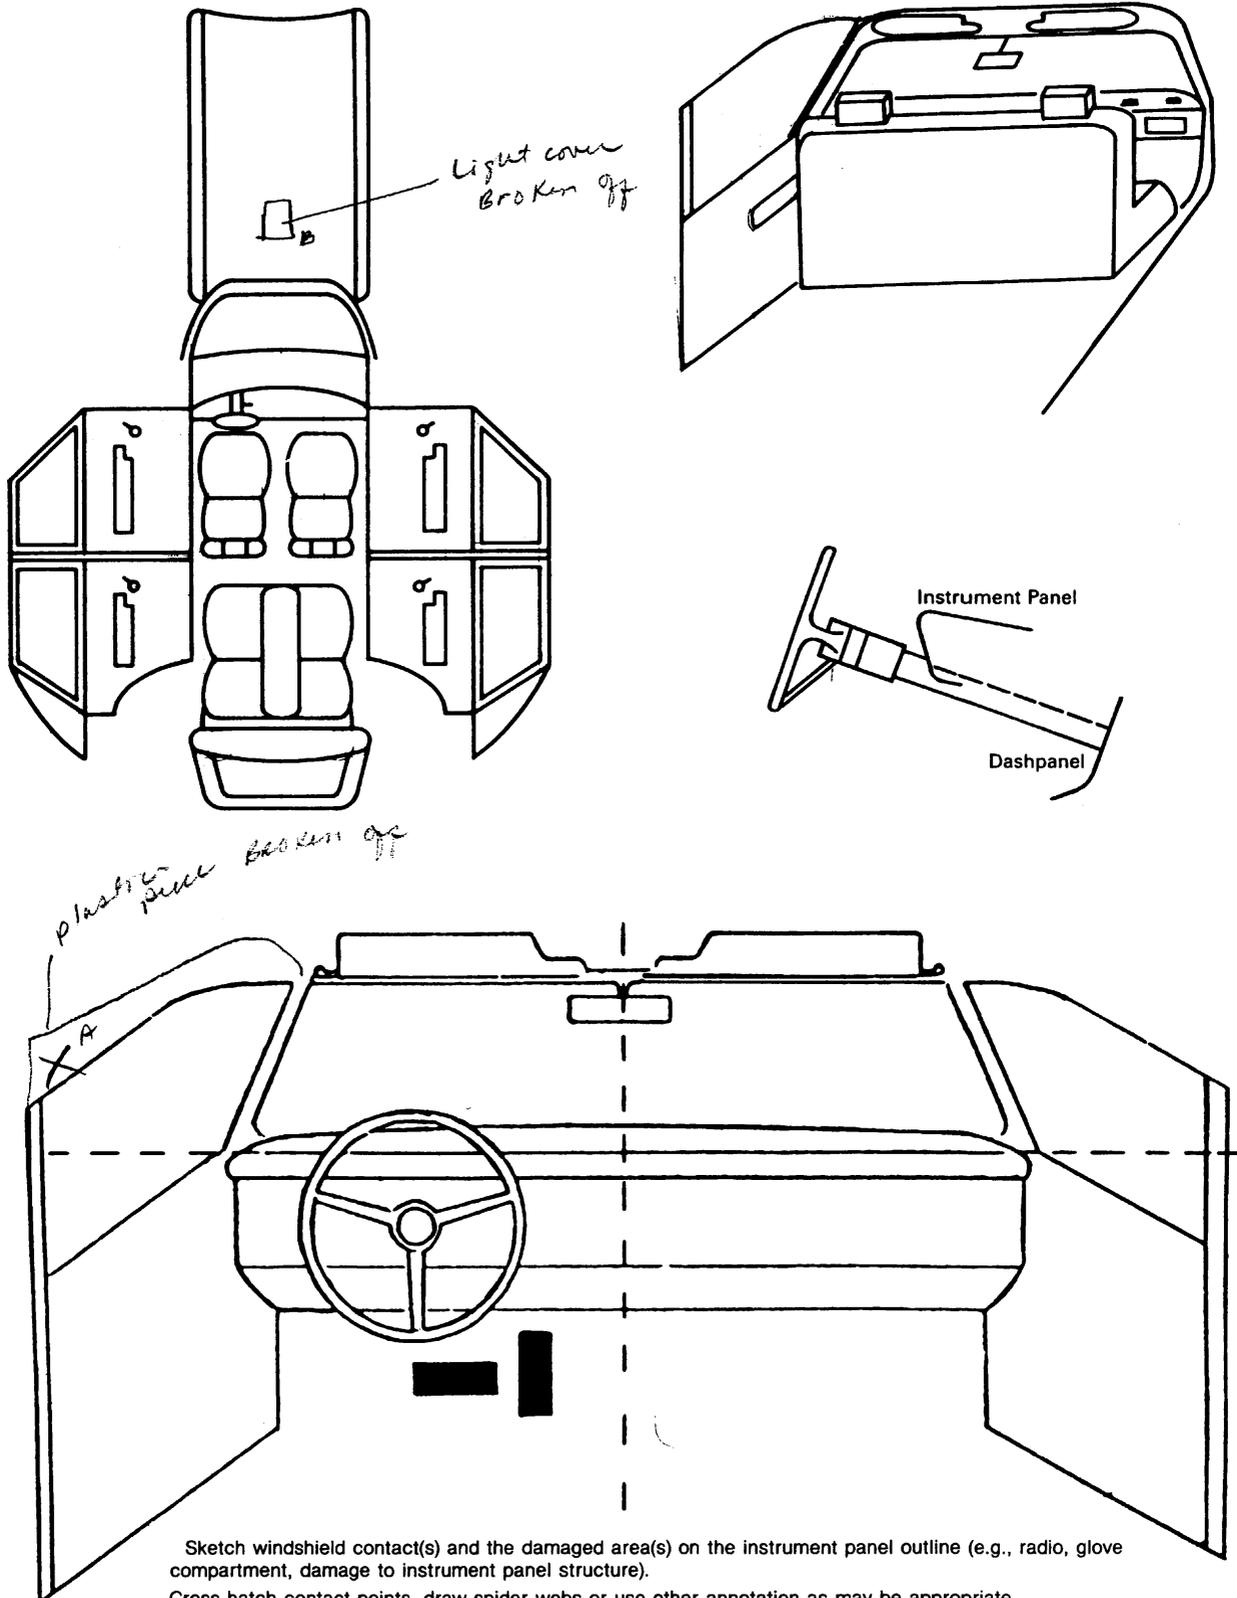
VEHICLE INTERIOR SKETCHES

Contact	Interior Component Contacted	Occupant No. If Known	Body Region If Known	Supporting Physical Evidence	Confidence Level of Contact Point
A	26	01	head	plastic piece broken off	2
B	54	01	head	Light cover Broken off	2
C					
D					
E					
F					
G					
H					
I					
J					
K					
L					
M					
N

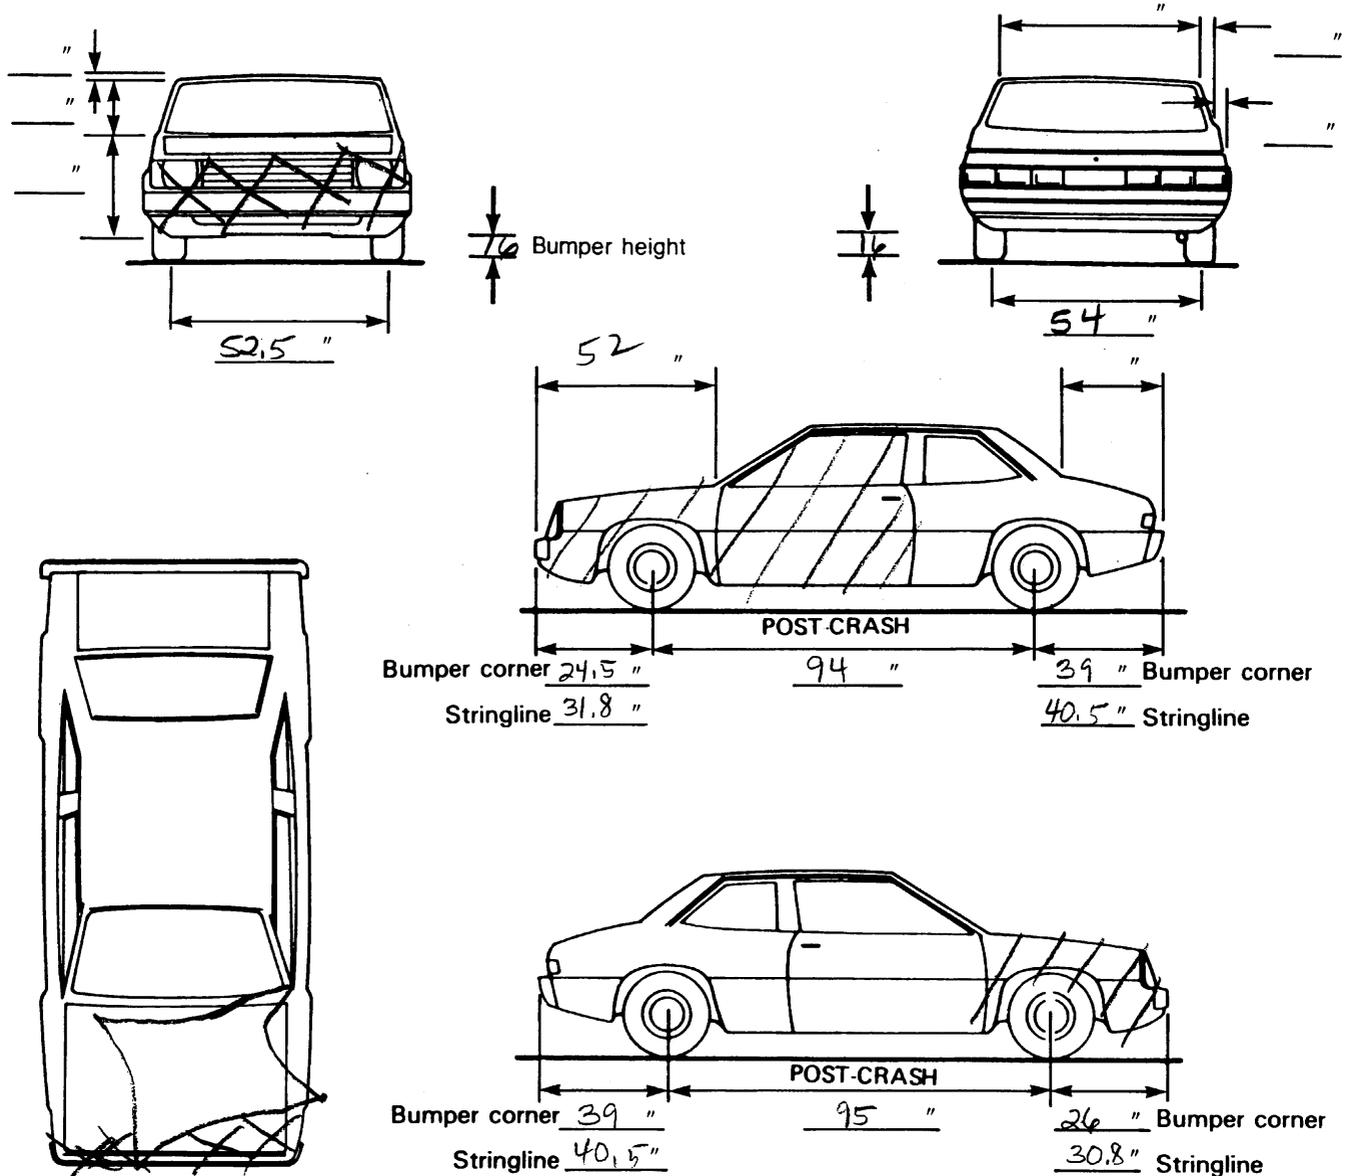
VEHICLE DAMAGE SKETCH

TIRE – WHEEL DAMAGE a. Rotation physically restricted RF <u>2</u> LF <u>2</u> RR <u>2</u> LR <u>2</u> (1) Yes (2) No (8) NA (9) Unk.		b. Tire deflated RF <u>2</u> LF <u>2</u> RR <u>2</u> LR <u>2</u>		ORIGINAL SPECIFICATIONS Wheelbase <u>94.5</u> Overall Length <u>166.3</u> Maximum Width <u>63.4</u> Curb Weight <u>2,116</u> Average Track <u>52.3</u> Front Overhang _____ Rear Overhang _____ Engine Size: cyl./ displ. <u>4cyl/196.8</u> Undeformed End Width <u>58.5</u>		WHEEL STEER ANGLES (For locked front wheels or displaced rear axles only) RF ± _____ ° LF ± _____ ° RR ± _____ ° LR ± _____ ° Within ± 5 degrees	
TYPE OF TRANSMISSION <input type="checkbox"/> Manual <input checked="" type="checkbox"/> Automatic				DRIVE WHEELS <input type="checkbox"/> FWD <input checked="" type="checkbox"/> RWD <input type="checkbox"/> 4WD		Approximate Cargo Weight _____
