CASE SUMMARY

NATIONAL ACCIDENT SAMPLING SYSTEM
CRASHWORTHINESS DATA SYSTEM

PSU 02 CASE NO. 051C TYPE OF ACCIDENT Car hits car

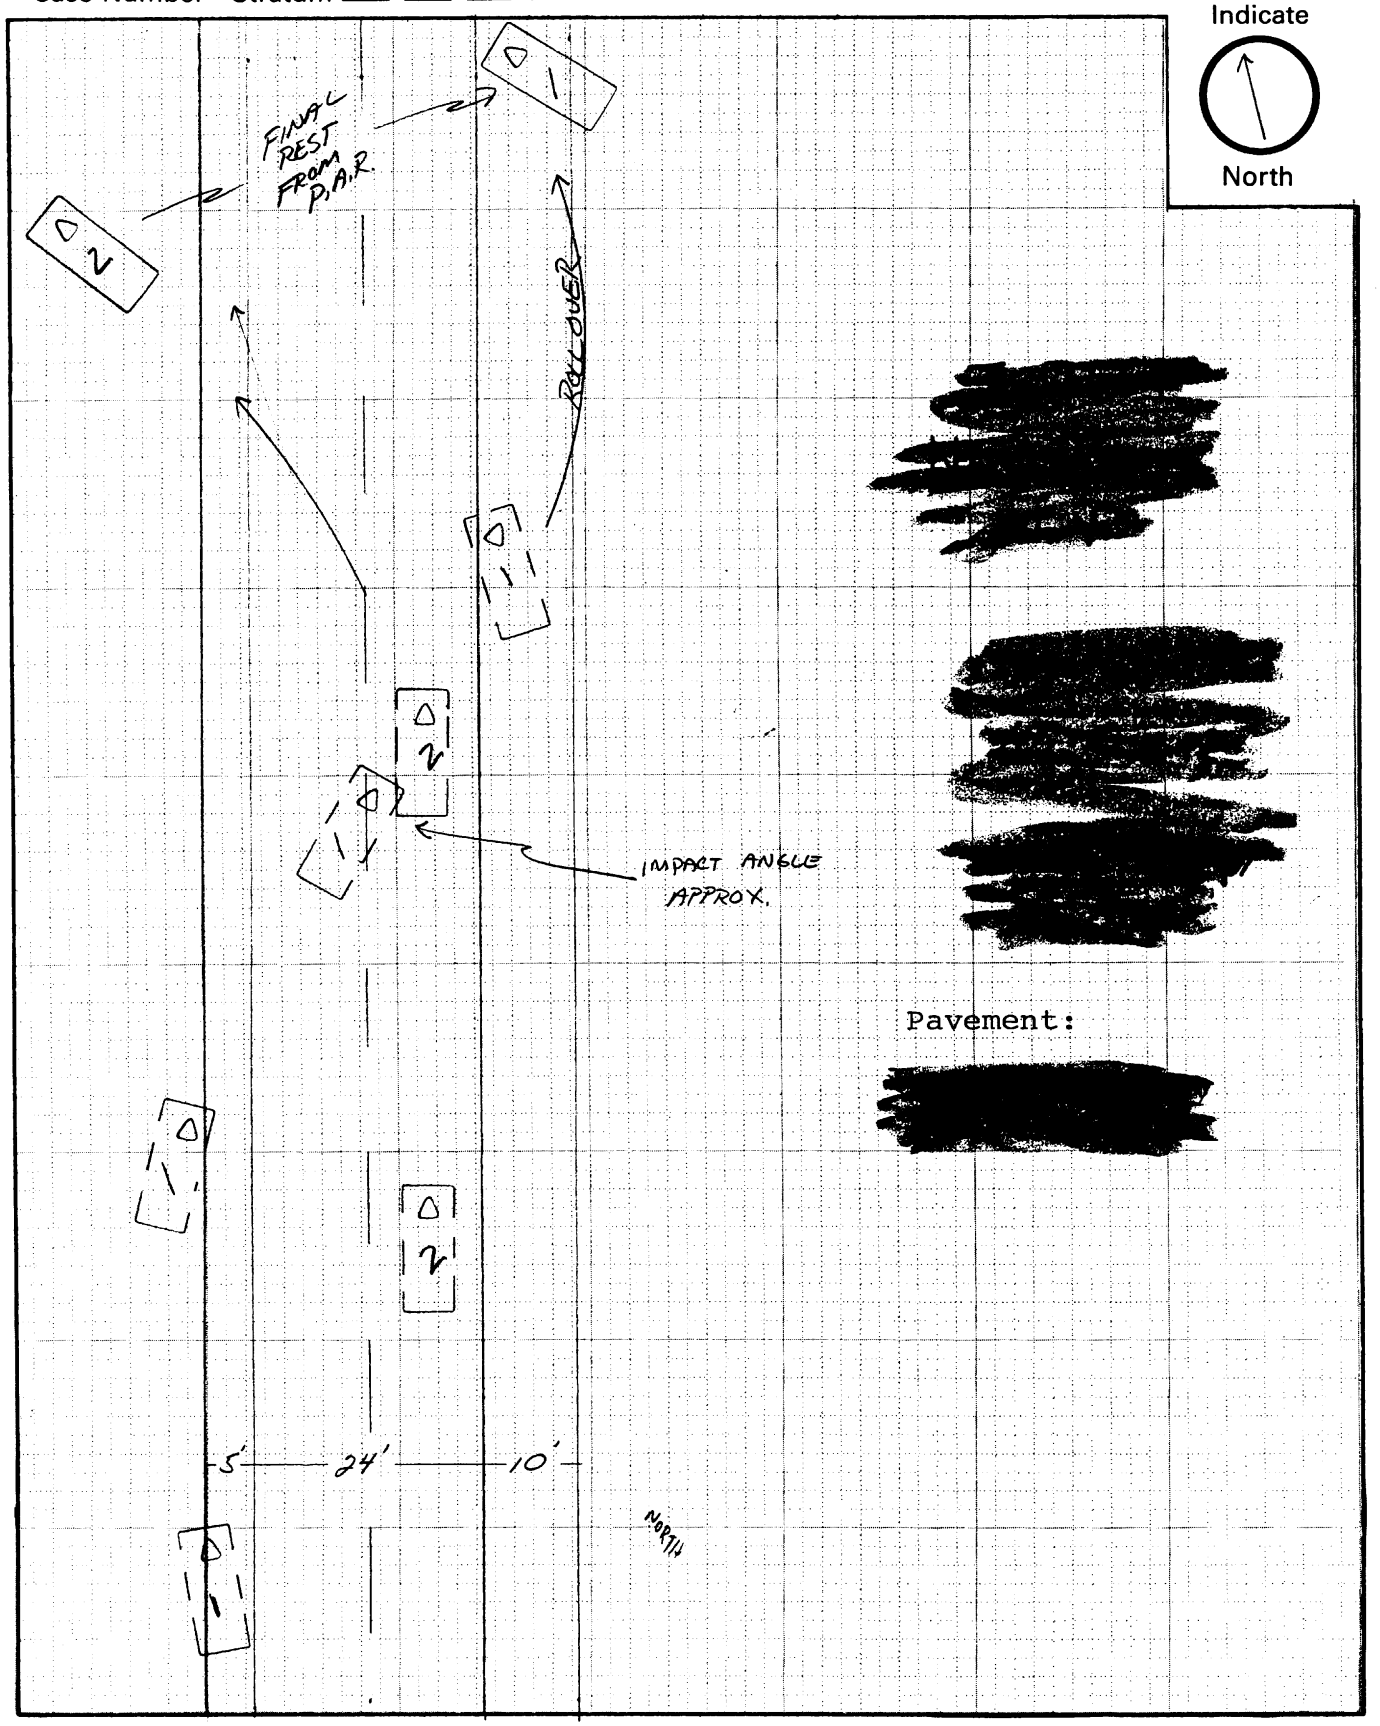
ACCIDENT COLLISION DIAGRAM

Both Vehicles NB on I87 - four lane divided highway, Two lanes each direction. V1 in passing lane, V2 in driving lane. V1 moves into driving lane, striking V2 in left side, V1 looses control and rolls over on Right shoulder of roadway, V2 goes off Left shoulder down embankment.

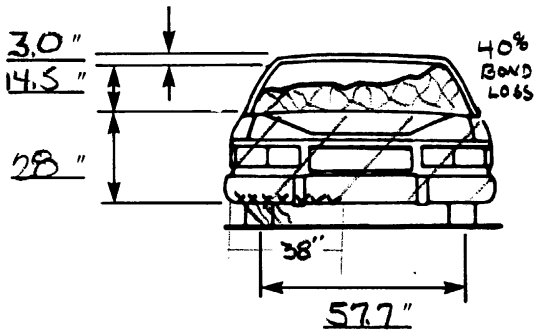
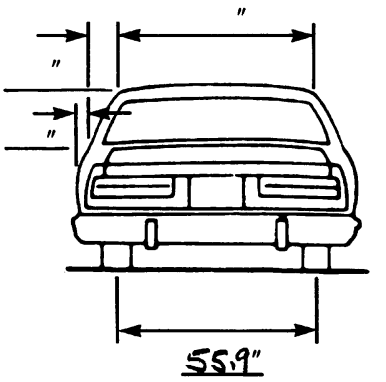
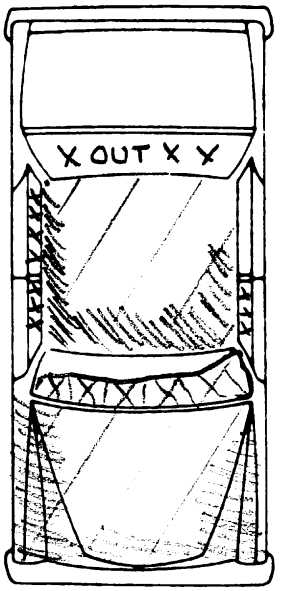
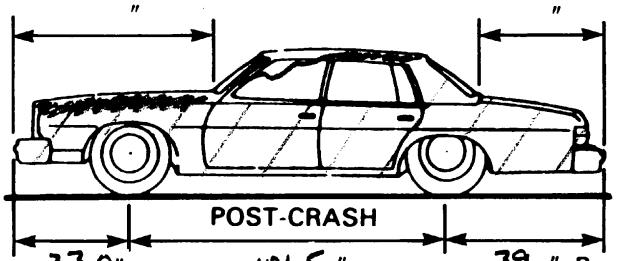
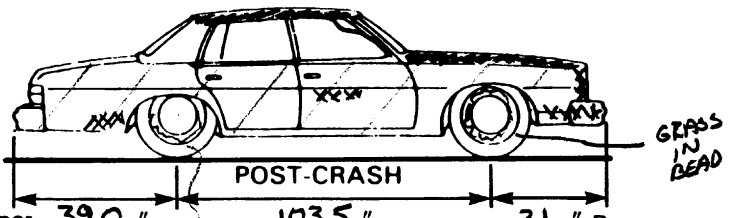
VEHICLE DAMAGE SKETCH

Bumper corner 33.0" 101.5" 39" Bumper corner

Bumper corner 39.0" 103.5" 31" Bumper corner

Stringline N/A " GRASS/ROCKS IN BEAD N/A " Stringline

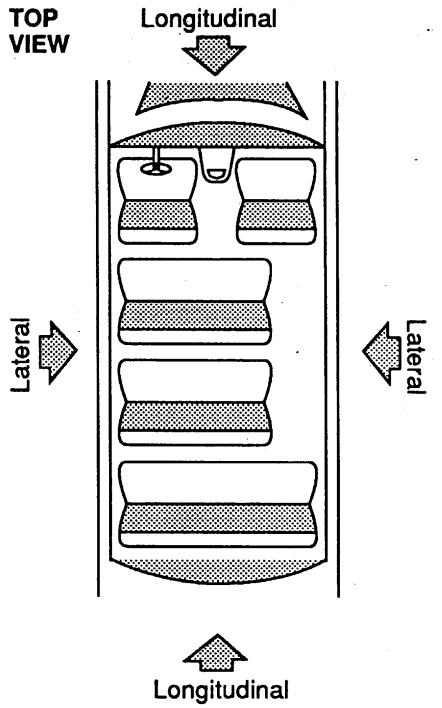
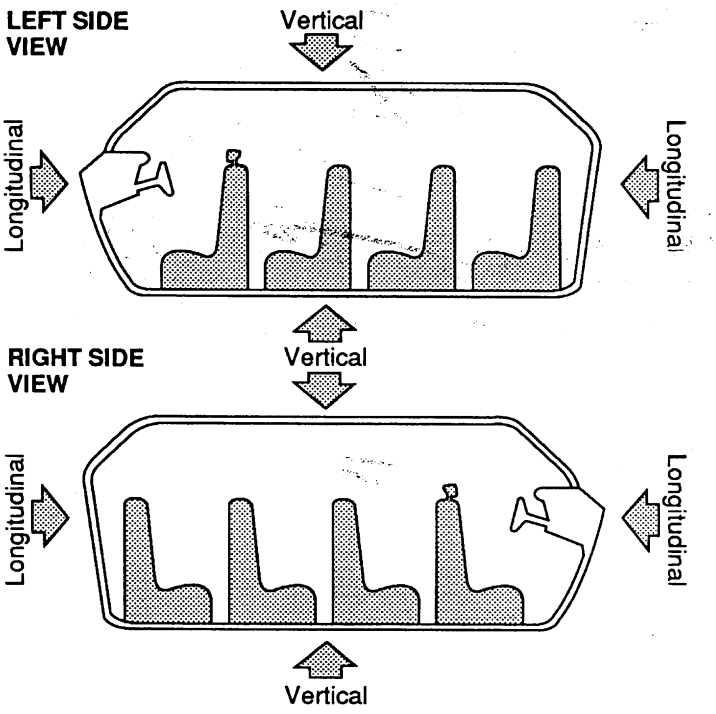
INTRUSION WORK SHEET

INTRUDED COMPONENT	LOCATION OF INTRUSION	DOMINANT CRUSH DIRECTION	COMPARISON VALUE	–	INTRUDED VALUE	=	INTRUSION	
	A	11	Vert		–		=	3-6"	EST "DIFF
	A	13	Vert		–		=	3-6"	—
3	W/S	11	Vert	39.5	–	30	=	9.5	TO FLOOR
2	W/S	12	Vert	30.5	–	10	=	20.5	TO CONSOLE
1	W/S	13	Vert	39.5	–	13	=	26.5	TO FLOOR
9 10	12, 13, 14	11	Vert	41.0	–	36	=	5	TO FLOOR
	12, - 14	12	Vert	32.0	–	31	=	1	TO CONSOLE
5 6 7	12, 13, 14	13	Vert	41.0	–	35	=	6	TO FLOOR
	WIND FRAME	11	LAT	0	–	5	=	5	
4	"	13	LATERAL	0	–	7	=	7	
					–		=		
					–		=		
					–		=		
					–		=		
					–		=

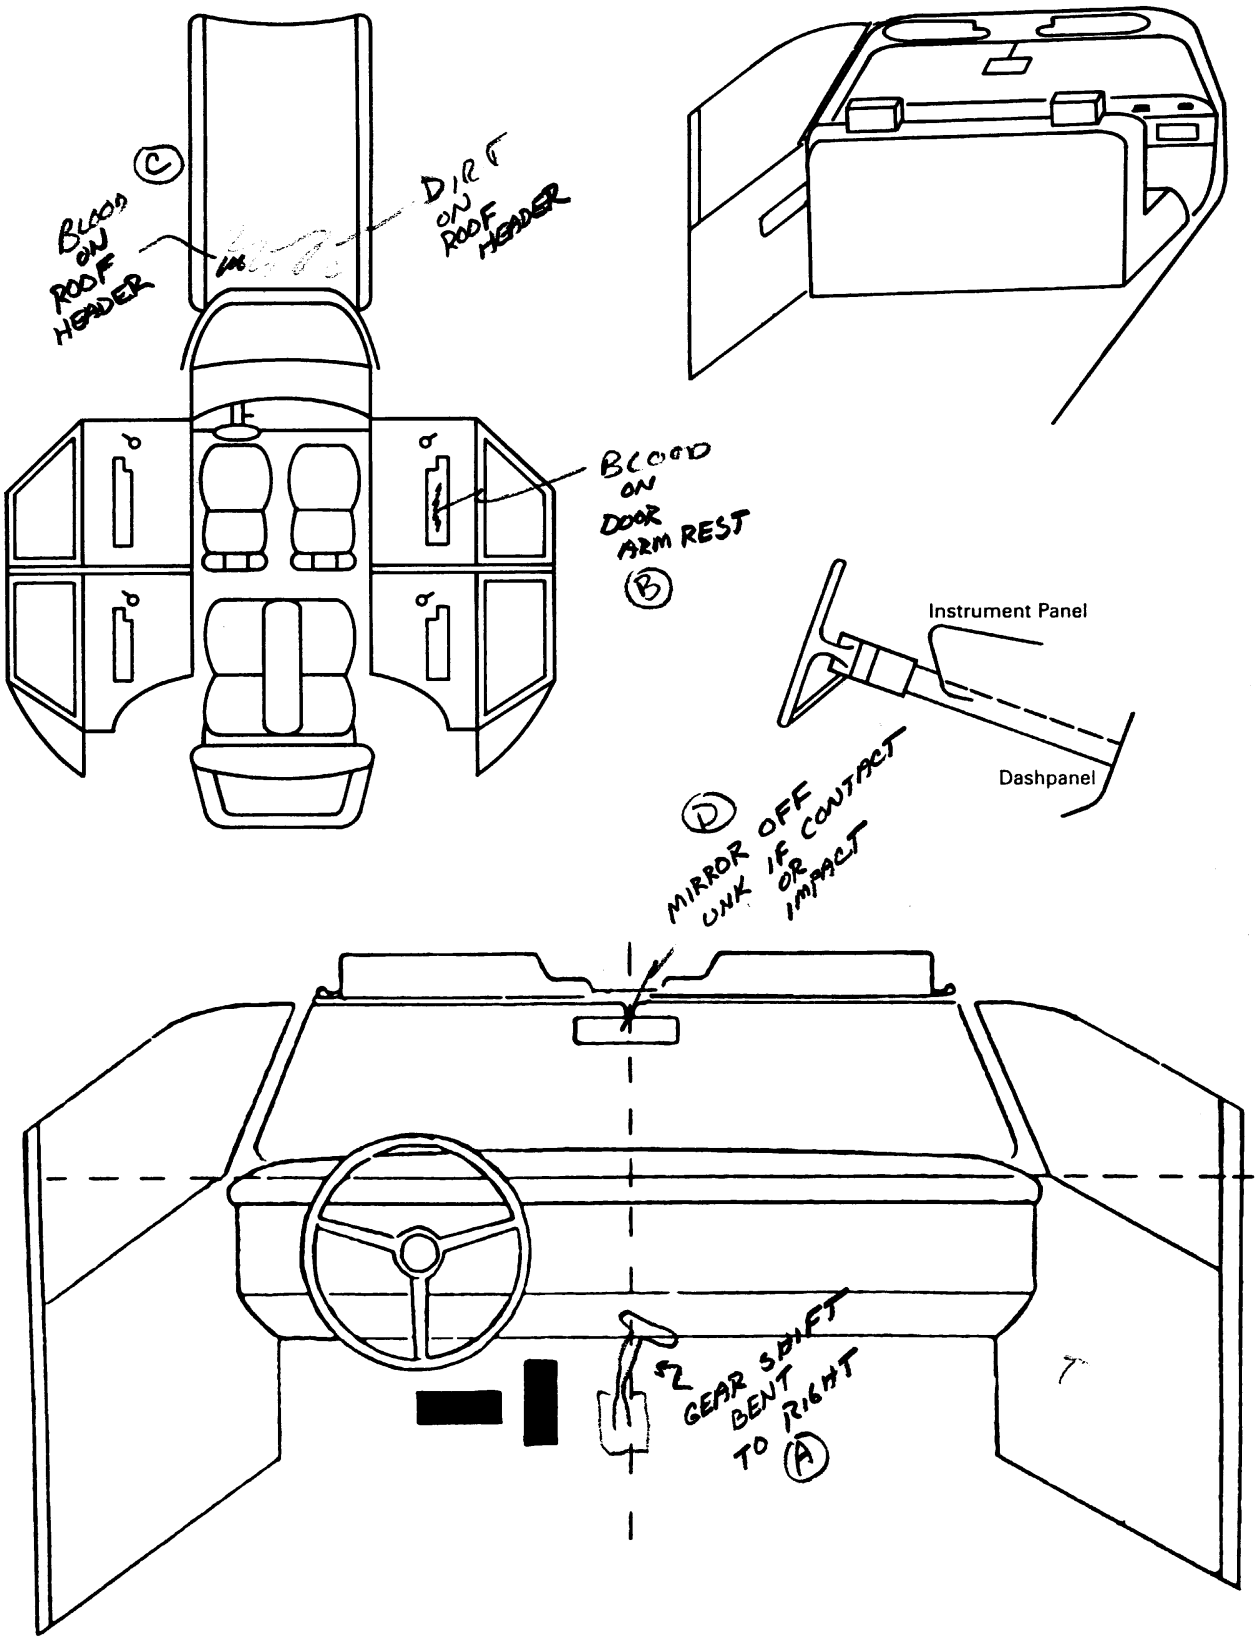
VEHICLE INTERIOR SKETCHES

Contact	Interior Component Contacted	Occupant No. If Known	Body Region If Known	Supporting Physical Evidence	Confidence Level of Contact Point
A	57	01	R/HIP	LEVER BENT	1
B	31	02	R/HIP	BLOOD / OCC TRAJ.	1
C	50/54	01/02	HEAD	BLOOD	2
D	02	01	?	BROKE OFF	3
E					
F					
G					
H					
I					
J					
K					
L					
M					
N
