CASE SUMMARY

NATIONAL ACCIDENT SAMPLING SYSTEM
CRASHWORTHINESS DATA SYSTEM

PSU 05 CASE NO. 152F TYPE OF ACCIDENT Vehicle to vehicle rearend w/rollover

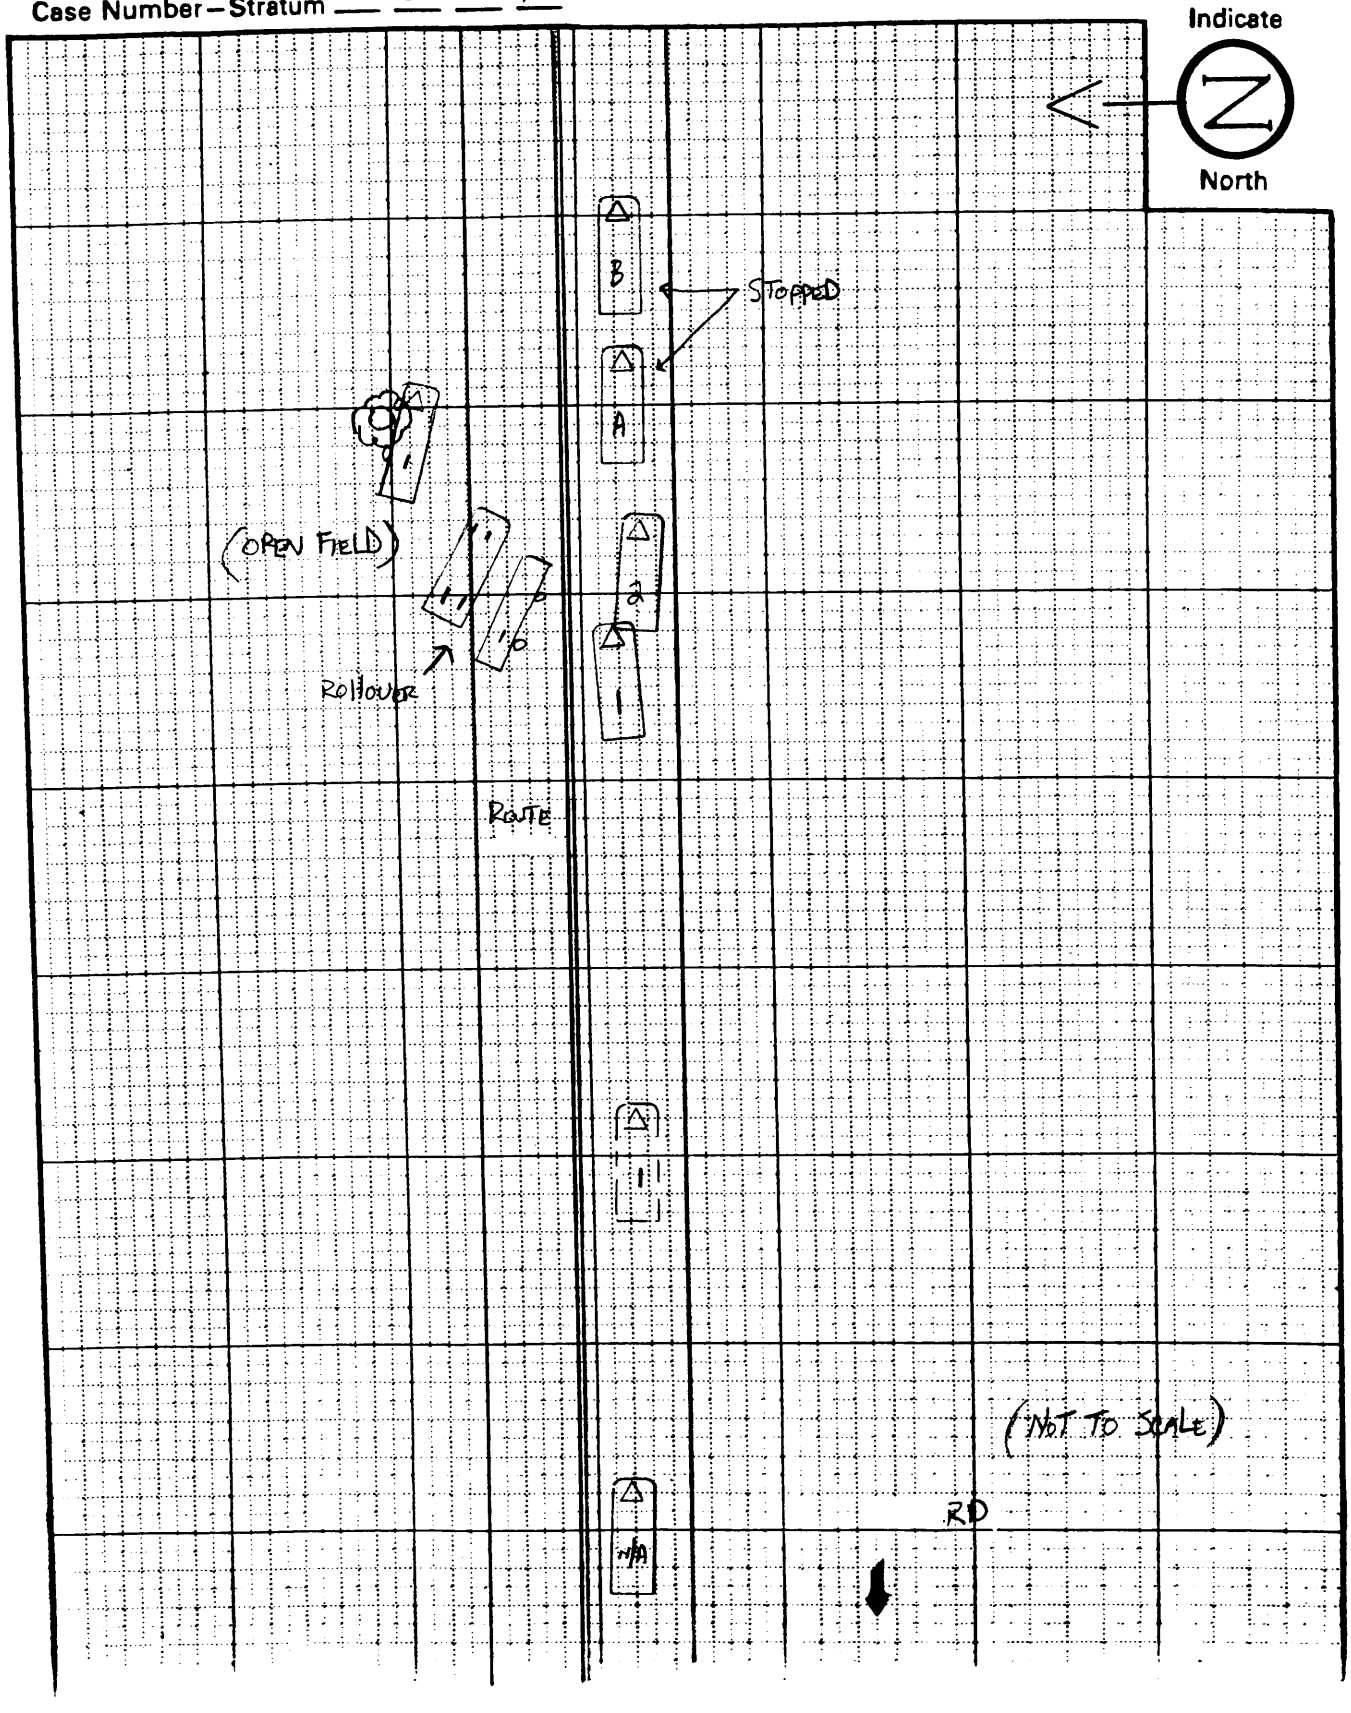
ACCIDENT COLLISION DIAGRAM

V1 was travelling east on a two lane divided roadway. V2 was stopped for traffic ahead of V1. V1 struck the rear of V2. It rotated clockwise and rolled over. It contacted a tree during rollover sequence.

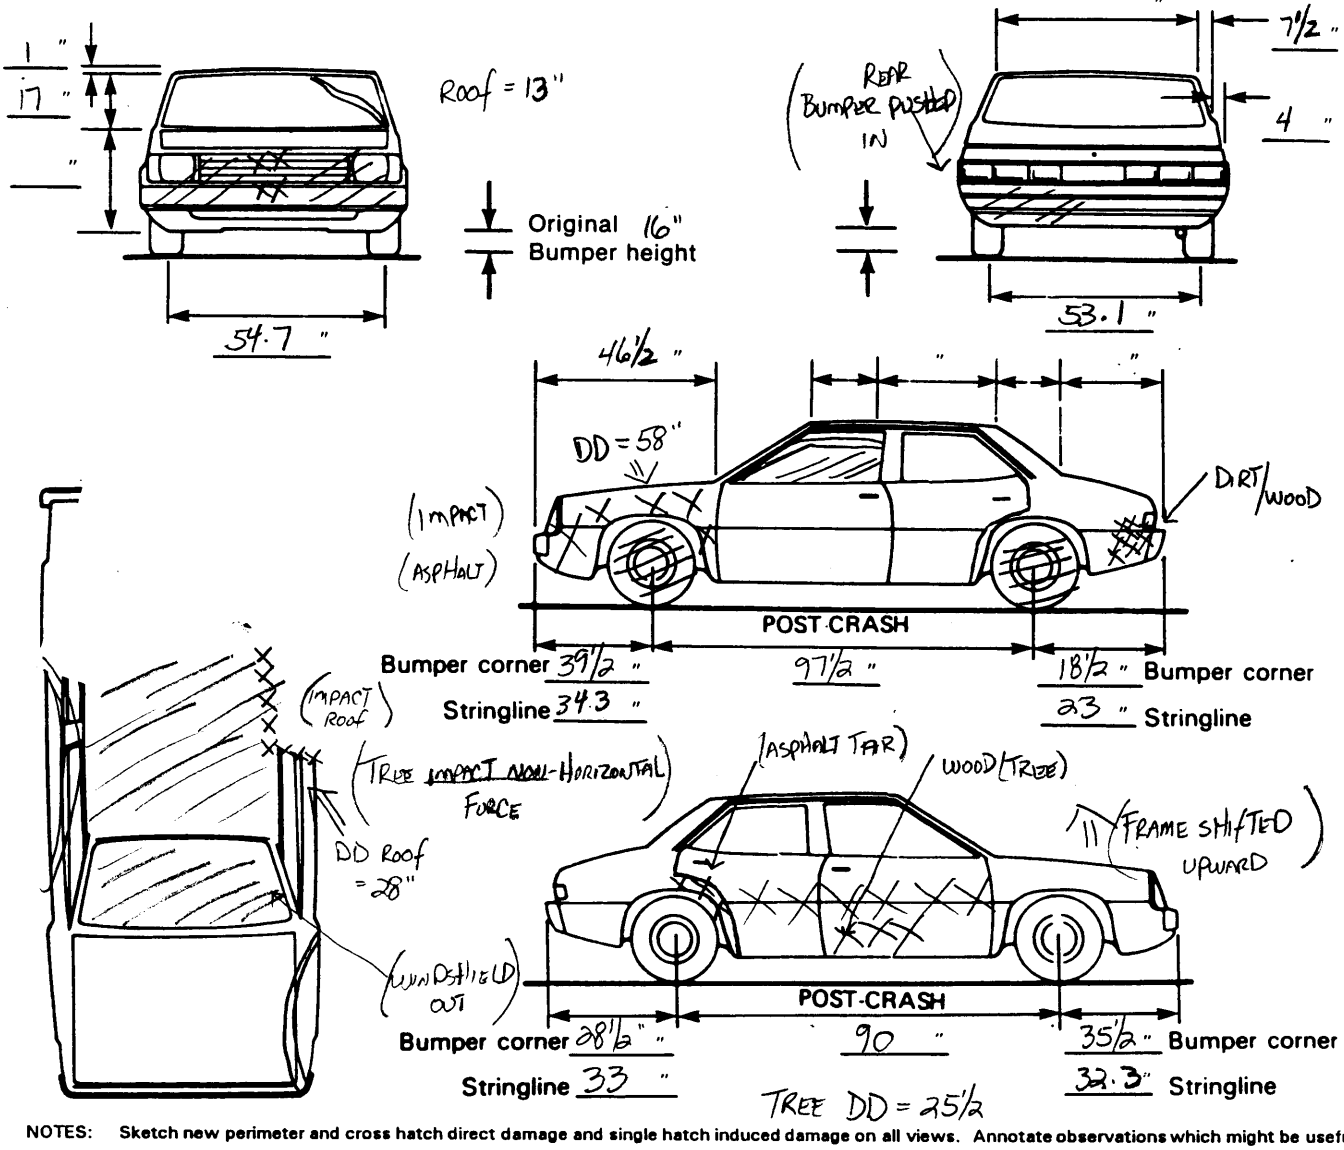
VEHICLE DAMAGE SKETCH

Specific Impact Number	Plane of Impact C-Measurements	Direct Damage		Field L	C_1	C_2	C_3	C_4	C_5	C_6	±D
		Width (CDC)	Max Crush								
3	FRONT BUMPER	—	↓	—	7	11½	17¾	15½	14	13	—
—	FREE SPACE	—	↓	—	1½	½	0	0	½	1½	—
*	CRUSH	33	19¾	50½	5½	11	17¾	15½	13½	11½	+11.25
2	ROOF	—	13½"	—							
1	TREE	25½"	18½"	—							
	(RIGHT SIDE)

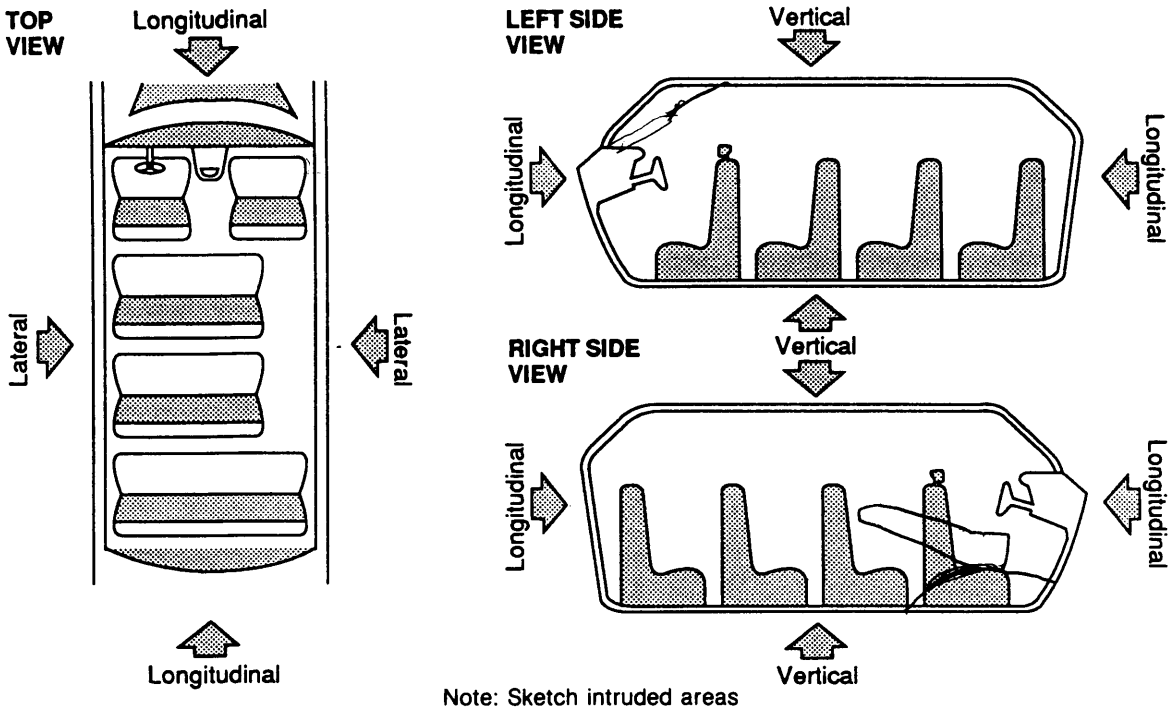
INTRUSION WORKSHEET

LOCATION OF INTRUSION	INTRUDED COMPONENT	COMPARISON VALUE	–	INTRUDED VALUE	=	INTRUSION	DOMINANT CRUSH DIRECTION
11	A Pillar	27"	–	22 Top of A Pillar	=	5"	Long
11	Roof	33"	–	23 to seat	=	10" ✓	Vert
12	Roof	33"	–	27 to seat	=	6" ✓	Vert
23	Seat back	28	–	20	=	8" ✓	Long.
13	Floor	—	–	—	=	15 ✓	Vert
			–		=		
			–		=		
			–		=		
			–		=		
			–		=		
			–		=		
			–		=		
			–		=		
			–		=		
			–		=

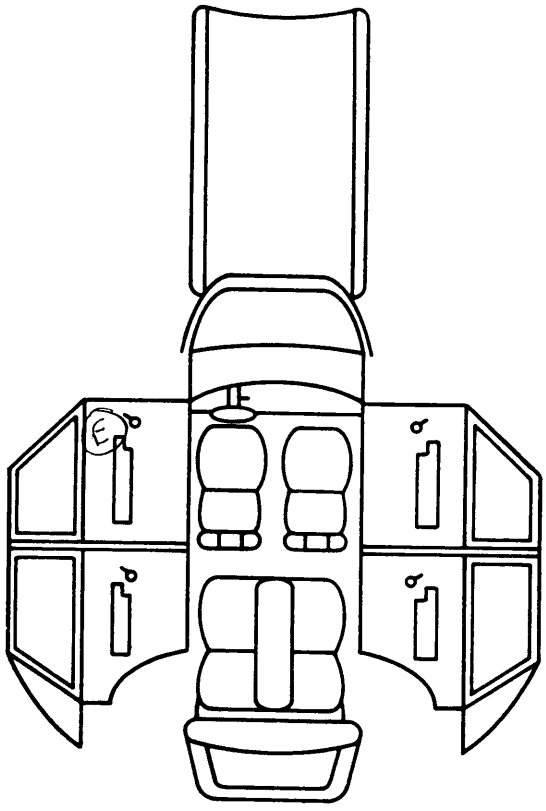
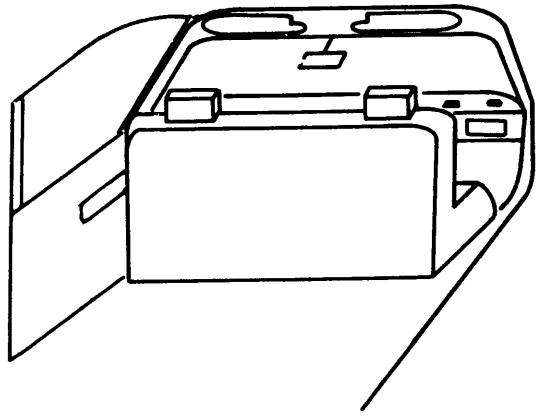
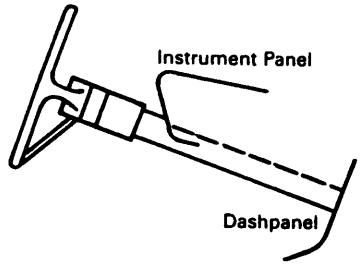
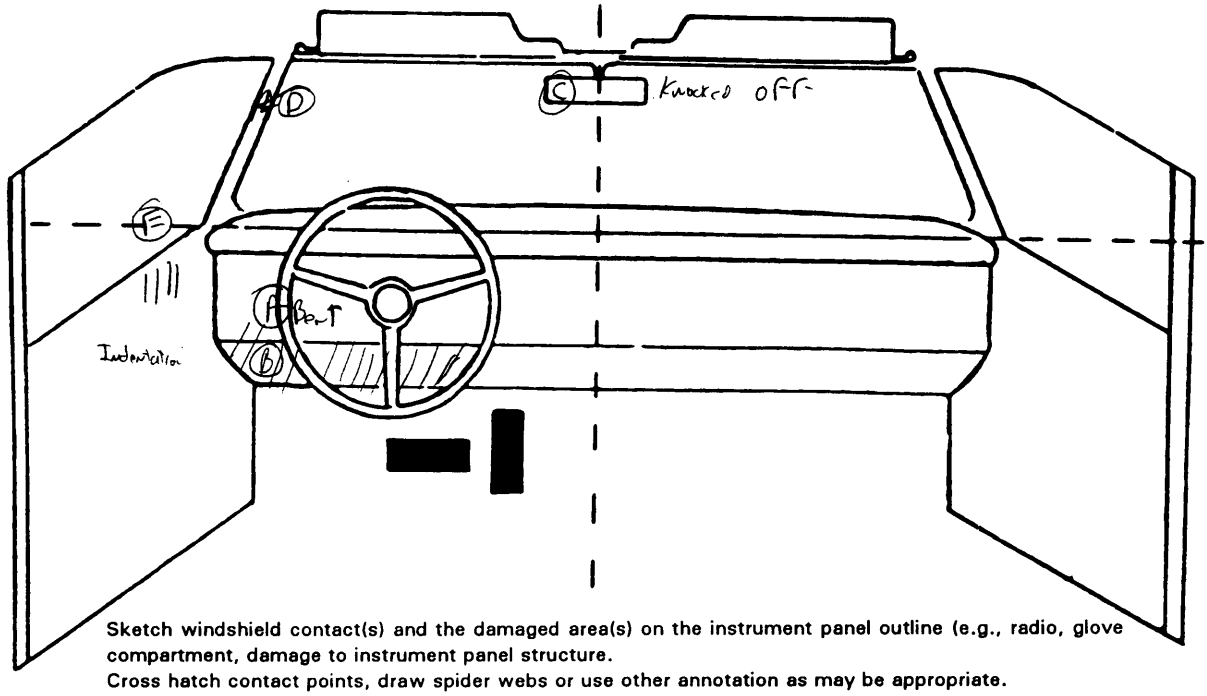
VEHICLE INTERIOR SKETCHES

Contact	Interior Component Contacted	Occupant No. If Known	Body Region If Known	Supporting Physical Evidence	Confidence Level of Contact Point
A	04	1	CHEST	BENT	1
B	09	1	KNEES	CRACK	2
C	02	1	HEAD	KNOCKED off	3
D	22	1	HEAD	CRACK	2
E	21	1	(4) TORSO	CRACK	1
F					
G					
H					
I					
J					
K					
L					
M					
N
