CASE SUMMARY

NATIONAL ACCIDENT SAMPLING SYSTEM
CRASHWORTHINESS DATA SYSTEM

PSU 79 CASE NO. 072F TYPE OF ACCIDENT Car/car - head-on

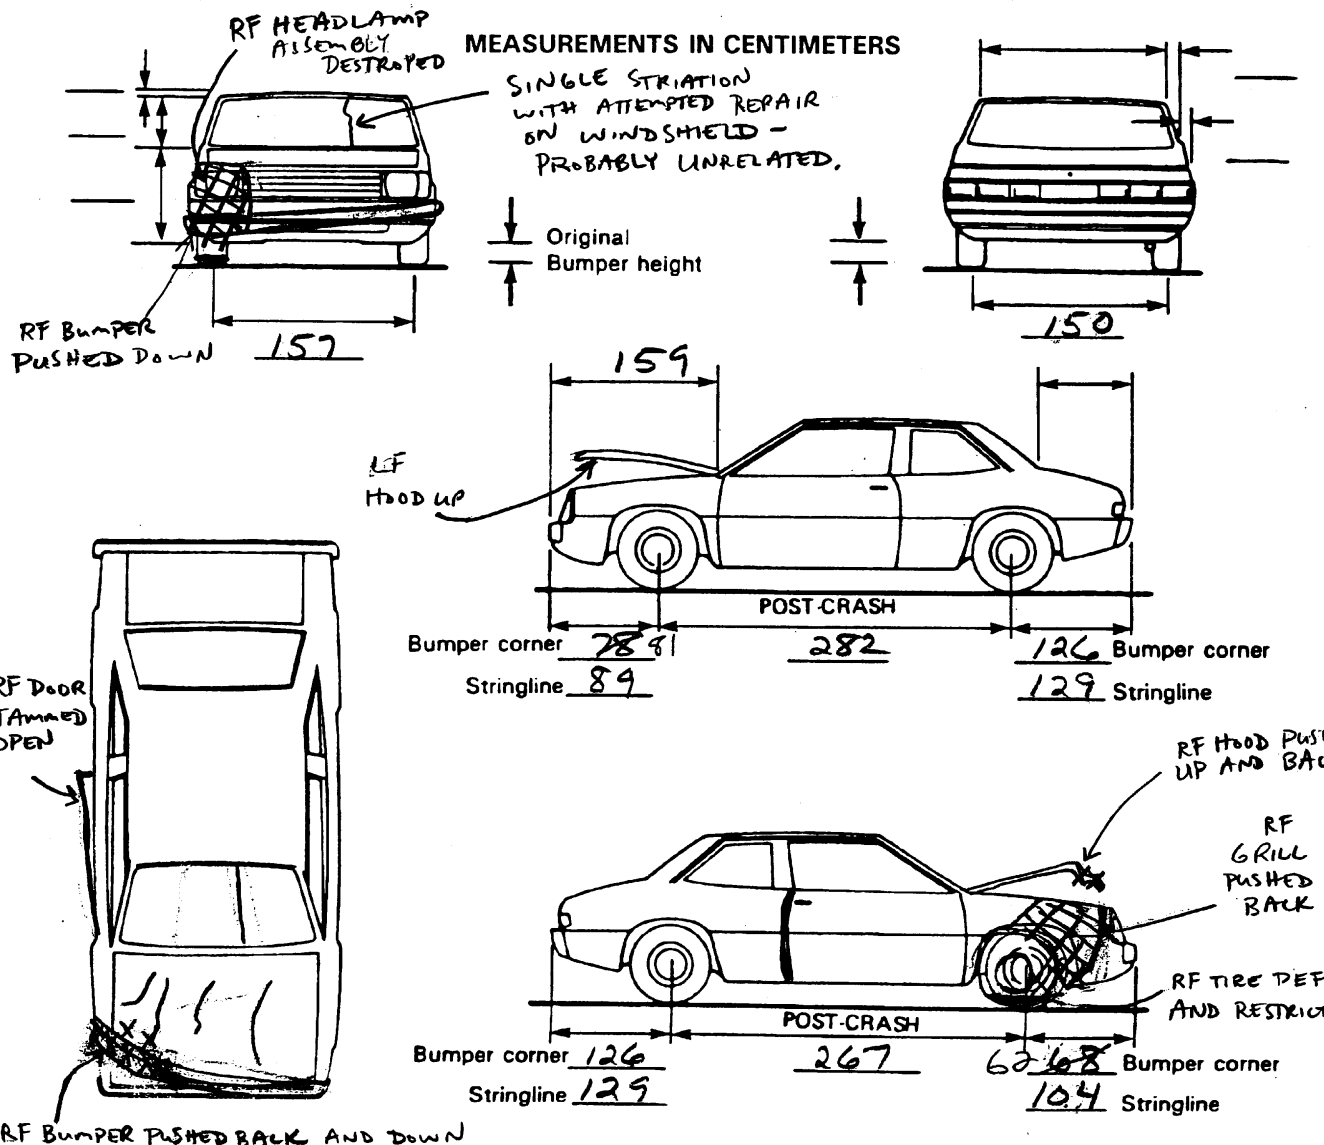
VEHICLE DAMAGE SKETCH

Specific Impact No.	Location of Direct Damage	Location of Field L
01	Begins at RF bumper corner to 26cm left of center	across entire front

Direct damage begins 26 cm left of longitudinal center

Specific Impact Number	Plane of Impact C-Measurements	Direct Damage Width (CDC)	Direct Damage Max Crush	Field L	C_1	C_2	C_3	C_4	C_5	C_6	±D
01	mid bumper	55 cm	42	163	7.5	2.5	6.5	12	20	42	~~Ø~~
USE	freespace		11		11	2	0	0	2	11	+54
	result		31		Ø	.5	6.5	12	18	31	
01	mid grill	55 cm	64	163	22	13	14	17	21	73	Ø
	freespace+adj.		10		22	11	12	12	12	32	
	result		54		Ø	2	2	5	9	41	
	~~Average~~ =

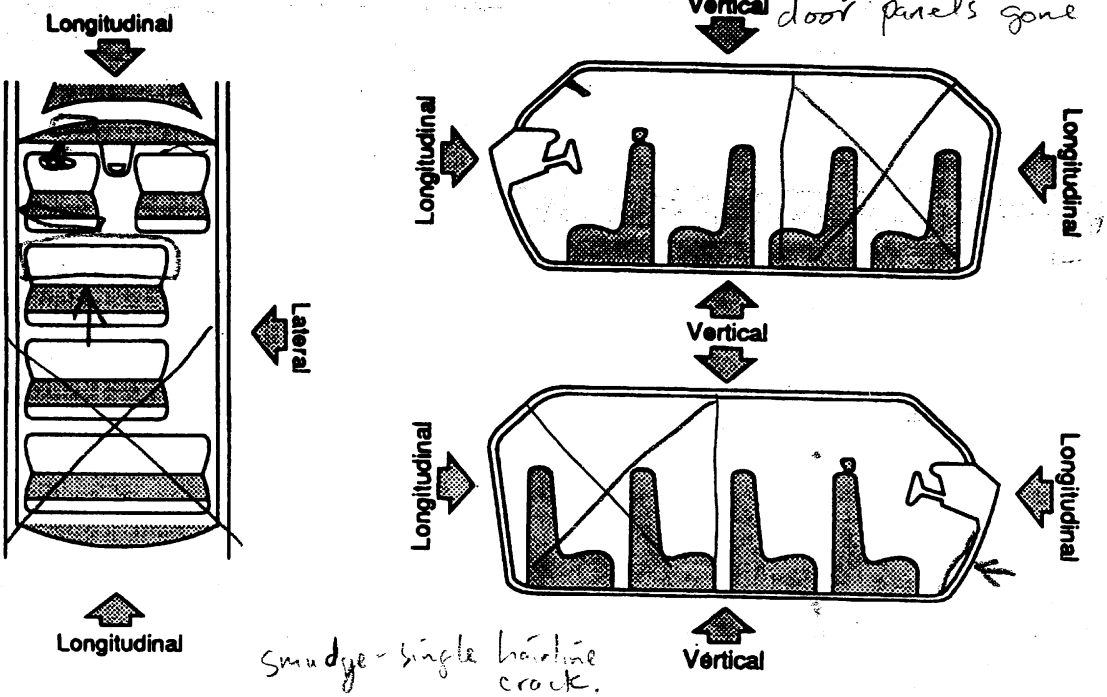
Note: Sketch intruded areas

Ⓛ and Ⓡ interior door panels gone

Smudge - single hairline crack.

LOCATION OF INTRUSION	INTRUDED COMPONENT	(All Measurements Are In Centimeters) COMPARISON VALUE	–	INTRUDED VALUE	=	INTRUSION	DOMINANT CRUSH DIRECTION	
11	instrument panel Ⓡ	0	–	0	=	0	—	
11	bezel only instr. panel Ⓒ	0	–	3	=	3	2	7
11	instr. panel Ⓛ	0	–	0	=	0	—	
11	windshield	0	–	0	=	0	—	
11	~~steering ass.~~	~~0~~	~~–~~	~~3~~	~~=~~	~~3~~	2	~~5~~
21/22/23	R, L, C rear seat cushion	0	–	10	=	10	2	1,2,3
11	Steering ass.	0	–	3.5	=	3.5	3	6
13	Ⓡ toe pan	0	–	5	=	5	1	5
11	Ⓓ visor	4	–	9	=	5	1	4
			–		=			
			–		=			
			–		=			
			–		=			
			–		=			
			–		=

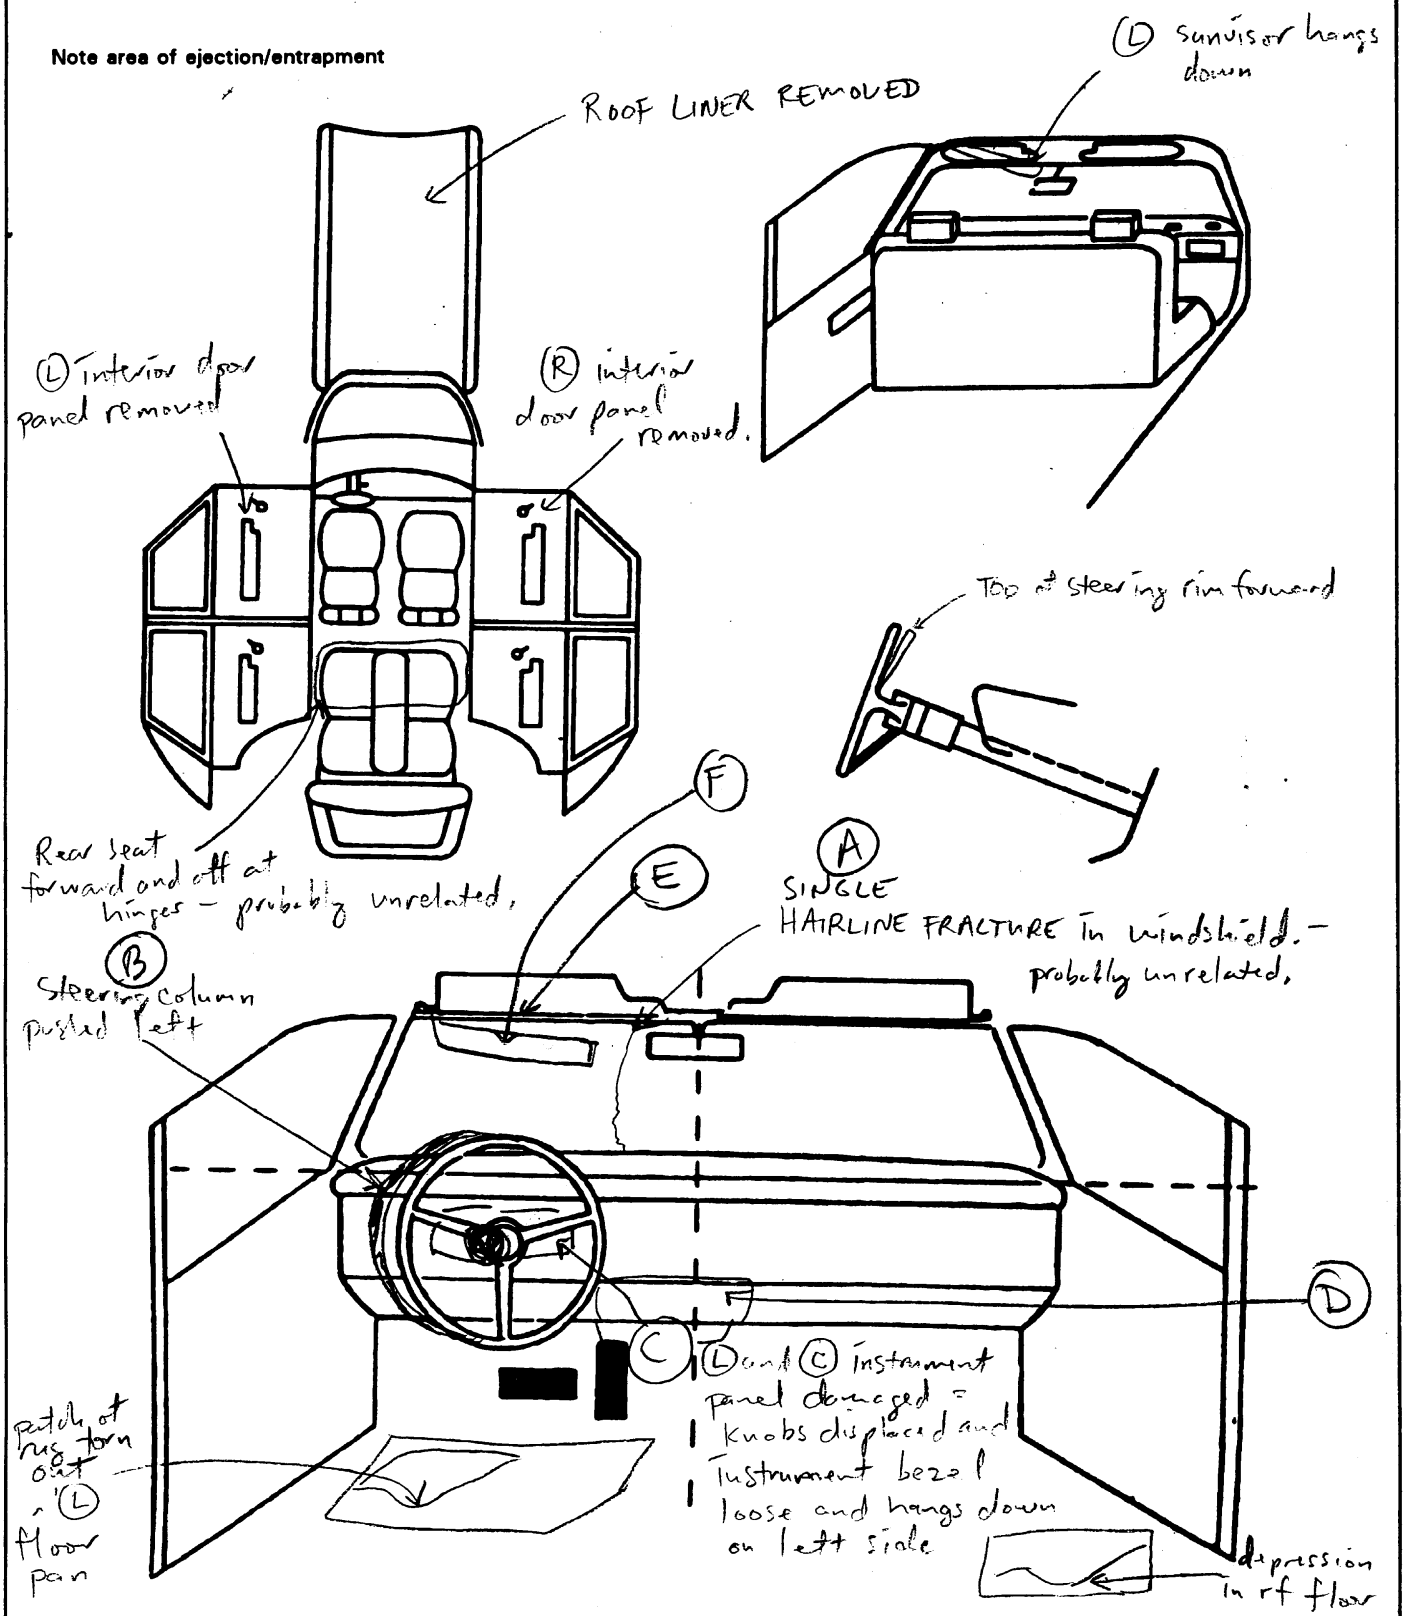
VEHICLE INTERIOR SKETCHES

Contact	Interior Component Contacted	Occupant No. If Known	Body Region If Known	Supporting Physical Evidence	Confidence Level of Contact Point
A	01	01	head/arm	single hairline crack & smudge	
B	06	01	chest	deformation	
C	09	01	knee	breakage	
D	10	01	knee	breakage	
E	50	01	head	visor damage & PTR	
F	19	01	head	deformation/intrusion	
G					
H					
I					
J					
K					
L					
M					
N
