CASE SUMMARY

NATIONAL ACCIDENT SAMPLING SYSTEM
CRASHWORTHINESS DATA SYSTEM

PSU 09 CASE NO. 154A TYPE OF ACCIDENT Two Car, T-Hit, Intersection

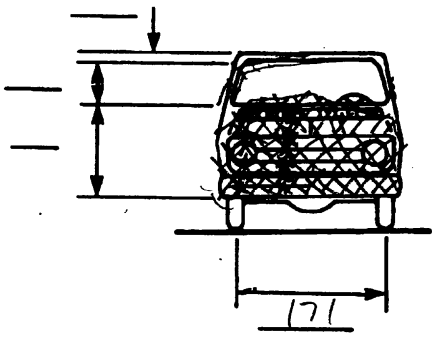
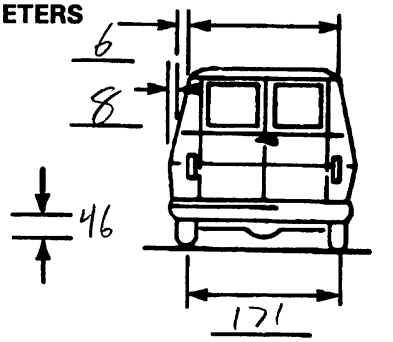
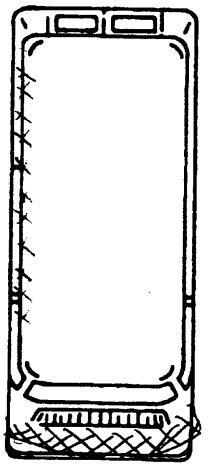
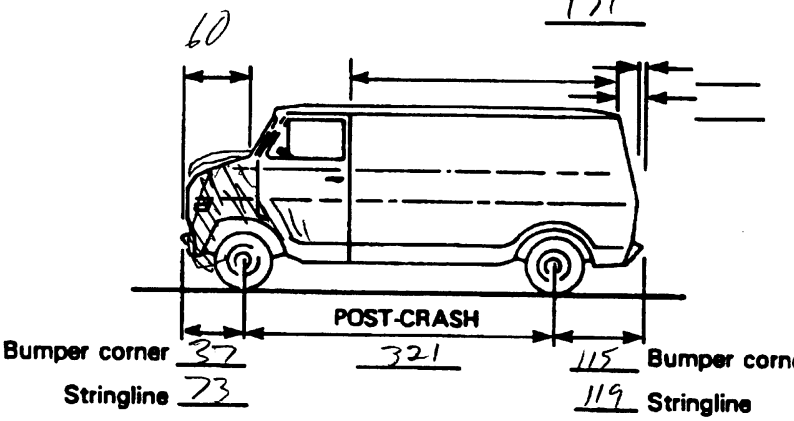
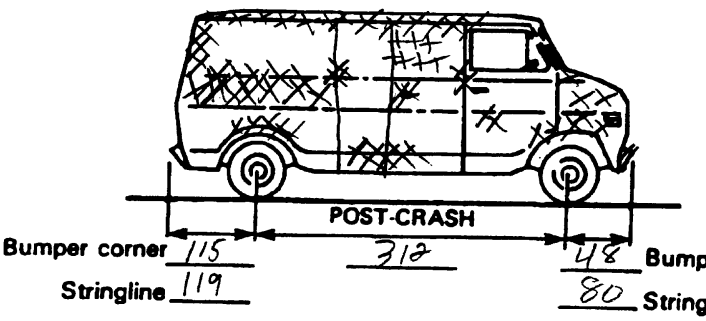
VEHICLE DAMAGE SKETCH

Specific Impact No.	Location of Direct Damage	Location of Field L	Location of Max Crush
01	Entire Front Bumper	Entire Front Bumper	C1
02	Rollover - right side	Rollover - Right side	Right side

Specific Impact Number	Plane of Impact C-Measurements	Direct Damage Width (CDC)	Direct Damage Max Crush	Field L	C_1	C_2	C_3	C_4	C_5	C_6	±D
01	Bumper	168	C1	168	38	21	21	19	24	32	0
	Freespace				10	2	1	1	2	10	
01	Final	168	C1	168	28	19	20	18	22	22	0
02	Rollover	—	6	—	Rollover	—	—	—	—	—	—

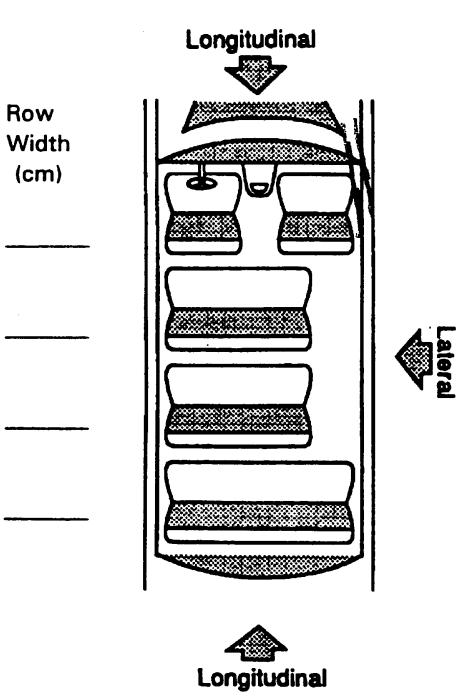
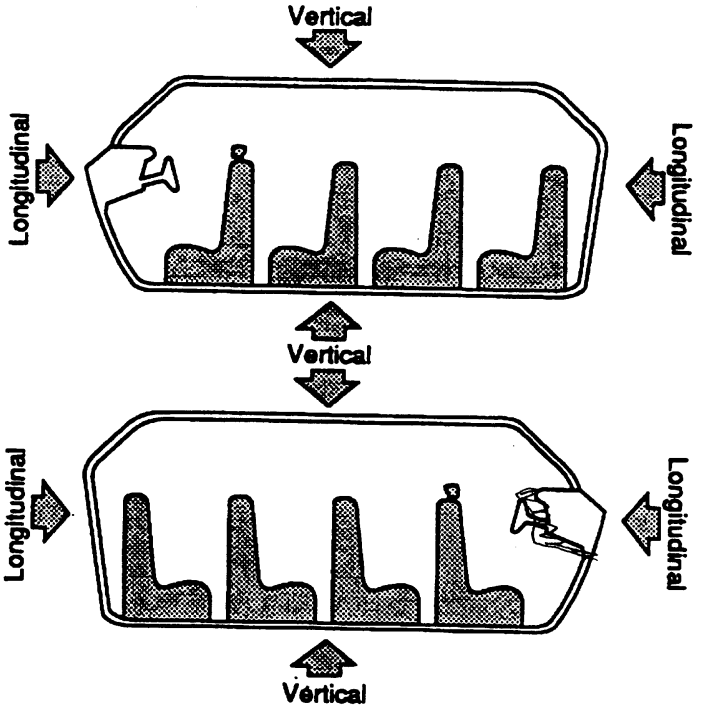
INTRUSION WORKSHEET

LOCATION OF INTRUSION	INTRUDED COMPONENT	(All Measurements Are In Centimeters) COMPARISON VALUE	—	INTRUDED VALUE	=	INTRUSION	DOMINANT CRUSH DIRECTION
12	03 C inst panel	26	—	20	=	6	2
13	04 R inst panel	28	—	24	=	4	2
13	06 A Pillar		—		=	5	3
13	14 Roof Side Rail		—		=	3	3
			—		=		
			—		=		
			—		=		
			—		=		
			—		=		
			—		=		
			—		=		
			—		=		
			—		=		
			—		=		
			—		=

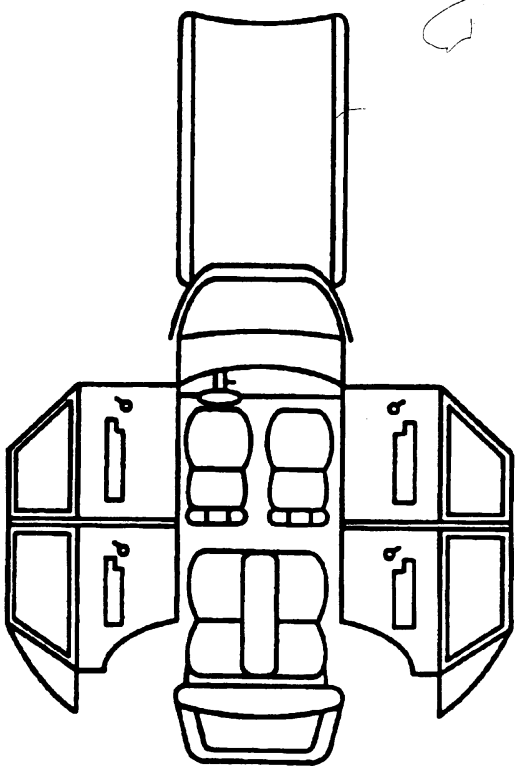
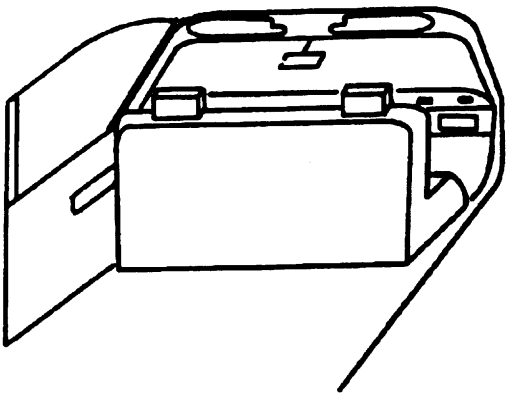
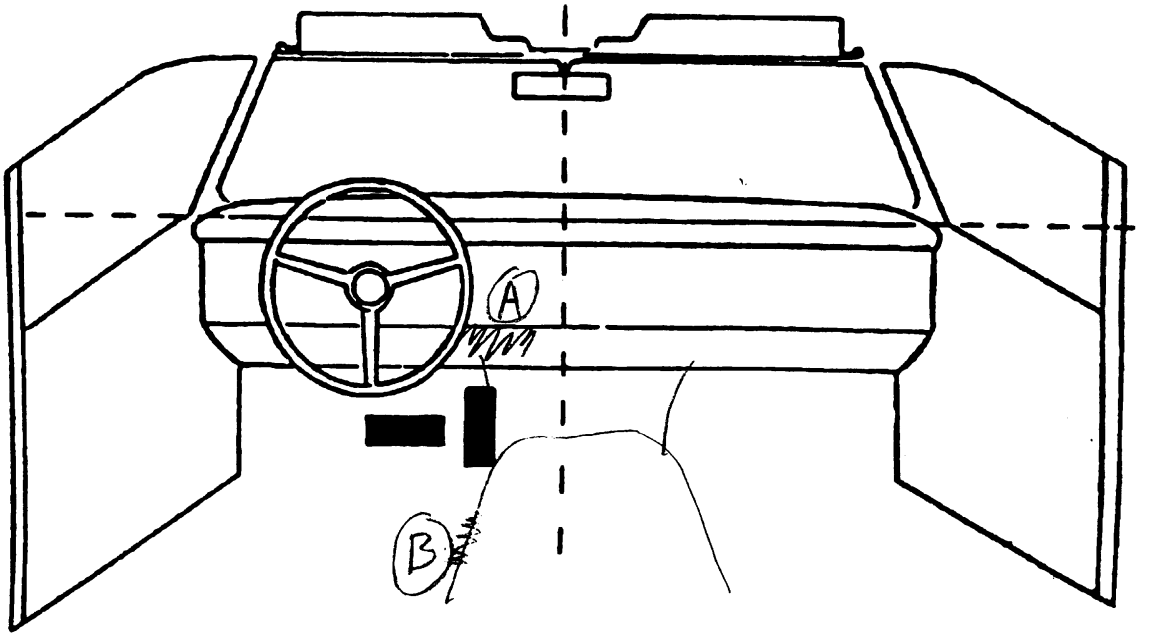
VEHICLE INTERIOR SKETCHES

Contact	Interior Component Contacted	Occupant No. If Known	Body Region If Known	Supporting Physical Evidence	Confidence Level of Contact Point
A	010	01	R-knee	panel cracked + pushed in	1
B	011	01	R-Leg	cntr console cracked + knocked	1
C				out of position	
D					
E					
F					
G					
H					
I					
J					
K					
L					
M					
N

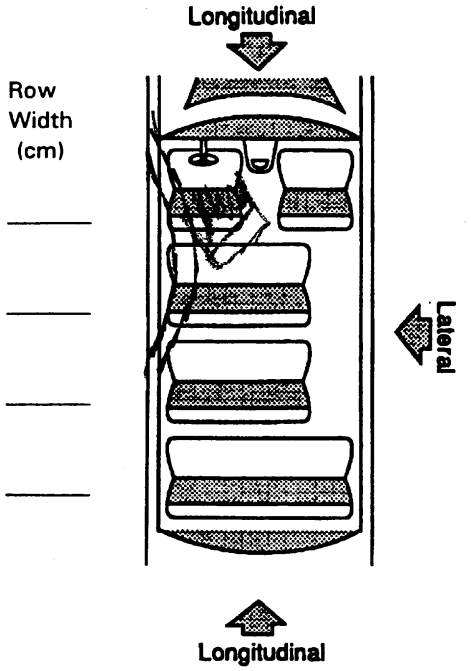
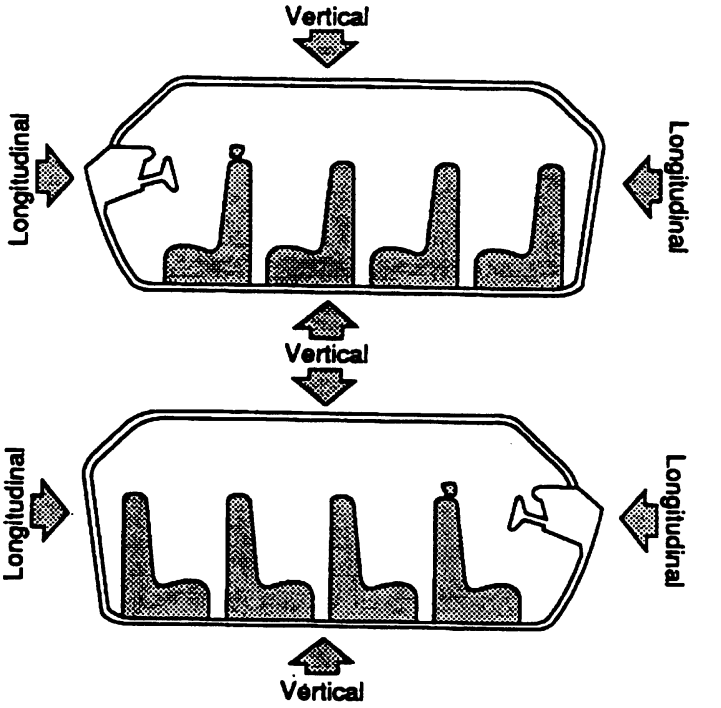
INTRUSION WORKSHEET

LOCATION OF INTRUSION	INTRUDED COMPONENT	(All Measurements Are In Centimeters) COMPARISON VALUE	—	INTRUDED VALUE	=	INTRUSION		DOMINANT CRUSH DIRECTION
11	06 A pillar	58	—	43	=	15	10	3
11	07 B pillar	69	—	12	=	57	2	3
11	11 Door Panel	59	—	37	=	22	9	3
11	14 Roof Side Rail	53	—	11	=	42	3	3
11	18 Sill	63	—	29	=	34	6	3
21	11 Door Panel	67	—	2	=	65	1	3
21	14 Roof Side Rail	53	—	16	=	37	5	3
21	18 Sill	63	—	22	=	41	4	3
21	08 C Pillar	63	—	32	=	31	7	3
13	20 Seat Back	60	—	41	=	29	8	3
21	20 Seat Back	31	—	20	=	11		2
			—		=			
			—		=			
			—		=			
			—		=

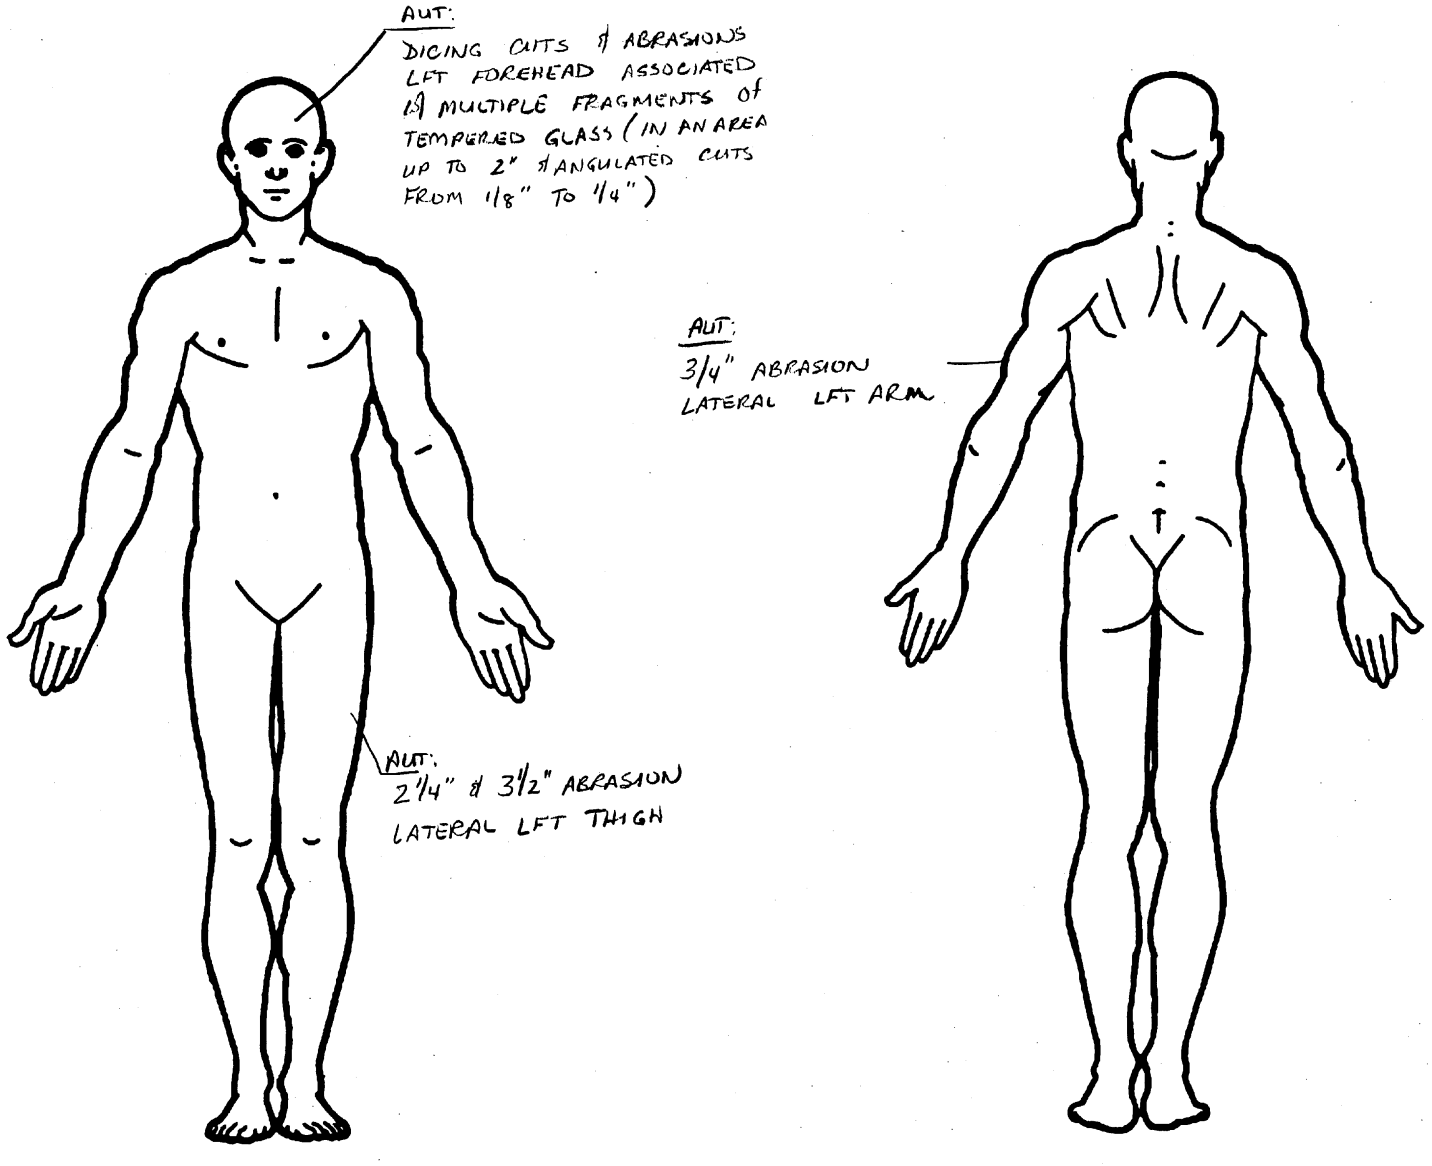
AUTOPSY. CAUSE OF DEATH: MULTIPLE INJURIES

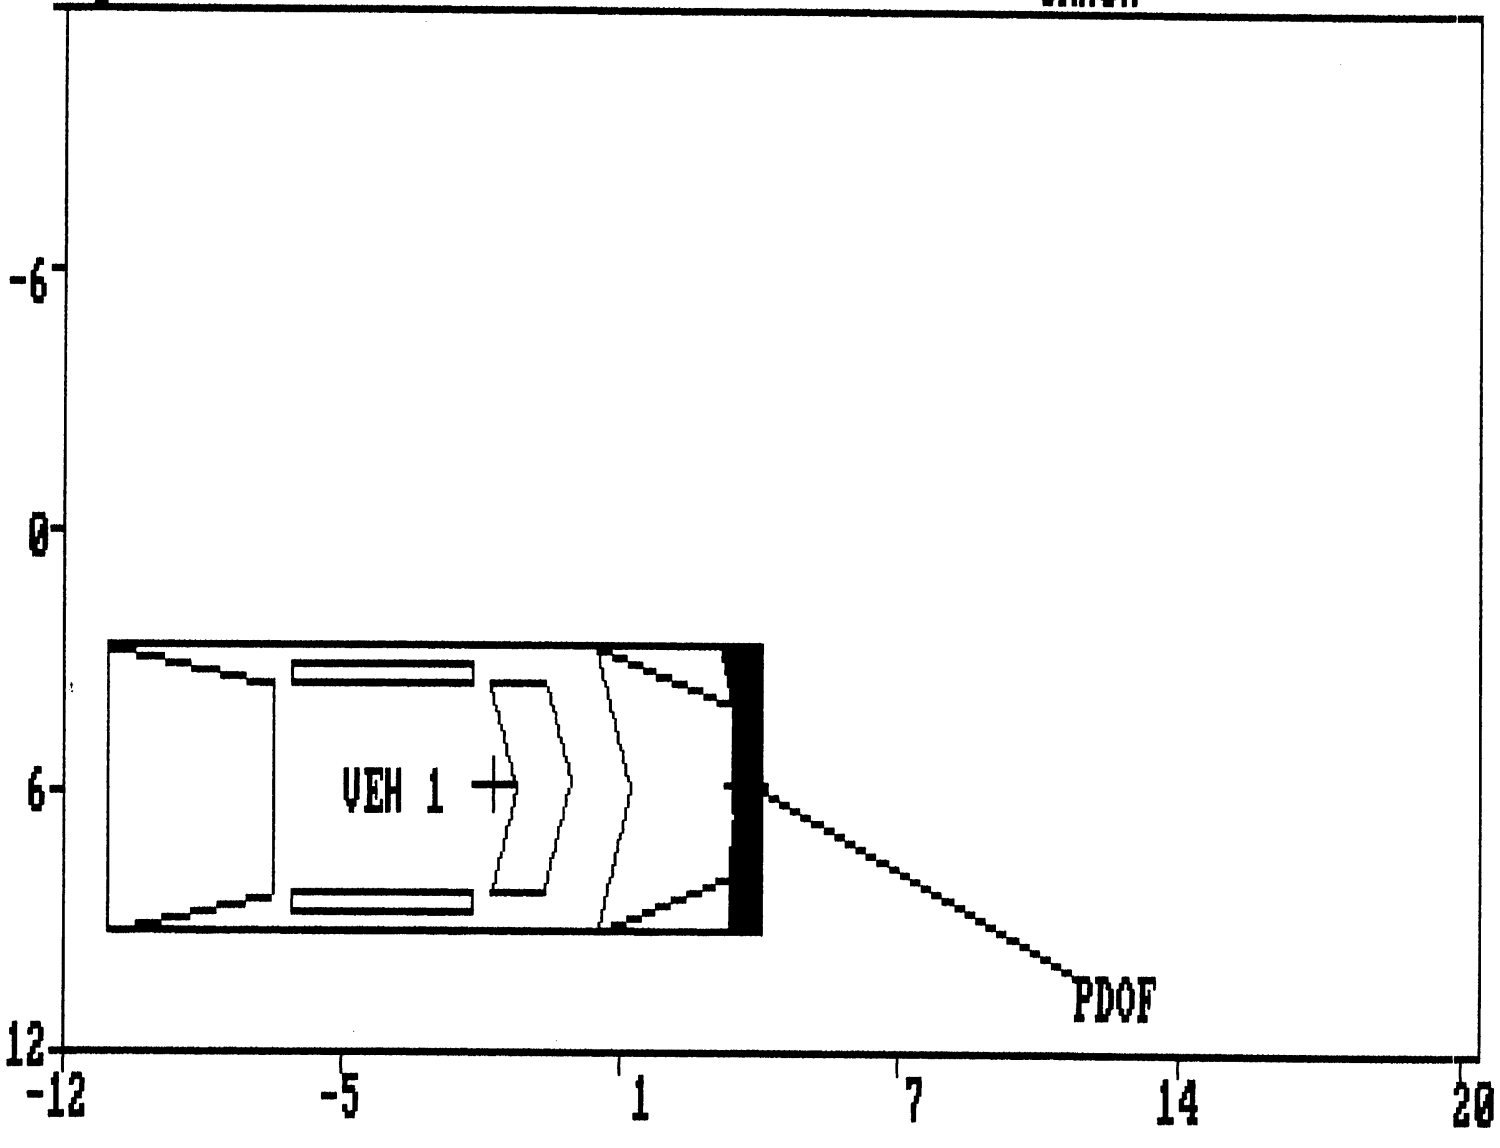
Printing Picture:

VEHICLE 1	VEHICLE 2
Damage Length	L	188 cm	___ ___ ___ cm
Crush Depths	C_1	028 cm	___ ___ ___ cm
	C_2	019 cm	___ ___ ___ cm
	C_3	020 cm	___ ___ ___ cm
	C_4	018 cm	___ ___ ___ cm
	C_5	022 cm	___ ___ ___ cm
	C_6	022 cm	___ ___ ___ cm
Damage Offset	D ±	000 cm	___ ___ ___ cm

SPEED CHANGE (DAMAGE)
VEHICLE #1	
TOTAL	29 KPH (18 MPH)
LONGITUDINAL	-25 KPH (-16 MPH)
LATITUDINAL	-15 KPH (-9 MPH)
PDOF ANGLE	30 DEGREES
ENERGY DISSIPATED =	89054 JOULES (65674 FT-LB)
VEHICLE #2	
TOTAL	0 KPH (0 MPH)
LONGITUDINAL	0 KPH (0 MPH)
LATITUDINAL	0 KPH (0 MPH)
PDOF ANGLE	0 DEGREES
ENERGY DISSIPATED =	0 JOULES (0 FT-LB)

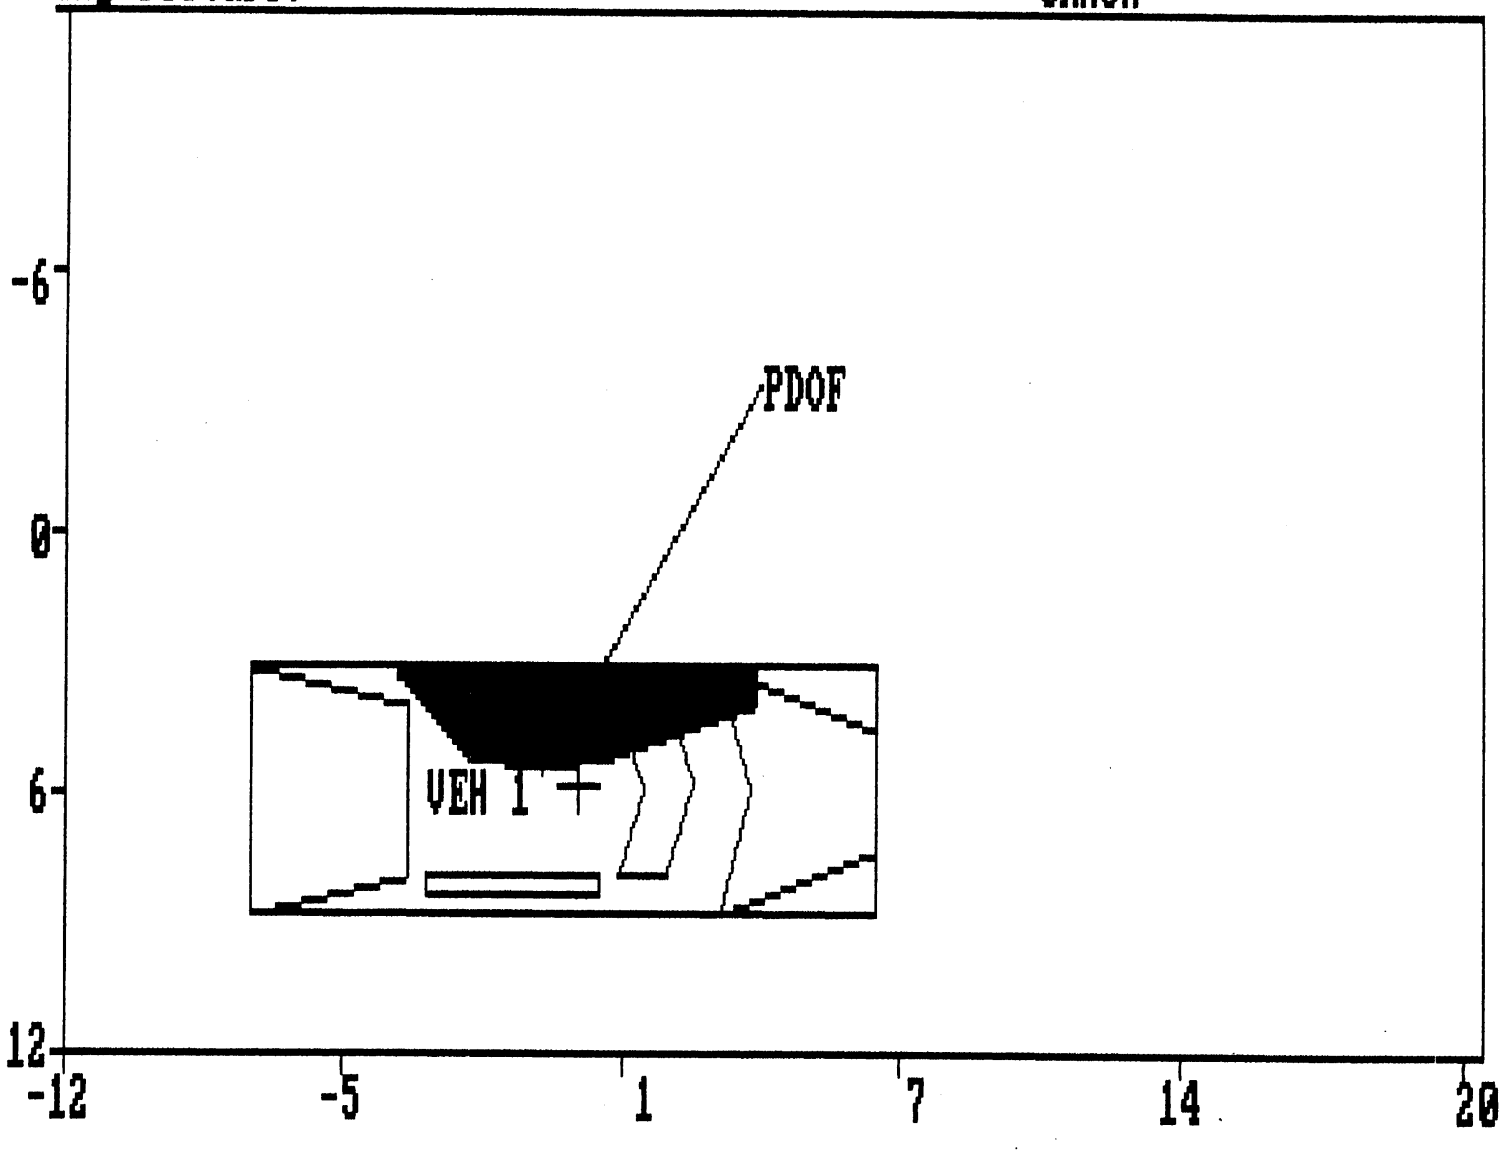
Printing Picture:

VEHICLE 1		VEHICLE 2	
Damage Length	L	255 cm	L	___ ___ ___ cm
Crush Depths	C_1	007 cm	C_1	___ ___ ___ cm
	C_2	064 cm	C_2	___ ___ ___ cm
	C_3	073 cm	C_3	___ ___ ___ cm
	C_4	064 cm	C_4	___ ___ ___ cm
	C_5	047 cm	C_5	___ ___ ___ cm
	C_6	030 cm	C_6	___ ___ ___ cm
Damage Offset	D ±	002 cm	D ±	___ ___ ___ cm

SPEED CHANGE (DAMAGE)
VEHICLE #1	
TOTAL	72 KPH (45 MPH)
LONGITUDINAL	-36 KPH (-22 MPH)
LATITUDINAL	62 KPH (39 MPH)
PDOF ANGLE	-60 DEGREES
ENERGY DISSIPATED = 289777 JOULES (213700 FT-LB)	
VEHICLE #2	
TOTAL	0 KPH (0 MPH)
LONGITUDINAL	0 KPH (0 MPH)
LATITUDINAL	0 KPH (0 MPH)
PDOF ANGLE	0 DEGREES
ENERGY DISSIPATED =	0 JOULES (0 FT-LB)
