CASE SUMMARY

NATIONAL ACCIDENT SAMPLING SYSTEM
CRASHWORTHINESS DATA SYSTEM

PSU 73 CASE NO. 140A TYPE OF ACCIDENT Utility vehicle-ran off toad

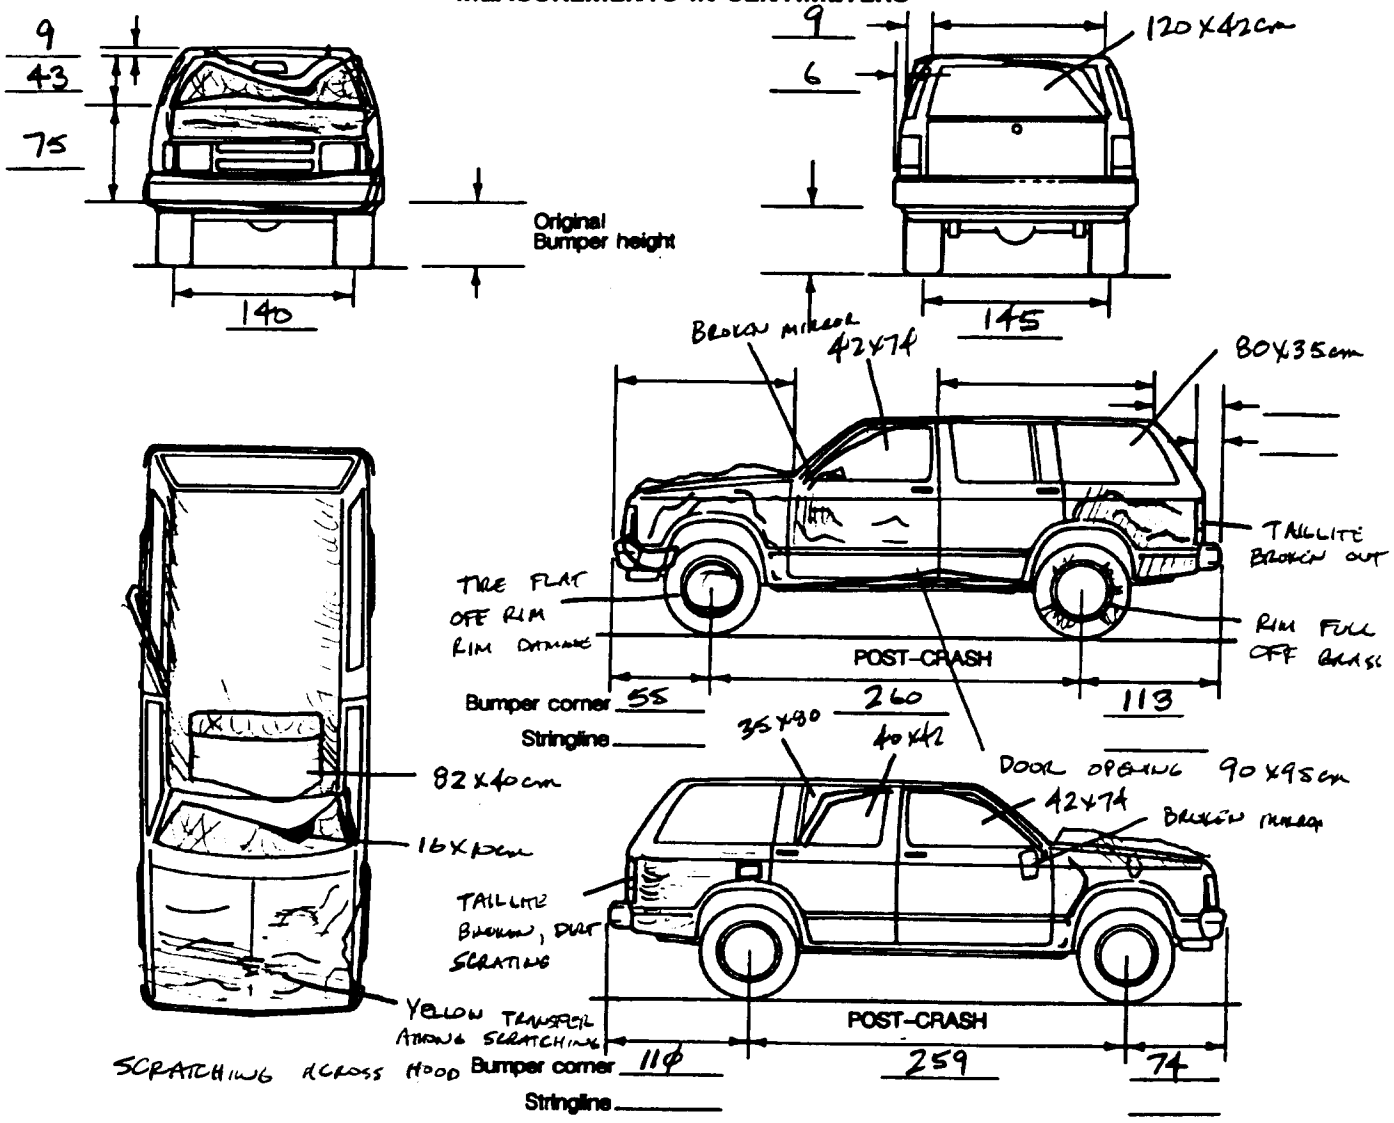
VEHICLE DAMAGE SKETCH

Specific Impact No.	Location of Direct Damage	Location of Field L	Location of Max Crush
01	TOP - FRONT TO BACK		
	SIDE - L FRONT TO BACK		
	SIDE - R BACK & FRONT

Specific Impact Number	Plane of Impact C-Measurements	Direct Damage Width (CDC)	Direct Damage Max Crush	Field L	C_1	C_2	C_3	C_4	C_5	C_6	±D
01	TOP (MOST SEVERE)		30 cm		— ROLLOVER —						
01	SIDE (LEFT)		16 cm		— ROLLOVER —

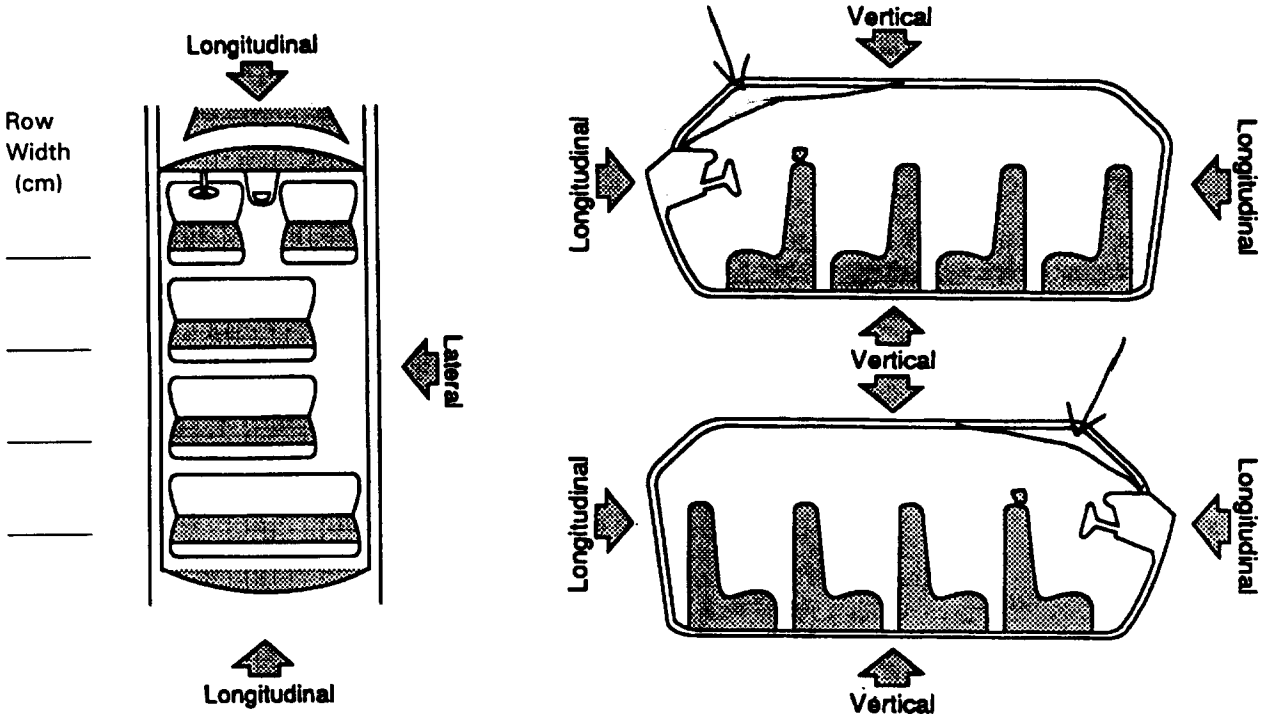
INTRUSION WORKSHEET

LOCATION OF INTRUSION	INTRUDED COMPONENT	(All Measurements Are In Centimeters) COMPARISON VALUE	–	INTRUDED VALUE	=	INTRUSION	DOMINANT CRUSH DIRECTION
11	ROOF	38	–	20	=	18 ✓	VERT.
12	11	38	–	18	=	20 ✓	11
13	11	38	–	23	=	15 ✓	11
11	WINDSHIELD HEADER	36	–	16	=	20 ✓	11
12	11	36	–	18	=	18 ✓	11
13	11	36	–	22	=	14 ✓	11
11	WINDSHIELD	34	–	7	=	27 ✓	11
12	11	34	–	6	=	28 ✓	11
13	11	34	–	8	=	26 ✓	11
11	ROOF SIDE RAIL	38	–	30	=	8 ✓	11
13	11	38	–	37	=	1	11
11	WINDOW FRAME	38	–	33	=	5	11
13	11	38	–	38	=	0	11
			–		=		
			–		=

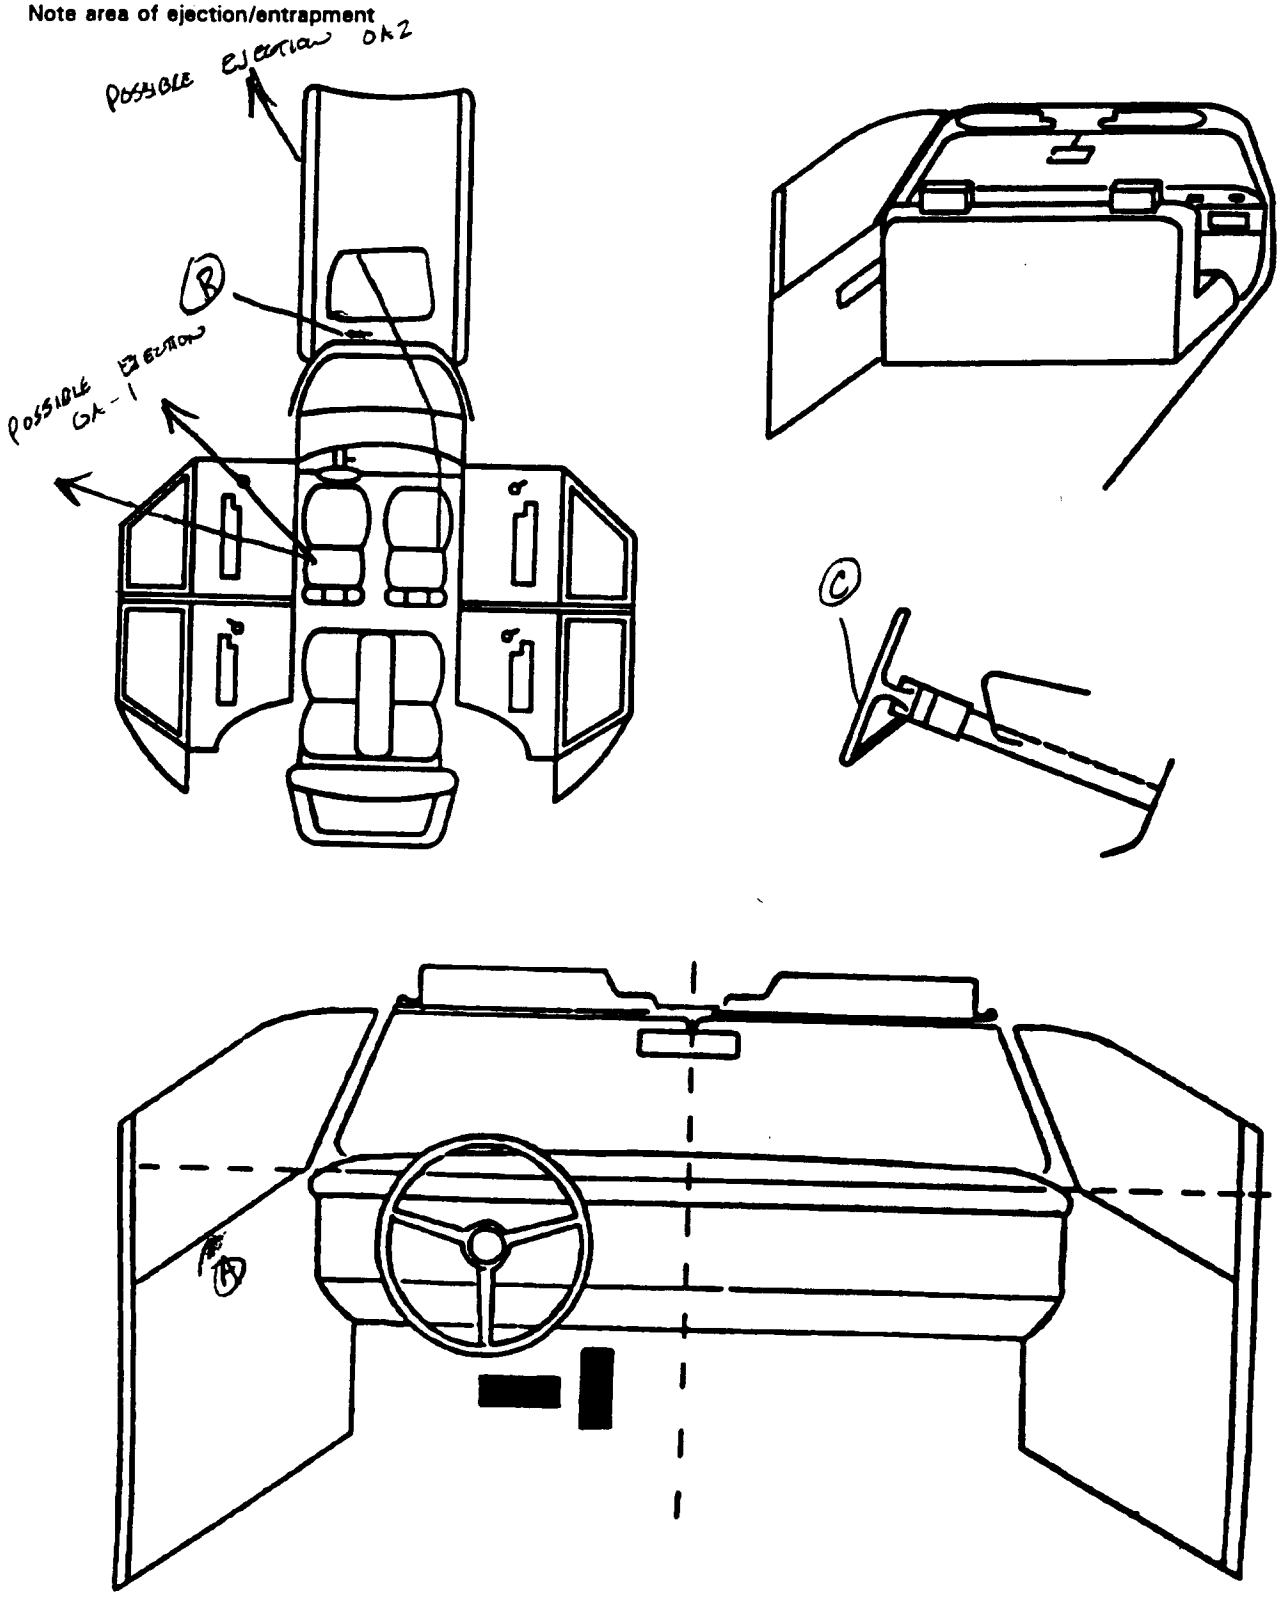
VEHICLE INTERIOR SKETCHES

Note area of ejection/entrapment

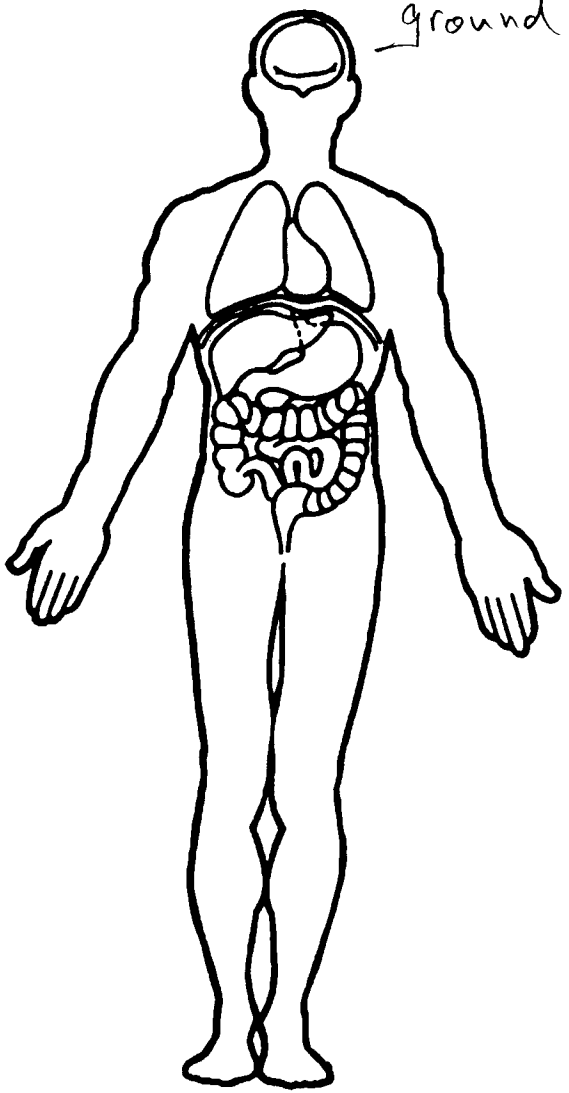
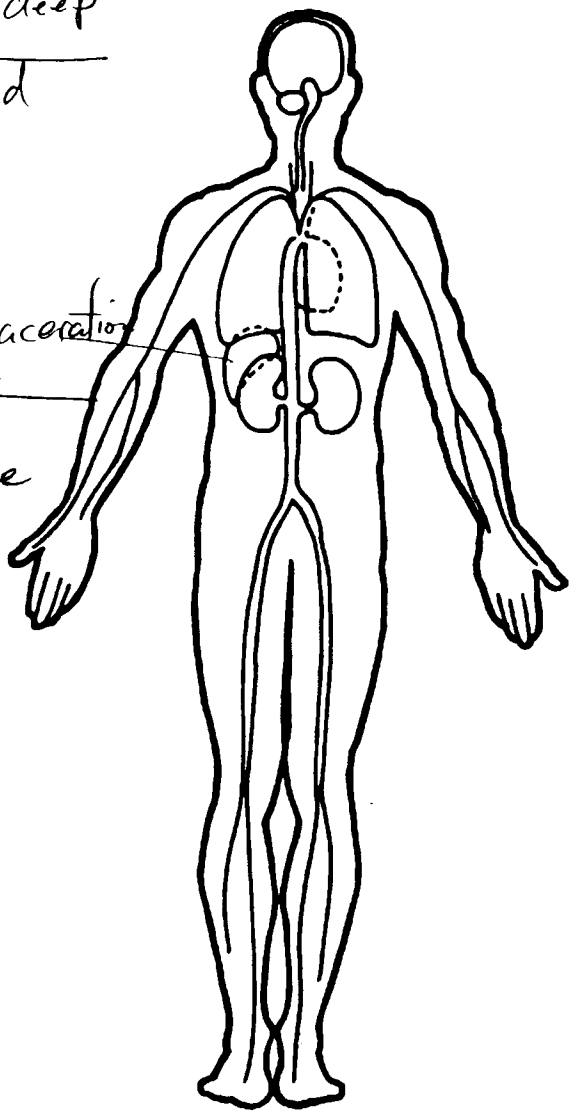
OFFICIAL INJURY DATA —INTERNAL INJURIES

Cerebral contusion NFS
ground

Comatose not responsive except to deep pain
ground

neuro deficit
Babinski—neg

severe laceration spleen
door surface
