CASE SUMMARY

NATIONAL ACCIDENT SAMPLING SYSTEM
CRASHWORTHINESS DATA SYSTEM

PSU 79 CASE NO. 040A TYPE OF ACCIDENT CAR/Curb-Rollover)

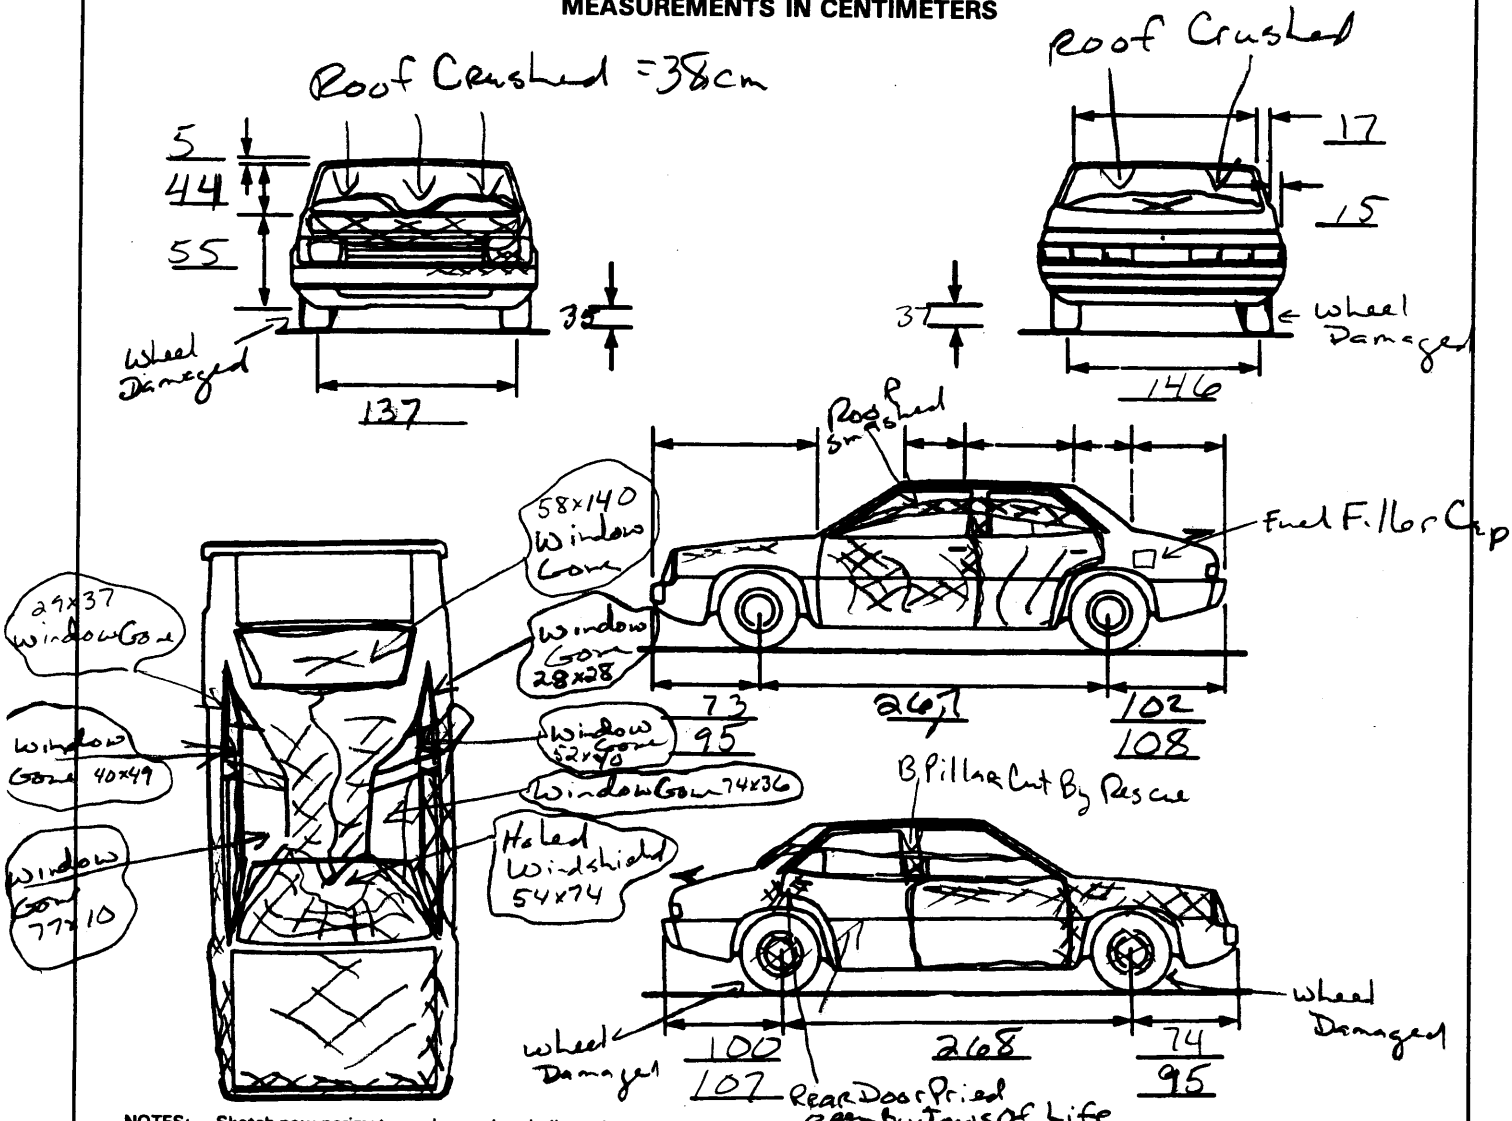
VEHICLE DAMAGE SKETCH

Specific Impact No.	Location of Direct Damage	Location of Field L	Location of Max Crush
01+02	01=RF TIRE 02=RR TIRE	NA	Zone 1
03	Roof		Zone 6
04	Roof		Zone 6

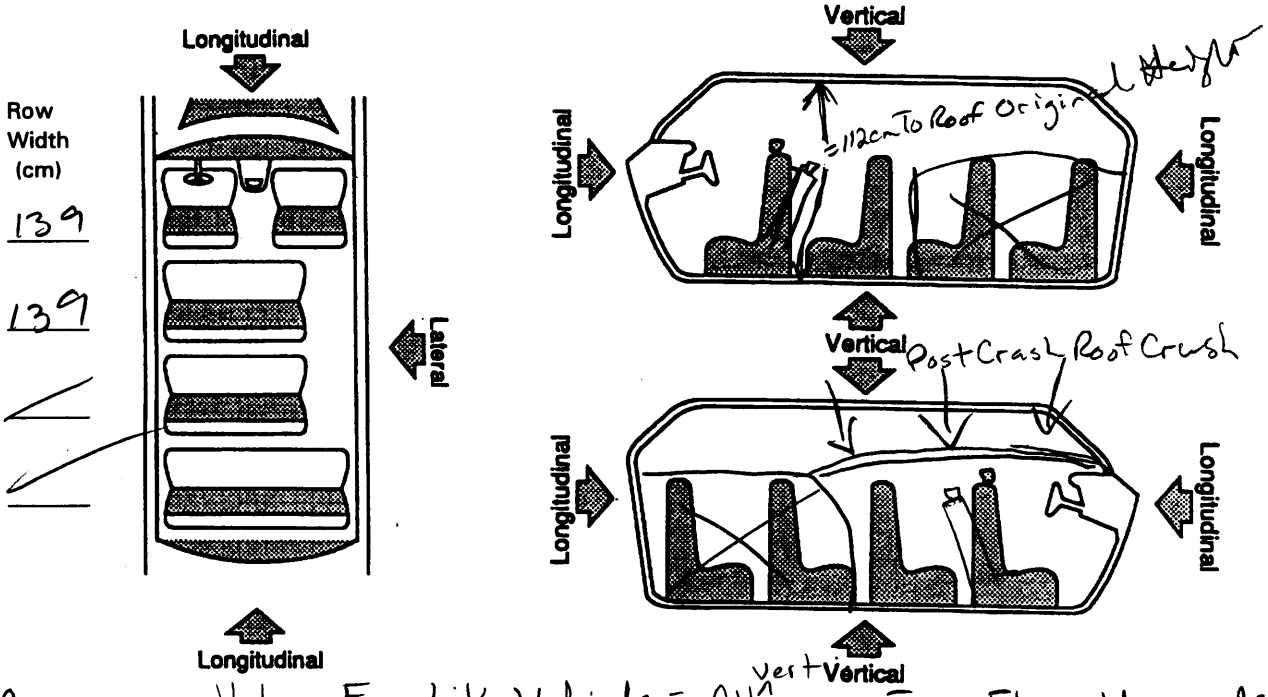
INTRUSION WORKSHEET

LOCATION OF INTRUSION	INTRUDED COMPONENT	(All Measurements Are In Centimeters) COMPARISON VALUE	–	INTRUDED VALUE	=	INTRUSION	DOMINANT CRUSH DIRECTION	
11	Roof Side Rail	105	–	72	=	33	Vert	
11	Roof	112	–	56	=	56	Vert	(3)
11	Head Rest	98	–	84	=	14	"	
12	Roof	112	–	50	=	62	"	(2)
13	Roof	112	–	48	=	64	"	(1)
11	W/S/Header	105	–	65	=	40	"	(7)
12	" "	105	–	55	=	50	"	(5)
13	" "	105	–	50	=	55	"	(4)
11	Roof Side Rail	105	–	70	=	35	"	(9)
21	" " "	105	–	74	=	31	"	
13	" " "	105	–	70	=	35	"	(10)
23	" " "	105	–	65	=	40	"	(8)
11	B Pillar	105	–	74	=	31	"	
11	A Pillar	105	–	64	=	41	"	(6)
			–		=		"

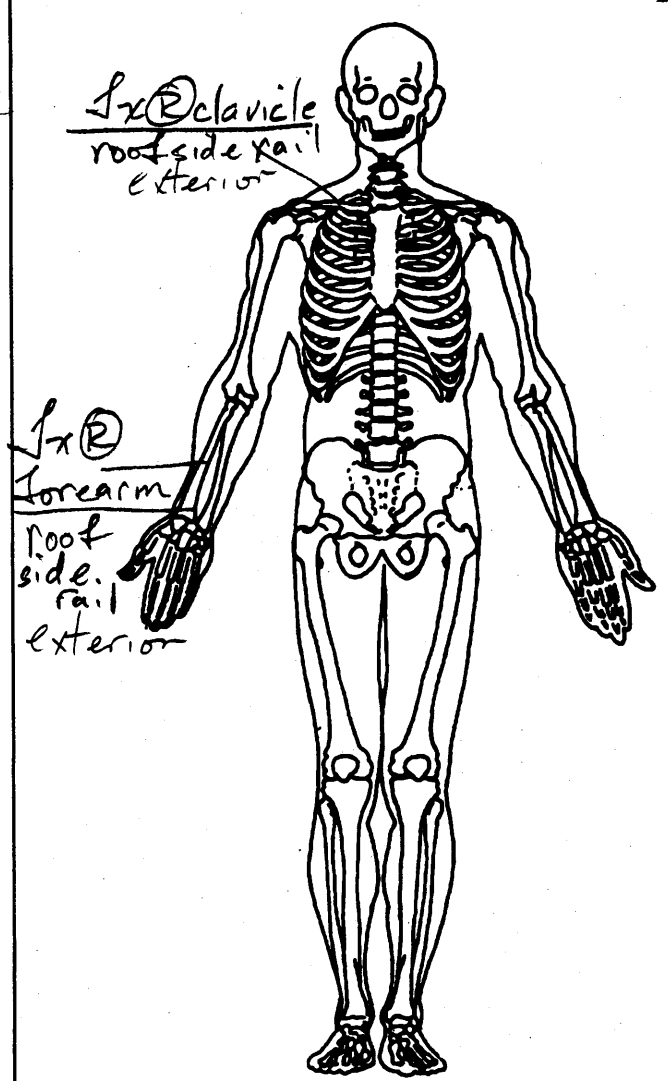
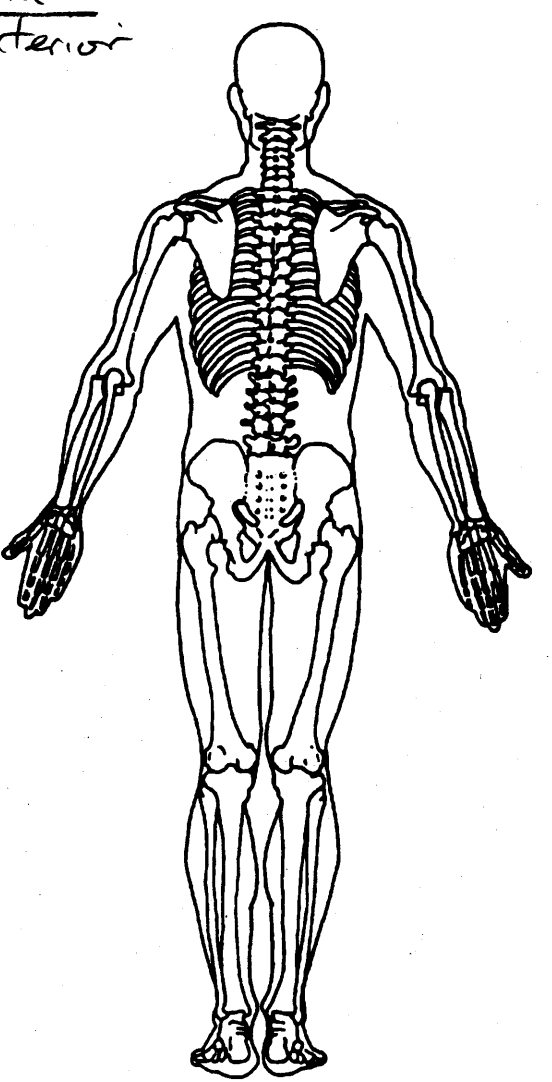
Craniocerebral trauma
Roof exterior

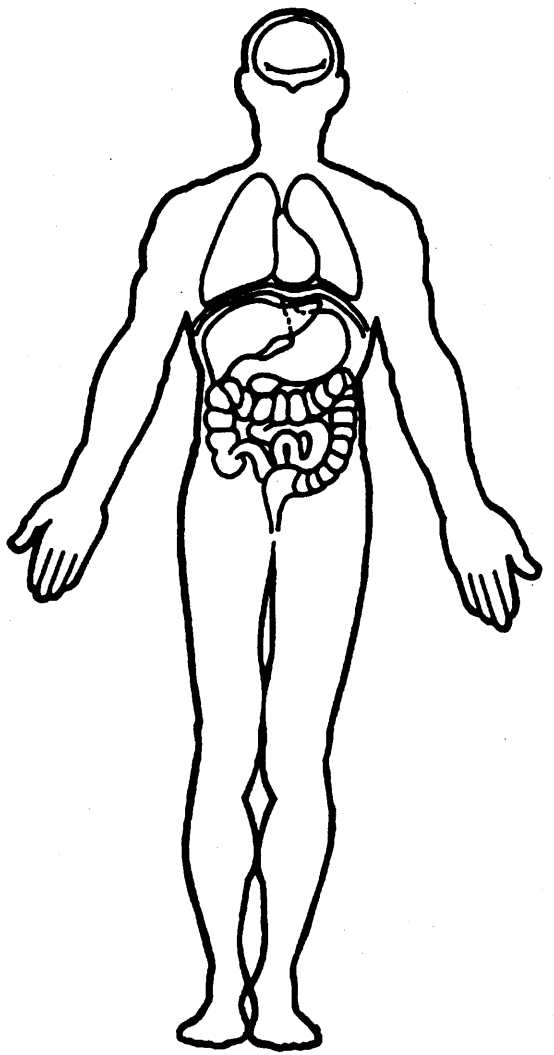
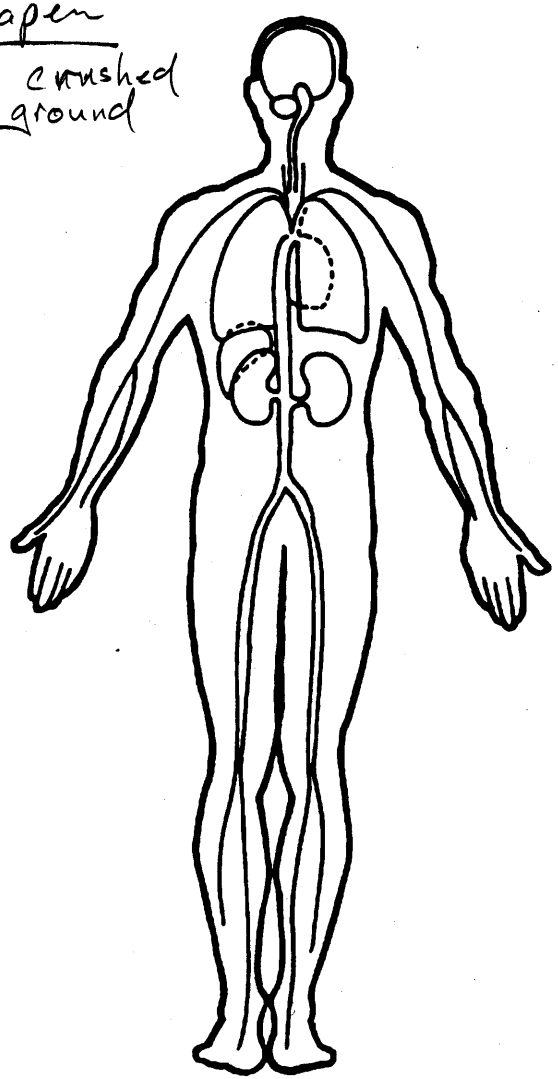
Crushing injury to skull
Head misshapen

Coded as crushed skull to ground
