CASE SUMMARY

NATIONAL ACCIDENT SAMPLING SYSTEM
CRASHWORTHINESS DATA SYSTEM

PSU 05 CASE NO. 023E TYPE OF ACCIDENT CAr/car right angle with rollover

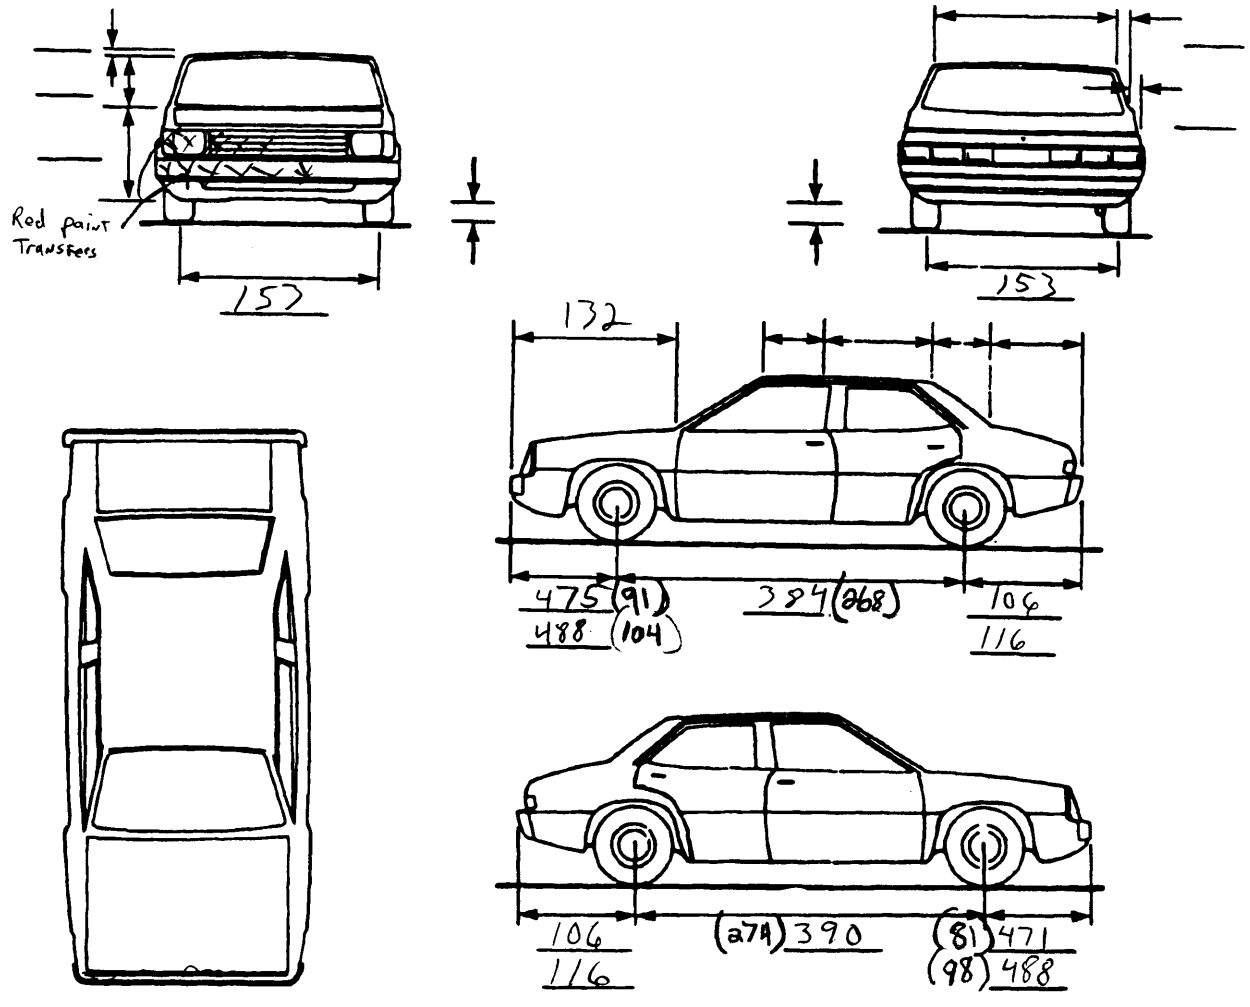
VEHICLE DAMAGE SKETCH

Specific Impact No.	Location of Direct Damage	Location of Field L
1	Begins (R) Front Bumper Corner	SAME

Specific Impact Number	Plane of Impact C-Measurements	Direct Damage Width (CDC)	Direct Damage Max Crush	Field L	C_1	C_2	C_3	C_4	C_5	C_6	±D
1	Front Bumper	84		140	13.5	5	2	2.5	5	15	+137
	FREESPACE			28	-13	-3	-2	-2	-3	-13	
	X Resultant	84		140	.5	2	0	.5	2	2	+137

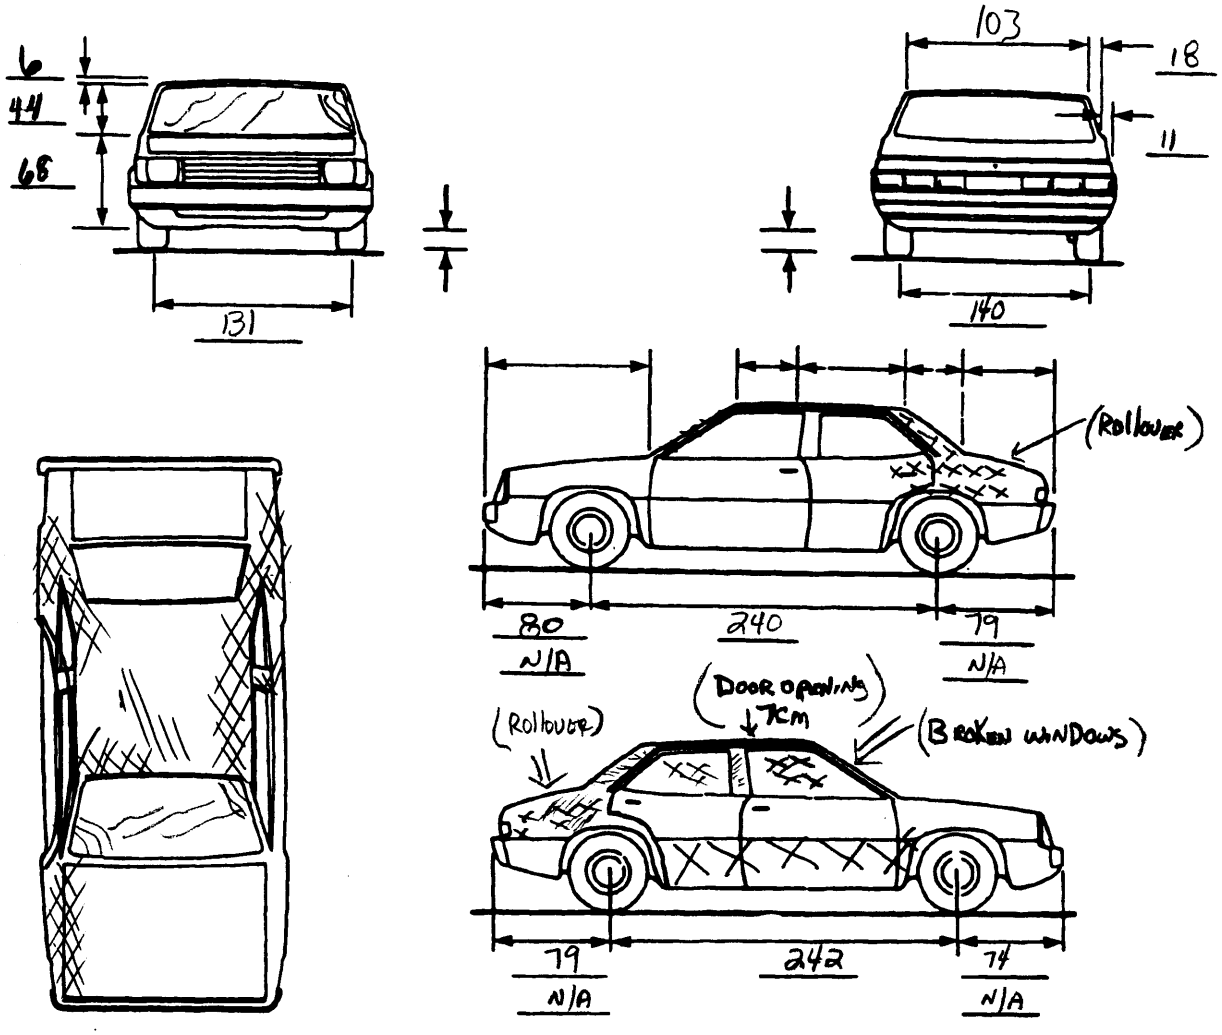
Specific Impact No.	Location of Direct Damage	Location of Field L
1	30 CM forward REAR AXLE	SAME

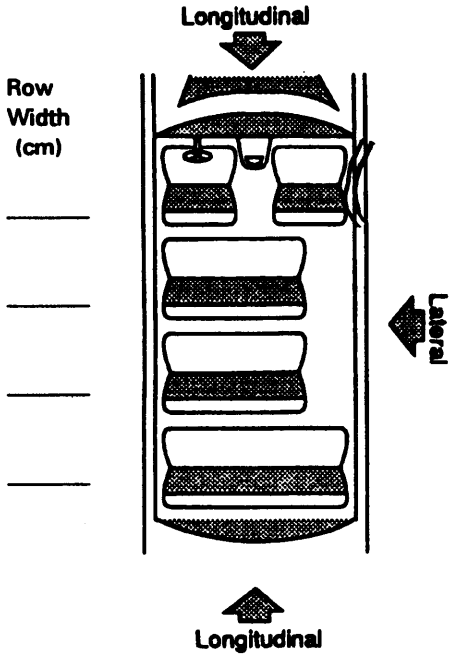
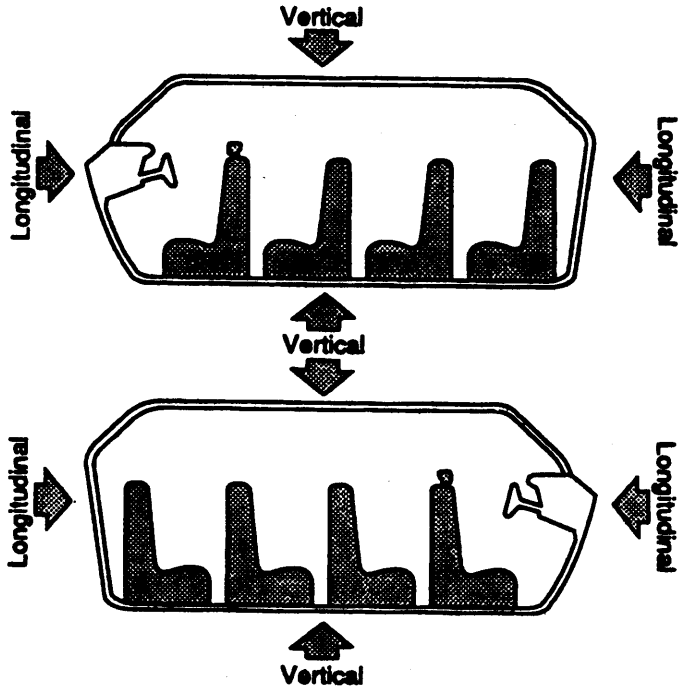
INTRUSION WORKSHEET

LOCATION OF INTRUSION	INTRUDED COMPONENT	(All Measurements Are In Centimeters) COMPARISON VALUE	–	INTRUDED VALUE	=	INTRUSION	DOMINANT CRUSH DIRECTION
13	Door panel	~70	–	61	=	9	LAT
			–		=		
			–		=		
			–		=		
			–		=		
			–		=		
			–		=		
			–		=		
			–		=		
			–		=		
			–		=		
			–		=		
			–		=		
			–		=		
			–		=
