CASE SUMMARY

NATIONAL ACCIDENT SAMPLING SYSTEM
CRASHWORTHINESS DATA SYSTEM

PSU 45 CASE NO. 214 K TYPE OF ACCIDENT Lt. Trk.-Car/Rt. Angle

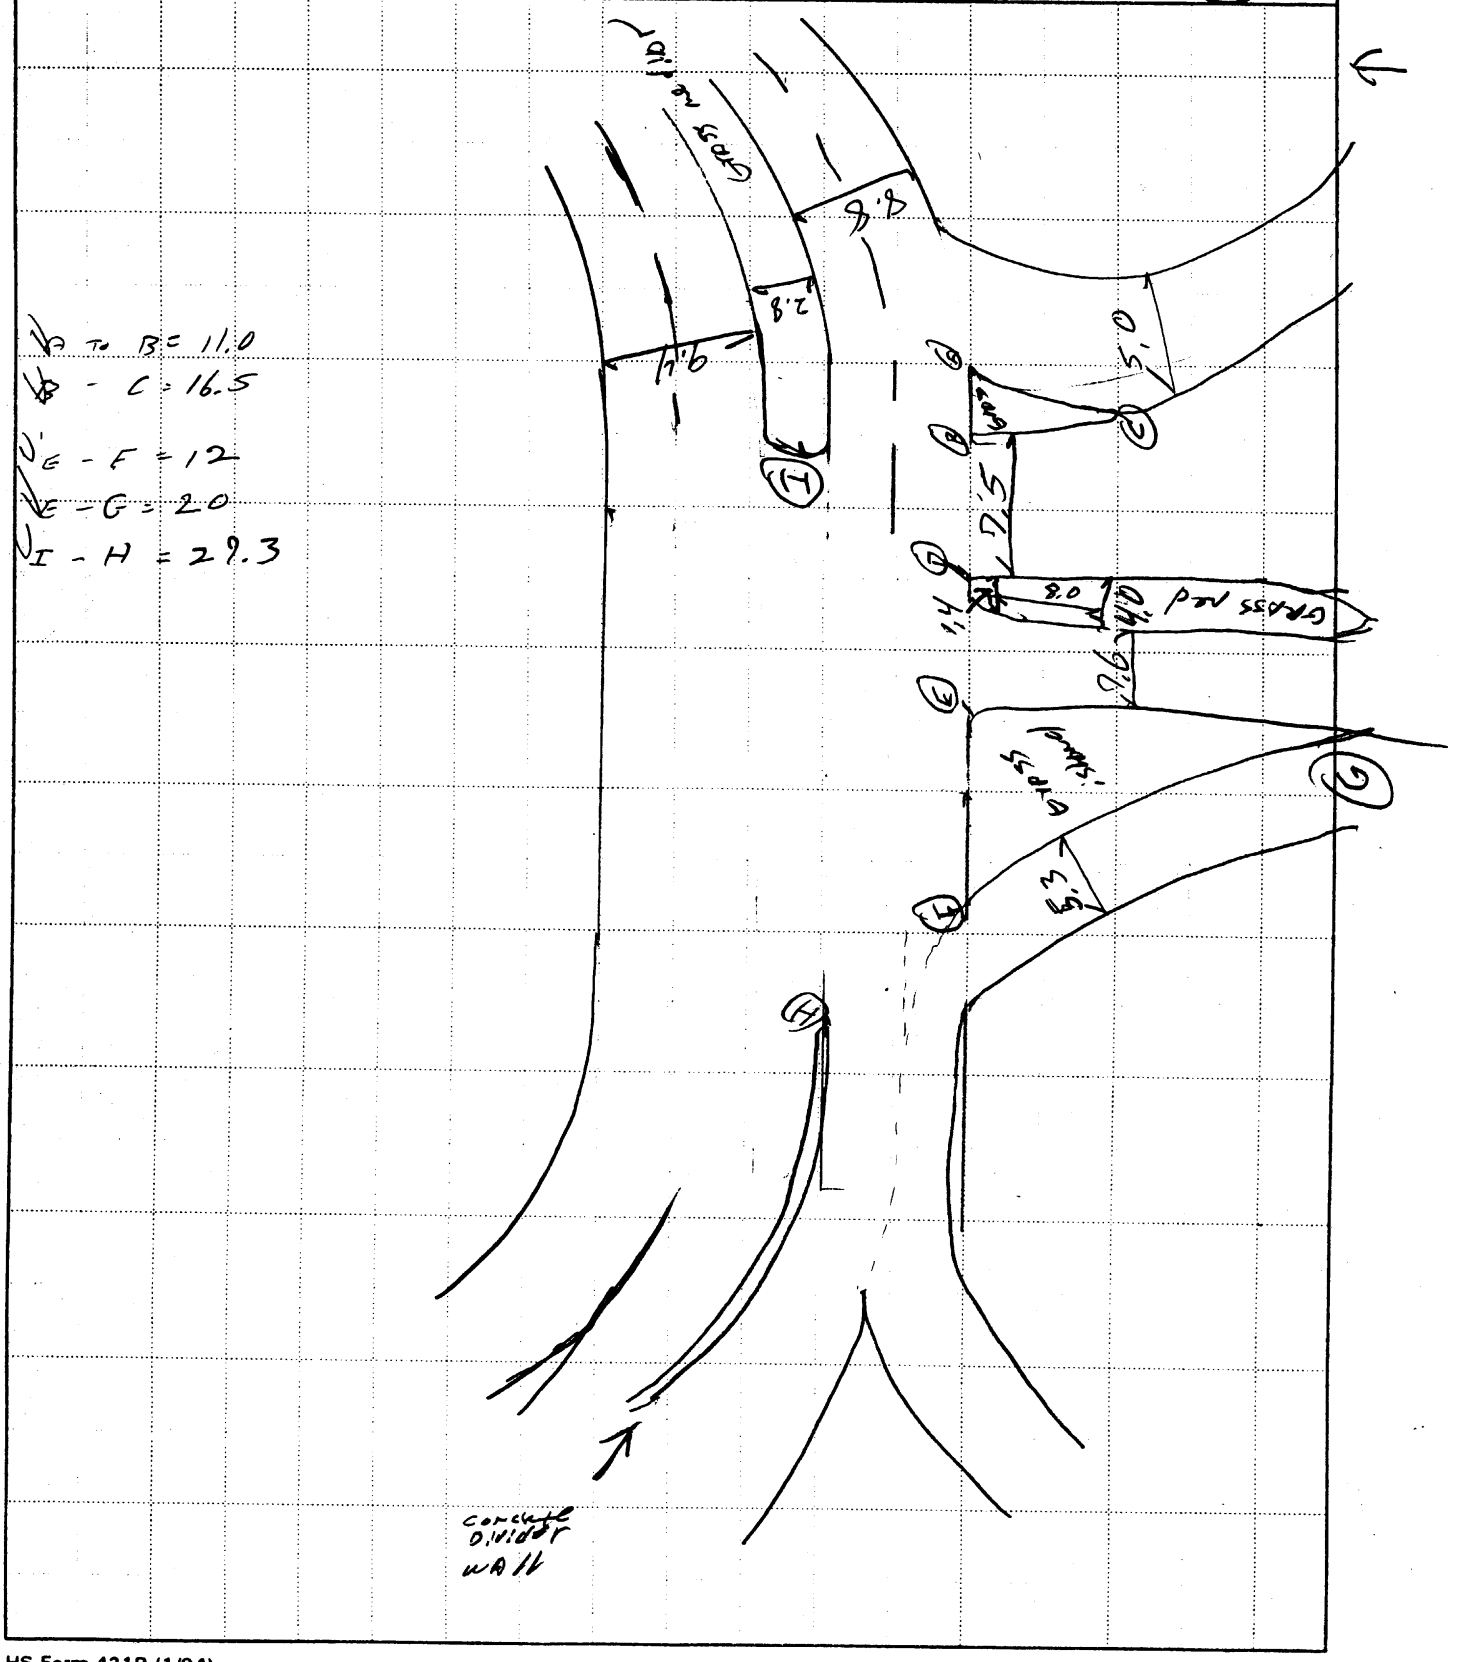
Vehicle one was westbound on a four lane median divided urban roadway, in dry daylight ~~xxxxxx~~ conditions. Vehiclw two was eastbound on same. V1 was attempting to make a left hand turn, and V2 front struck V1 right, causing V1 to roll over 1/4 turn on to V1 left side. V1 came to rest facing sw, on its side near the point of impact.
V2 came to rest facing east, near the point of impact

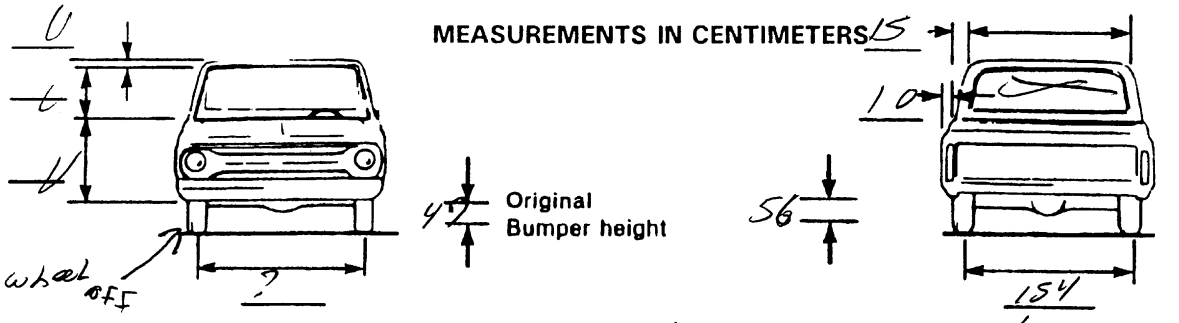
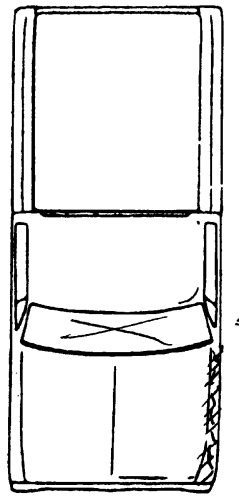
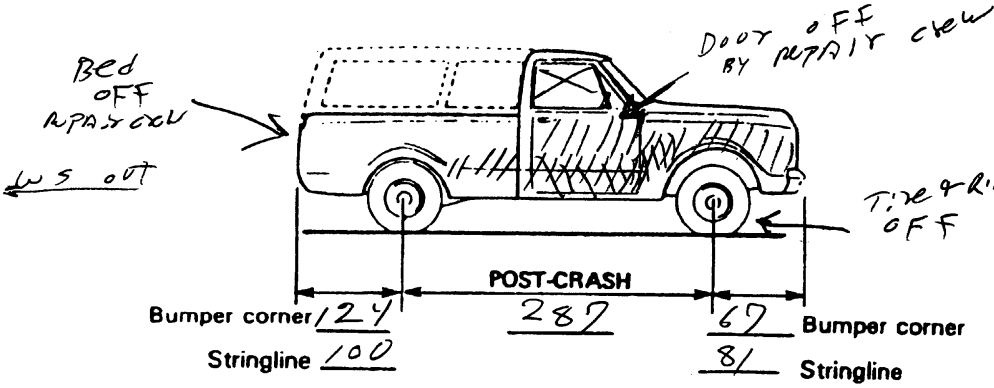
VEHICLE DAMAGE SKETCH

NO C MEASUREMENTS, VEH UNDER REPAIR

ALL GLASS REMOVED BY REPAIR PERSONNEL

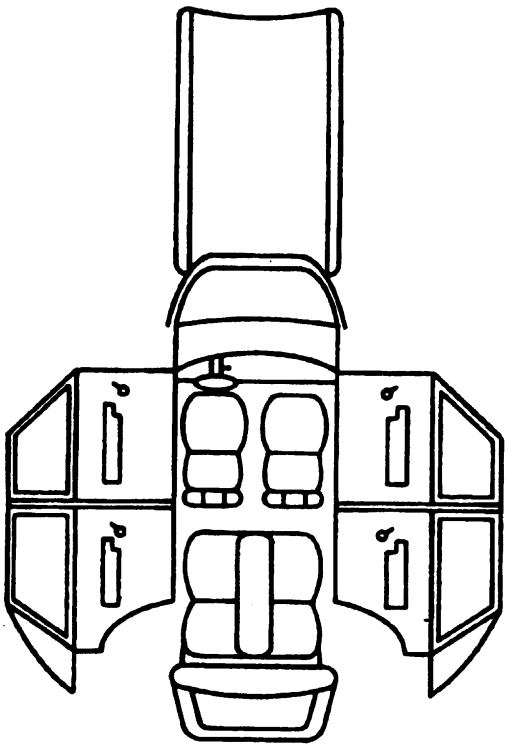
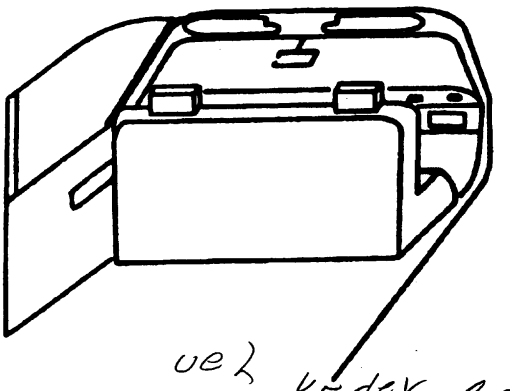
veh under repair, no visible contacts

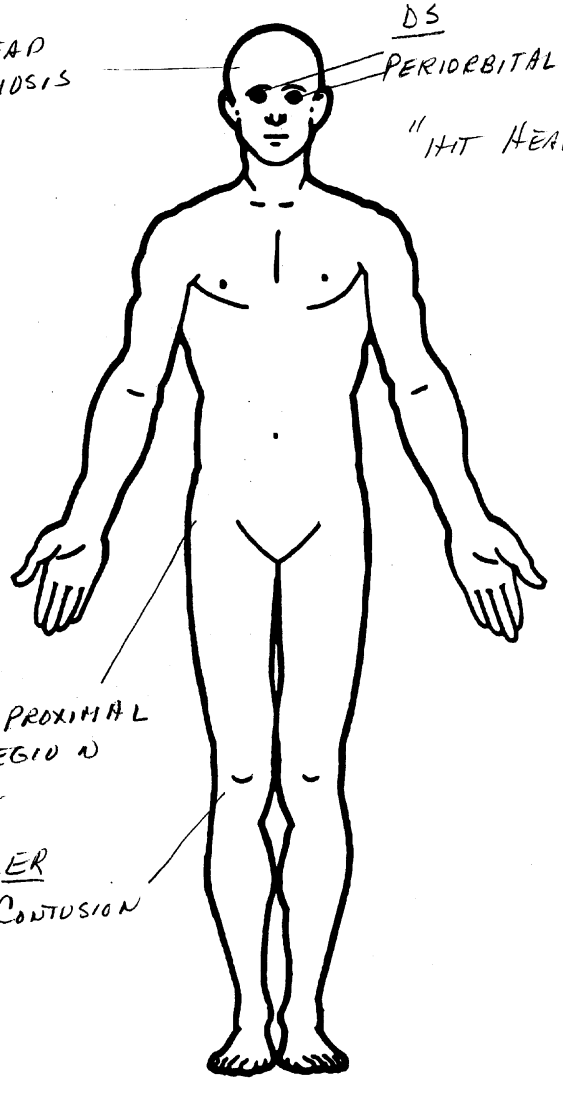
DS
PERIORBITAL ECCHYMOSIS

"HIT HEAD ON WINDSHIELD"
