CASE SUMMARY

NATIONAL ACCIDENT SAMPLING SYSTEM
CRASHWORTHINESS DATA SYSTEM

PSU 13 CASE NO. 056E TYPE OF ACCIDENT CAR/CAR/CAR-HEAD ON

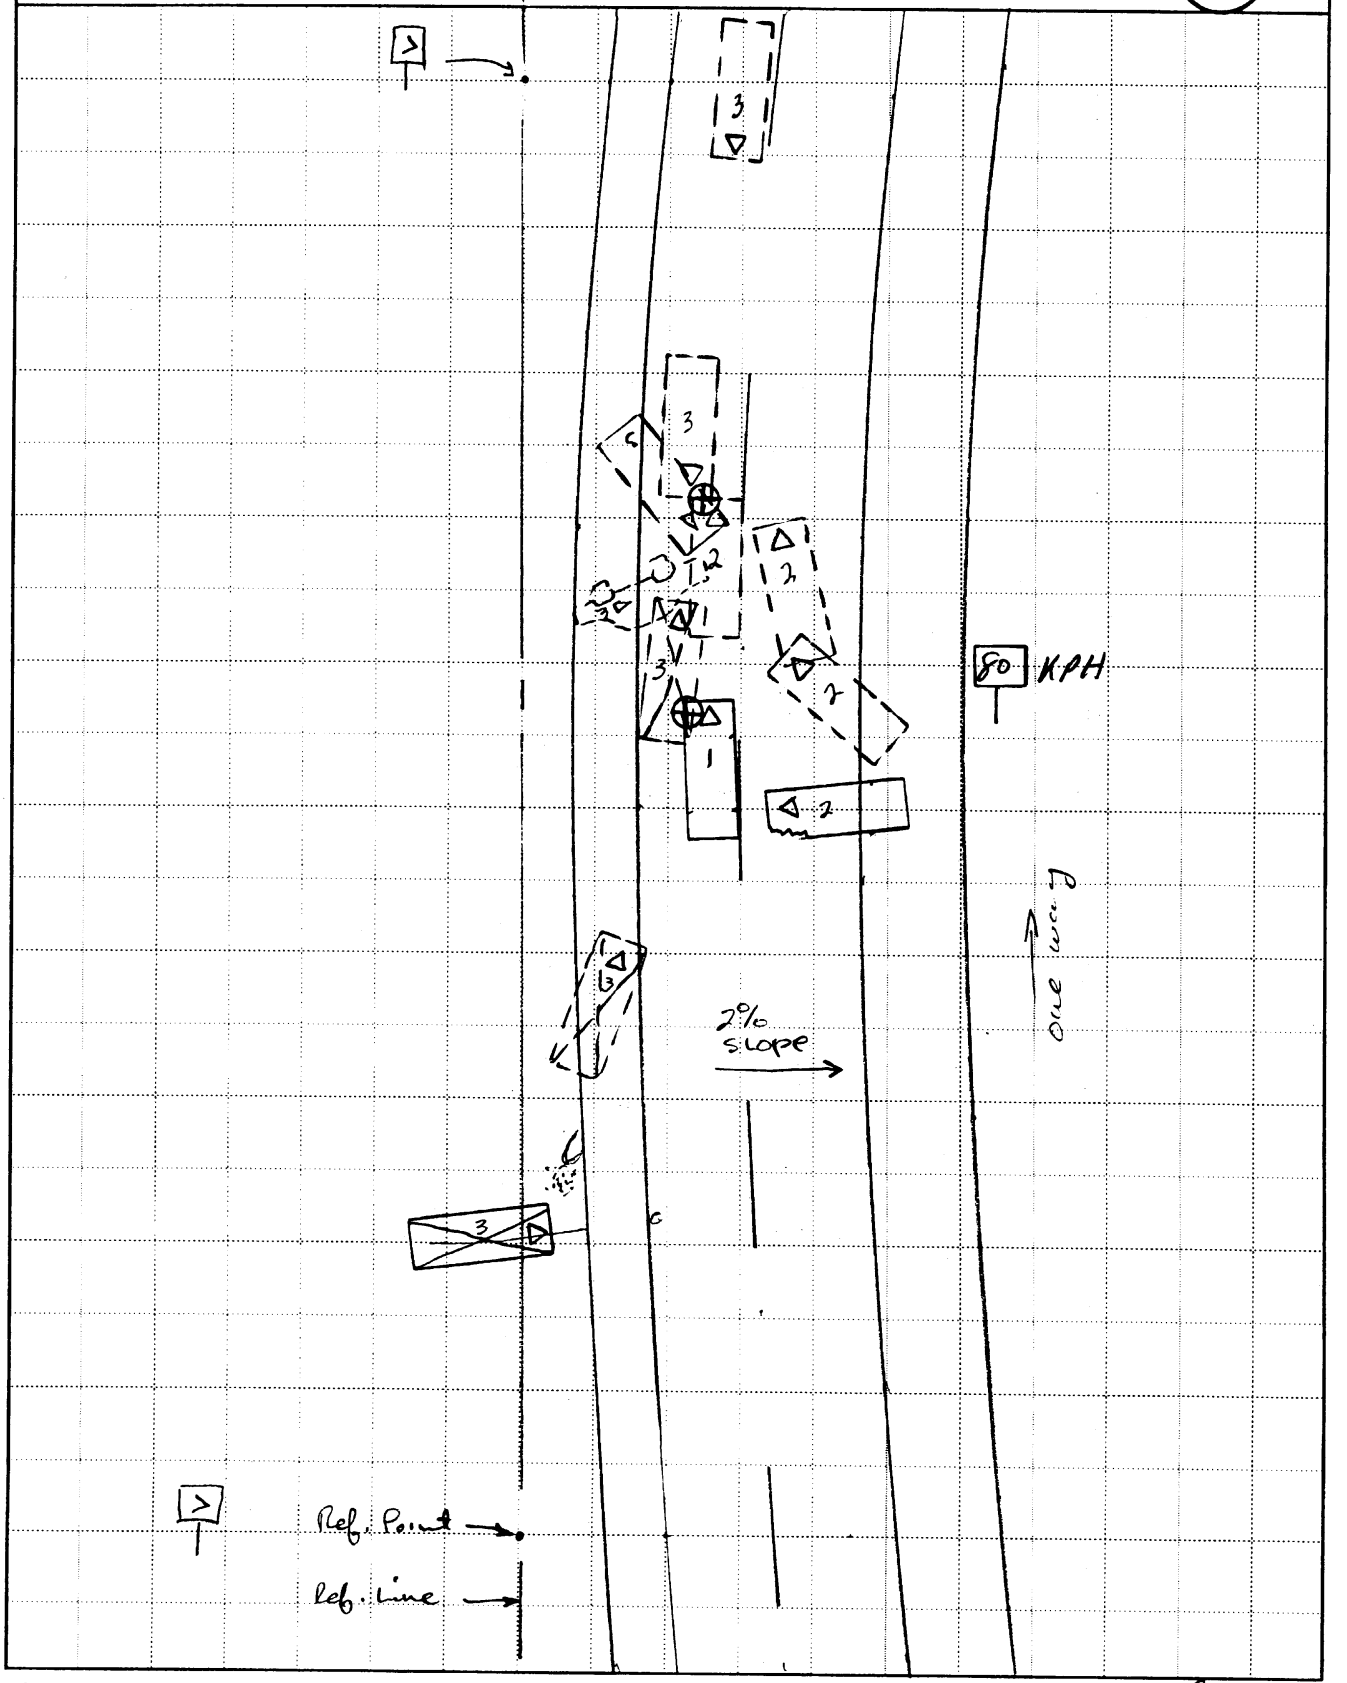
PSU No. 13 Case Number—Stratum 0568

VEH. #1	VEH. #2	VEH. #3
Heading Angle	270	270	90
Surface Type	conc.		
Surface Condition	dry		
Coefficient of Friction	.75		
Grade (v/h) Measurement (between impact and final rest)	00		
Grade (v/h) Measurement (at location of rollover initiation)

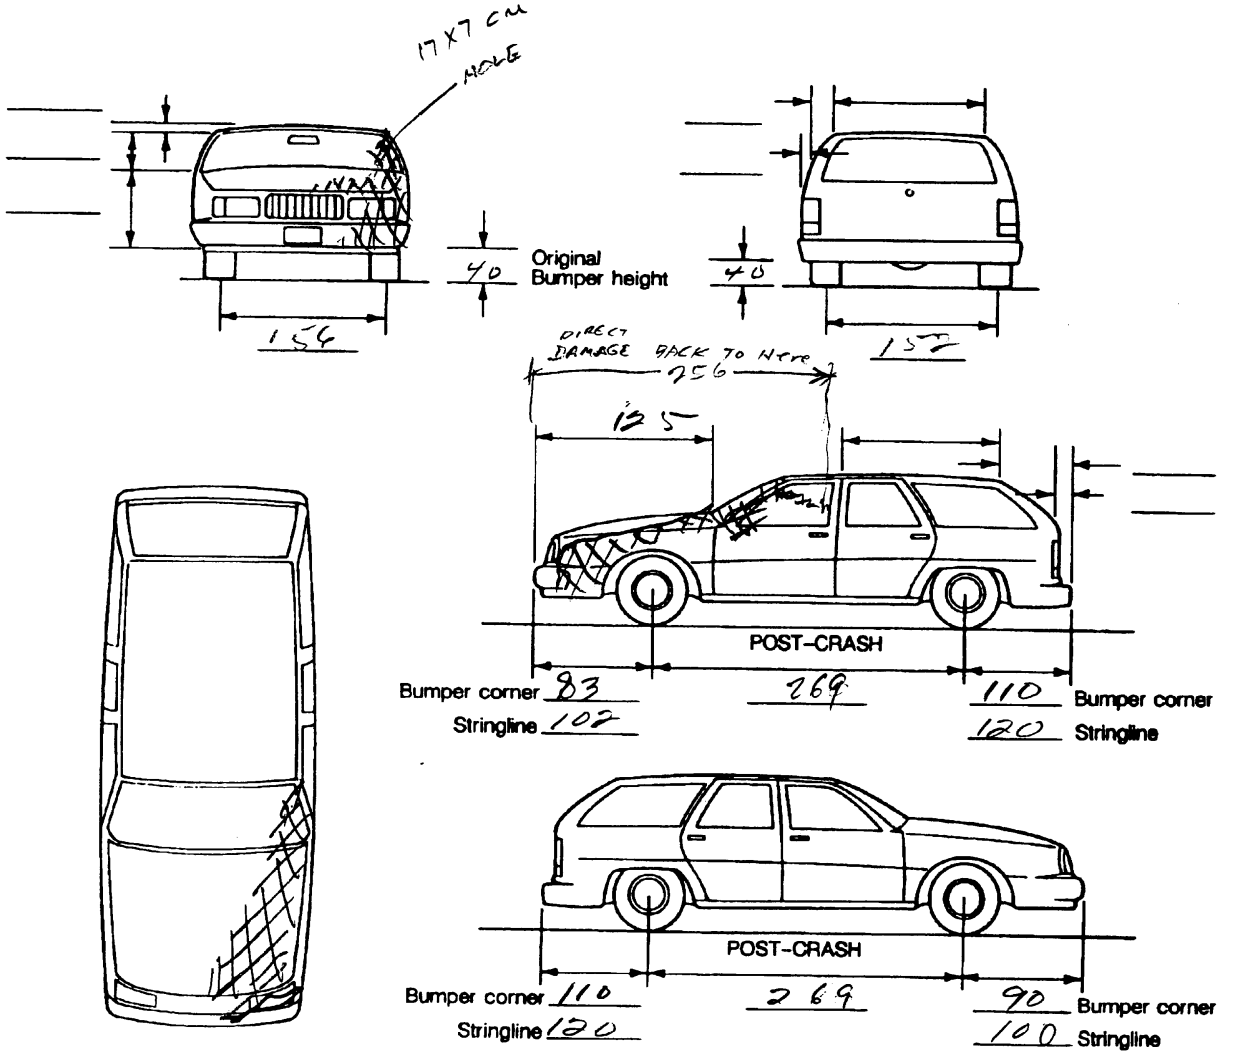
Specific Impact No.	Location of Direct Damage	Location of Field L	Location of Max Crush
1	center to LF corner	ENTIRE FRONT	C1

Specific Impact Number	Plane of Impact C-Measurements	Direct Damage Width (CDC)	Direct Damage Max Crush	Field L	C_1	C_2	C_3	C_4	C_5	C_6	±D
1	FRONT BUMP.	70	19	140	19	6	2	1	4	13	-35
	TAPER		13		13	4	0	0	4	13	
	ACTUAL		6		6	2	2	1	0	0

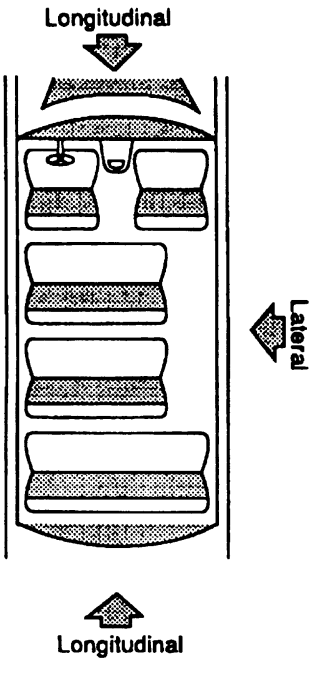
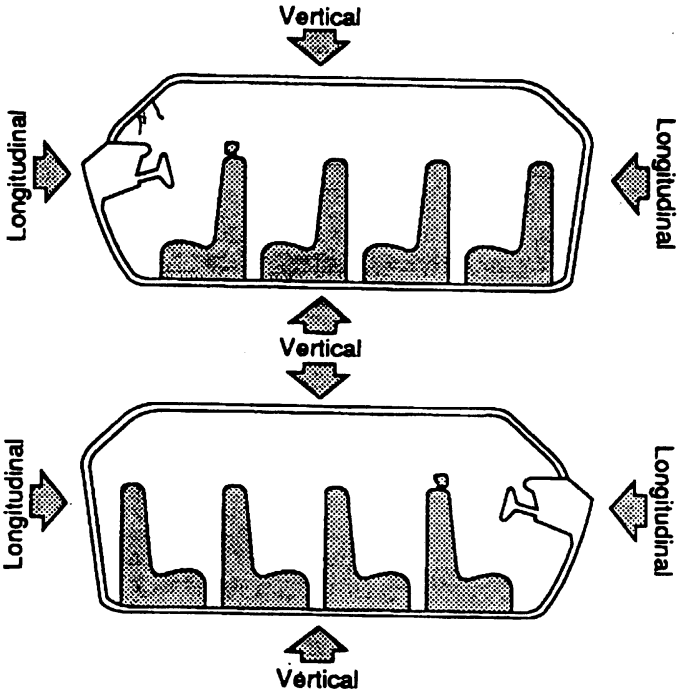
LOCATION OF INTRUSION	INTRUDED COMPONENT	(All Measurements Are In Centimeters) COMPARISON VALUE	–	INTRUDED VALUE	=	INTRUSION	DOMINANT CRUSH DIRECTION
11	Windshield	16	–	6	=	10	long
			–		=		
			–		=		
			–		=		
			–		=		
			–		=		
			–		=		
			–		=		
			–		=		
			–		=		
			–		=		
			–		=		
			–		=		
			–		=		
			–		=		
			–		=

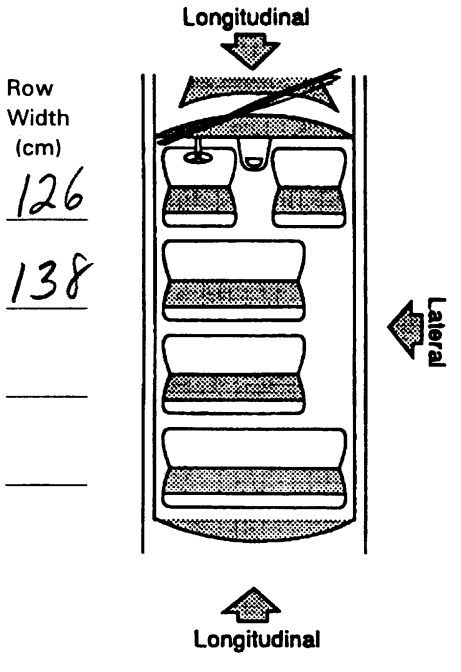
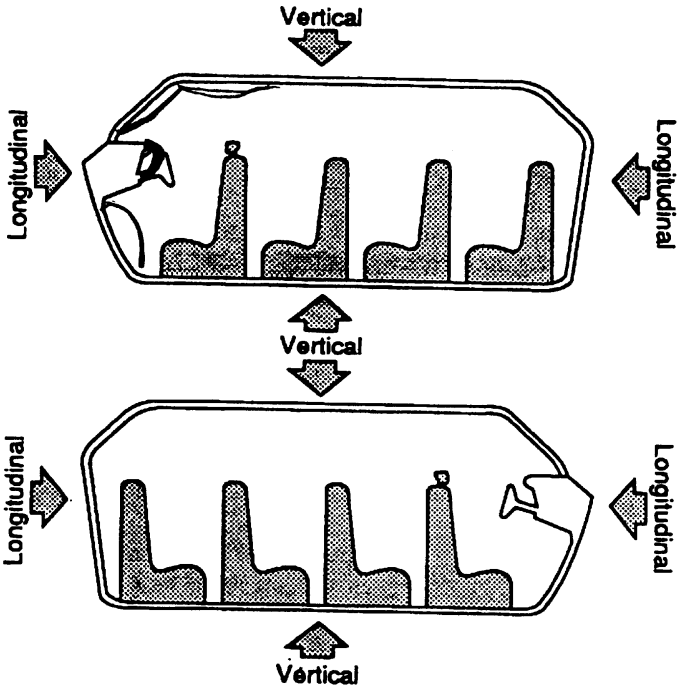
LOCATION OF INTRUSION	INTRUDED COMPONENT	(All Measurements Are In Centimeters) COMPARISON VALUE	—	INTRUDED VALUE	=	INTRUSION	DOMINANT CRUSH DIRECTION
11	INS. PANEL	77	–	36	=	41	LONG
12	11 11	77	–	65	=	22	11
13	11 11	77	–	68	=	9	11
11	Roof side Rail	59	–	31	=	28	LAT
11	Roof	90	–	72	=	18	VERT
21	Roof side Rail	59	–	34	=	25	LAT
11	STEER. WHEEL	60	–	49	=	11	LONG
11	WINDSHIELD	178	–	150	=	28	11
11	B PILLAR	58	–	30	=	28	LAT
11	DOOR	70	–	56	=	14	11
			–		=		
			–		=		
			–		=		
			–		=		
			–		=

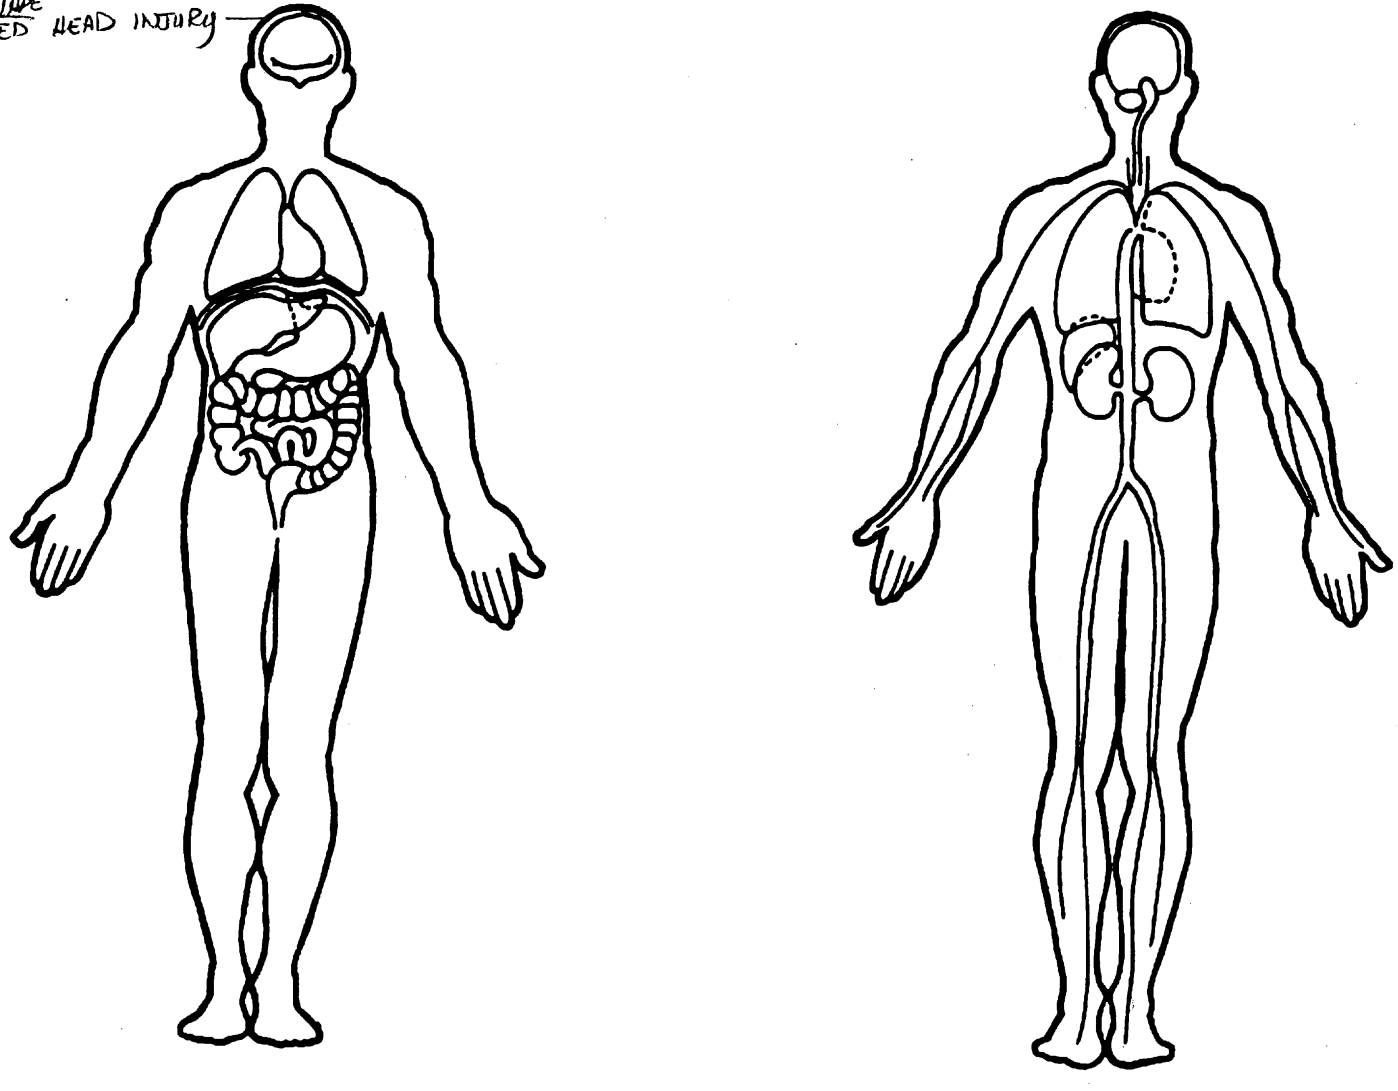
DS/ER AMNESTIC TO EVENT — CONFUSED

DS/CONSULT/HPE CLOSED HEAD INJURY

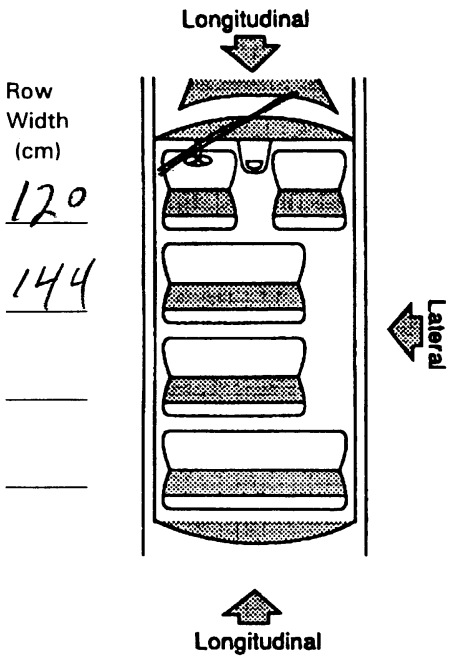
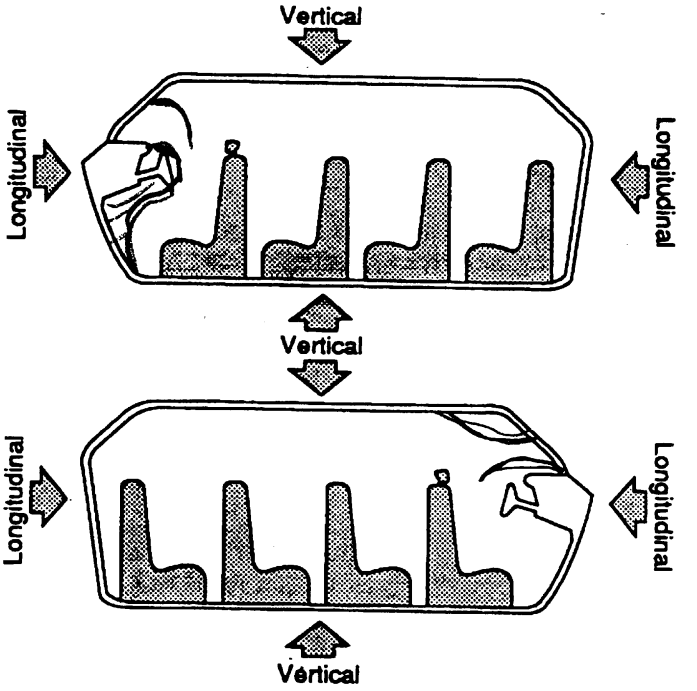
LOCATION OF INTRUSION	INTRUDED COMPONENT	(All Measurements Are In Centimeters) COMPARISON VALUE	–	INTRUDED VALUE	=	INTRUSION	DOMINANT CRUSH DIRECTION
11	INS. PANEL	73	–	46	=	27	LONG
13	WIND. HEADER	42	–	35	=	7	VERT
12	INS. PANEL	73	–	61	=	12	LONG
13	11 11	73	–	65	=	8	11
11	STEER WHEEL	55	–	16	=	39	11
11	WINDSHIELD	53	–	31	=	22	11
12	11	53	–	31	=	22	11
13	11	53	–	31	=	22	11
11	TOE PAN	156	–	125	=	31	11
11	ROOF SIDE RAIL	44	–	33	=	11	VERT
11	ROOF	85	–	79	=	6	11
13	11	85	–	73	=	12	11
			–		=		
			–		=		
			–		=
