CASE SUMMARY

NATIONAL ACCIDENT SAMPLING SYSTEM
CRASHWORTHINESS DATA SYSTEM

PSU 43 CASE NO. 160J TYPE OF ACCIDENT UTILTY-UTILITY: RIGHT ANGLE

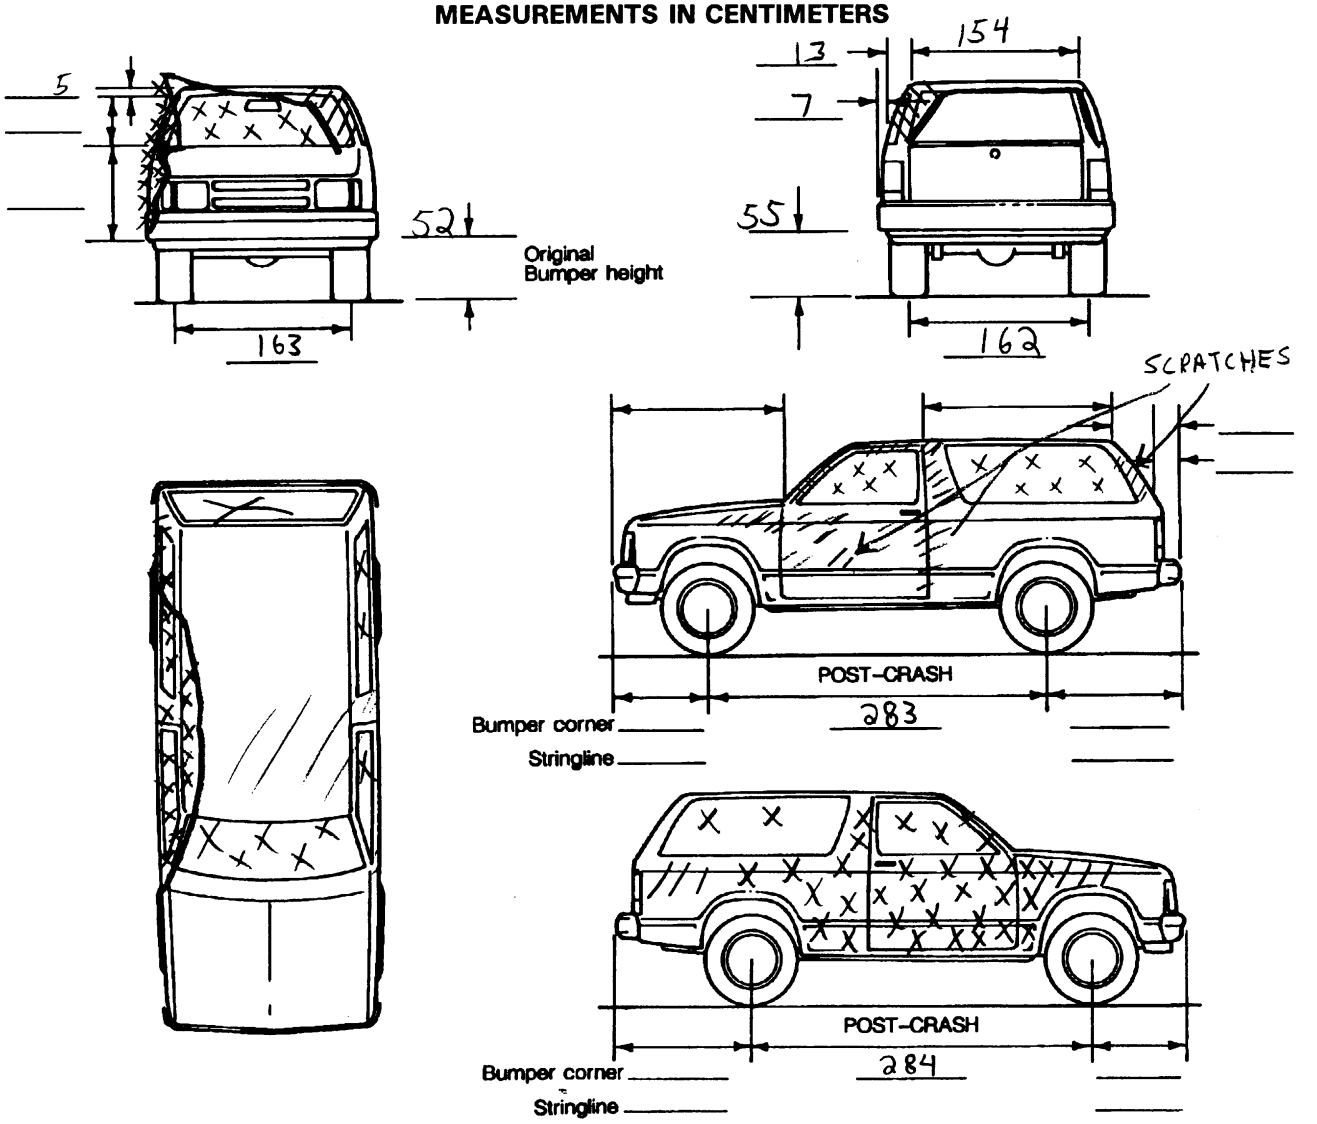
VEHICLE DAMAGE SKETCH

Specific Impact Number	Plane of Impact C-Measurements	Direct Damage		Field L	C_1	C_2	C_3	C_4	C_5	C_6	±D
		Width (CDC)	Max Crush								
01	R PLANE	214	72	297	9	43	72	40	17	13	+40
01	FREE SPACE	214	-1	297	0	-1	-1	-1	-1	0	+40
01	RESULTANT	214	71	297	9	42	71	39	16	13	+40
01	TOP		4								
	ROLLOVER

RESEARCHER MOVED C' MEASUREMENT FORWARD FOR PHOTOS. ACTUAL C' MEASURMENT WAS TAKEN AT THE END OF INDIRECT DAMAGE ON RIGHT PLANE.

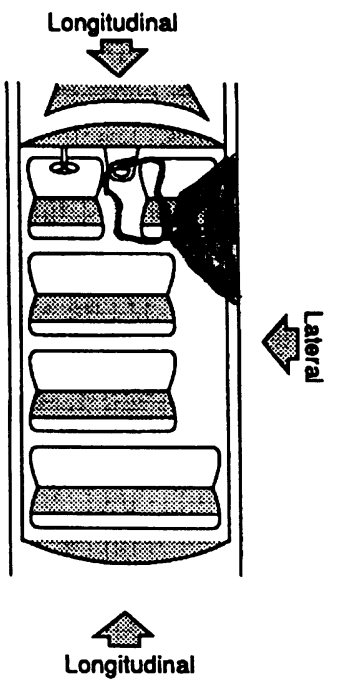
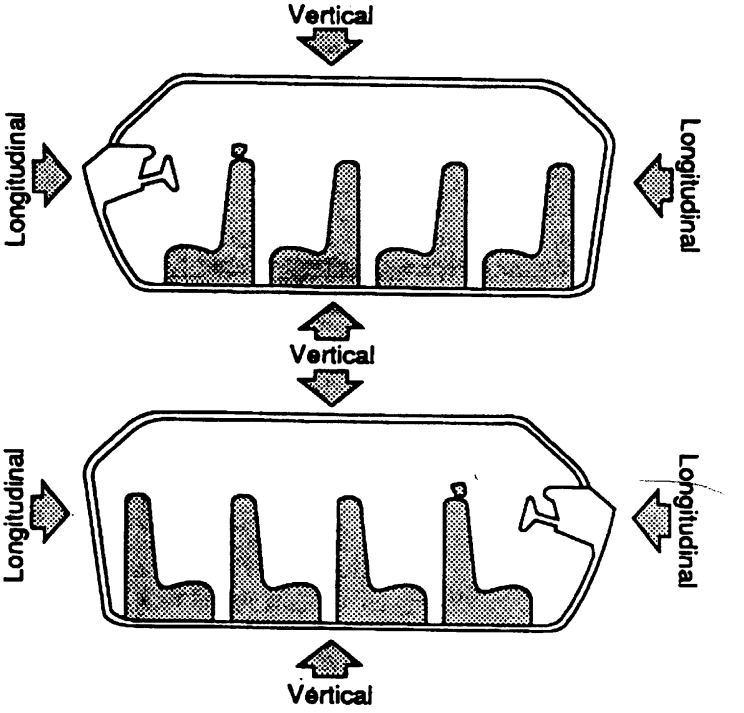
LOCATION OF INTRUSION	INTRUDED COMPONENT	(All Measurements Are In Centimeters) COMPARISON VALUE	–	INTRUDED VALUE	=	INTRUSION	DOMINANT CRUSH DIRECTION
FR	DOOR	85	–	42	=	43	LAT.
2R	B-PILLAR	60	–	51	=	9	LAT.
2R	SIDE PANEL	61	–	53	=	8	LAT.
	ROOF?		–		=		
	REAR SEAT?		–		=		
	WINDSHIELD?		–		=		
			–		=		
			–		=		
			–		=		
			–		=		
			–		=		
			–		=		
			–		=		
			–		=		
			–		=		
			–		=

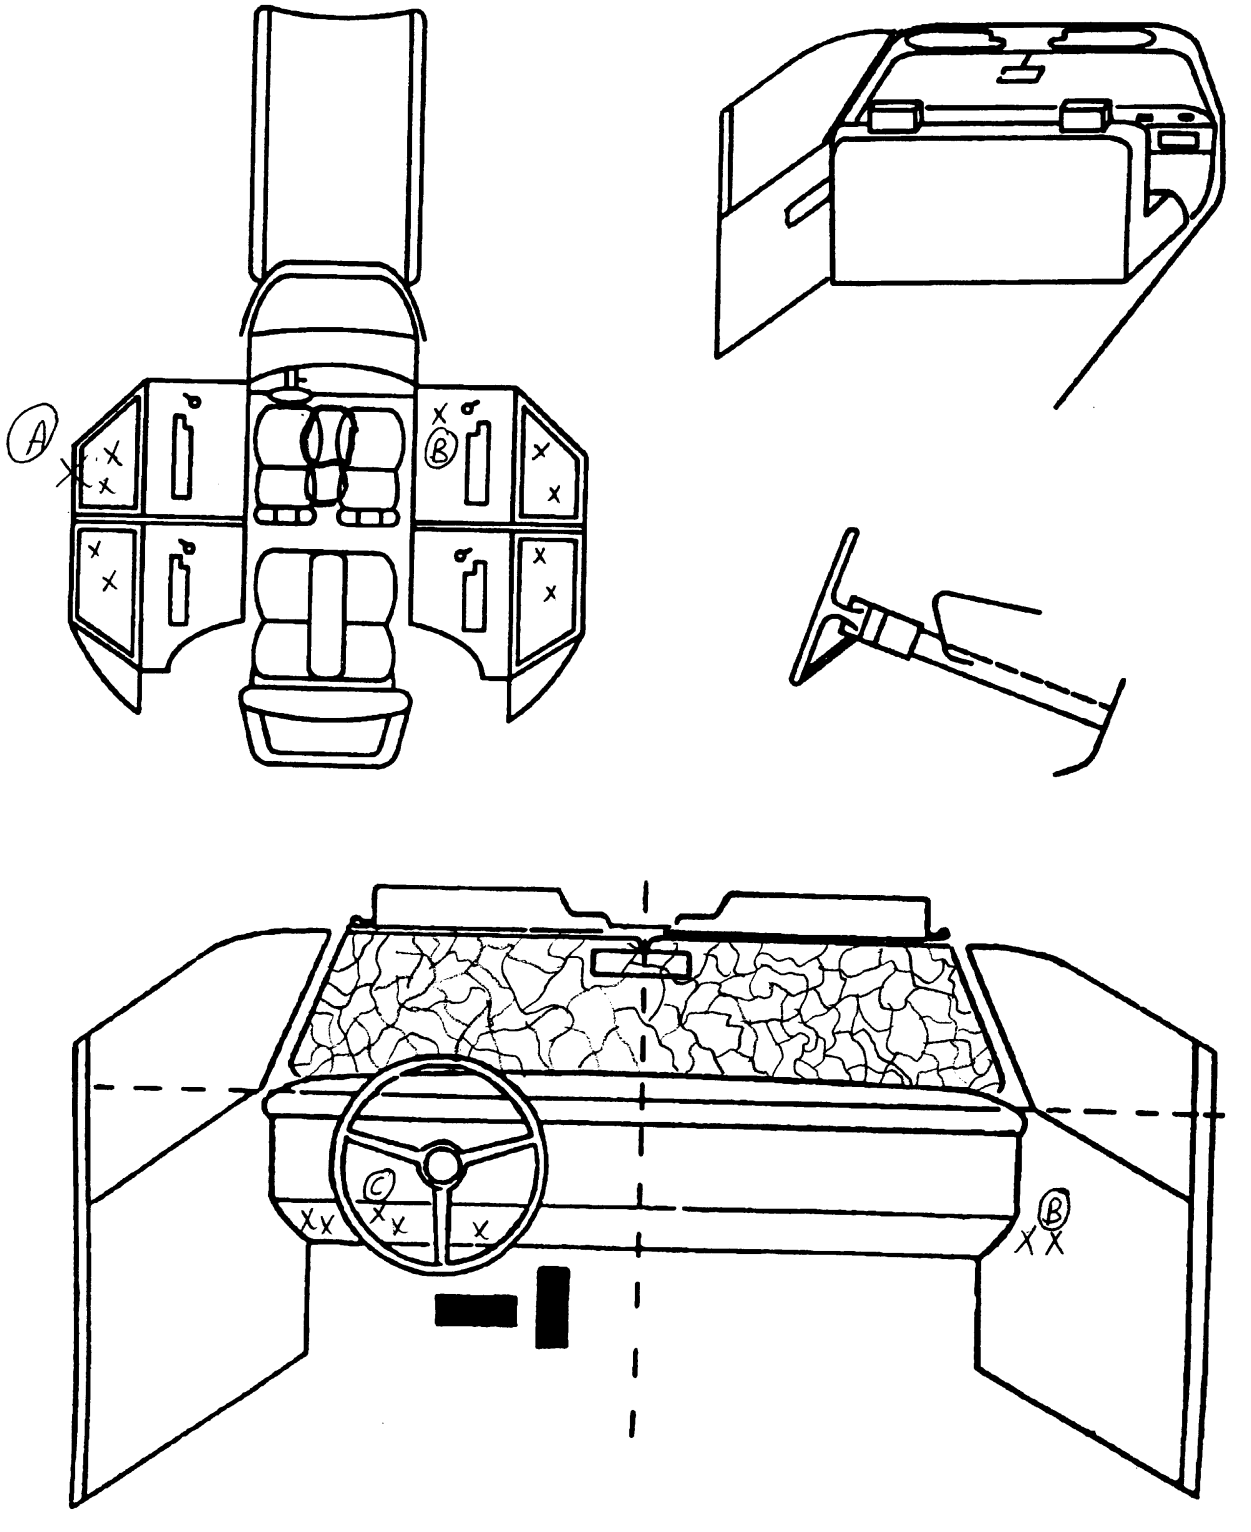
VEHICLE INTERIOR SKETCHES

Contact	Interior Component Contacted	Occupant No. If Known	Body Region If Known	Supporting Physical Evidence	Confidence Level of Contact Point
A	057	01	HEAD	DEFORMED WINDOW FRAME	3
B	102	02	R ARM	DEFORMED & INTRUDED DOOR	2
C	011	01	KNEES	CRACKED PANEL	2
D					
E					
F					
G					
H					
I					
J					
K					
L					
M					
N

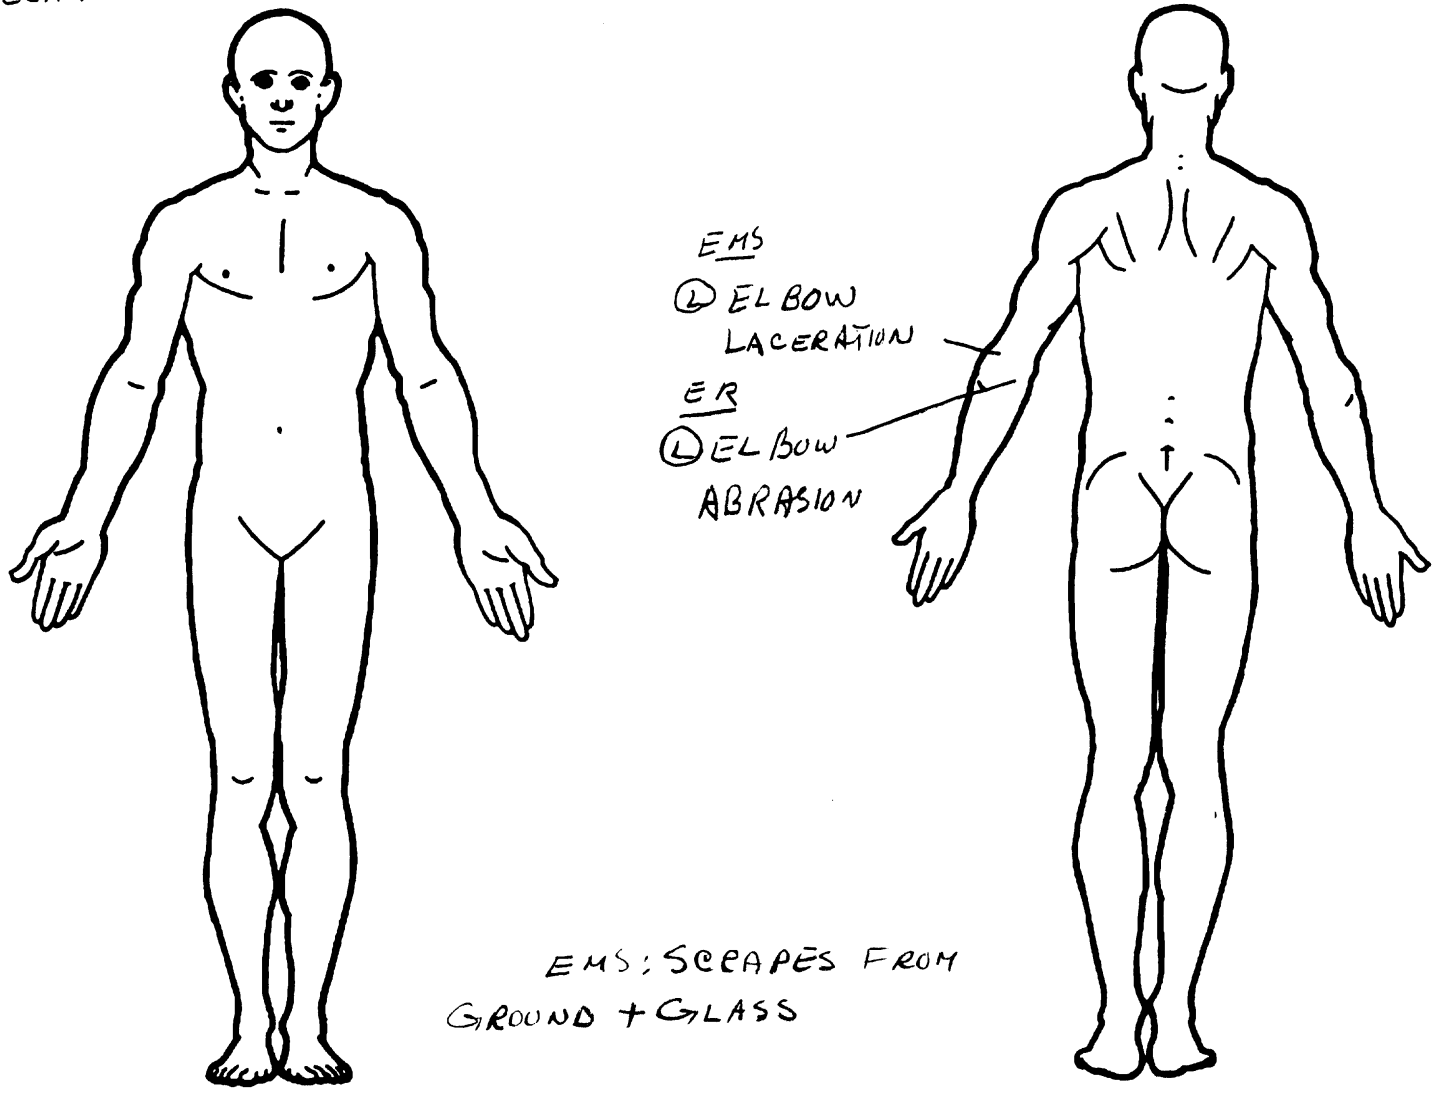
EMS: PT. STUPEROUS WHEN EMS FIRST ARRIVED; ALERT TO VERBAL ONLY (?) LOC BECAME MORE ALERT ENROUTE

EMS; SCRAPES FROM GROUND + GLASS

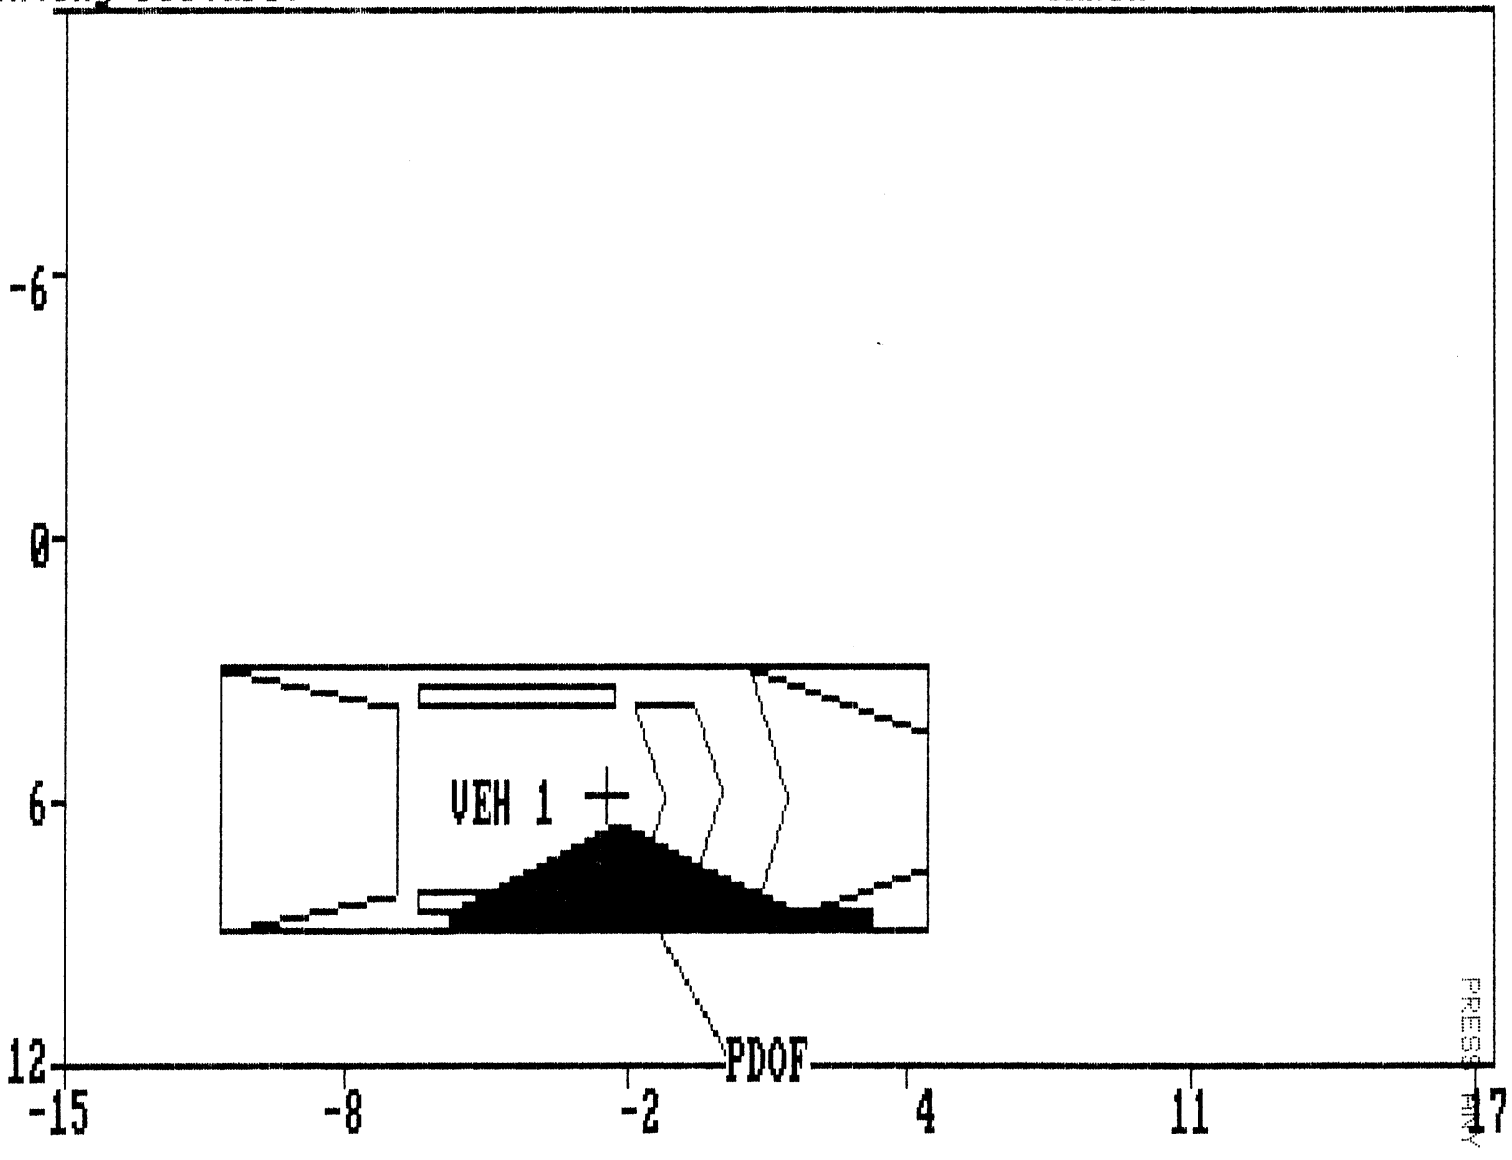
Printing Picture: CRASH

VEHICLE #1	VEHICLE #2
CG TO FRONT AXLE	130 CM. (51 IN.)	127 CM. (50 IN.)
CG TO REAR AXLE	141 CM. (56 IN.)	127 CM. (50 IN.)
TRACK	150 CM. (59 IN.)	127 CM. (50 IN.)
CG TO FRONT OF VEH	228 CM. (90 IN.)	127 CM. (50 IN.)
CG TO REAR OF VEH	-270 CM. (-106 IN.)	-127 CM. (-50 IN.)
CG TO SIDE OF VEH	92 CM. (36 IN.)	127 CM. (50 IN.)
MOMENT OF INERTIA	19844 KGS (43747 LBS)	****** KGS (******** LBS)
VEHICLE MASS	6 KGS (13 LBS)	2600 KGS (5732 LBS)

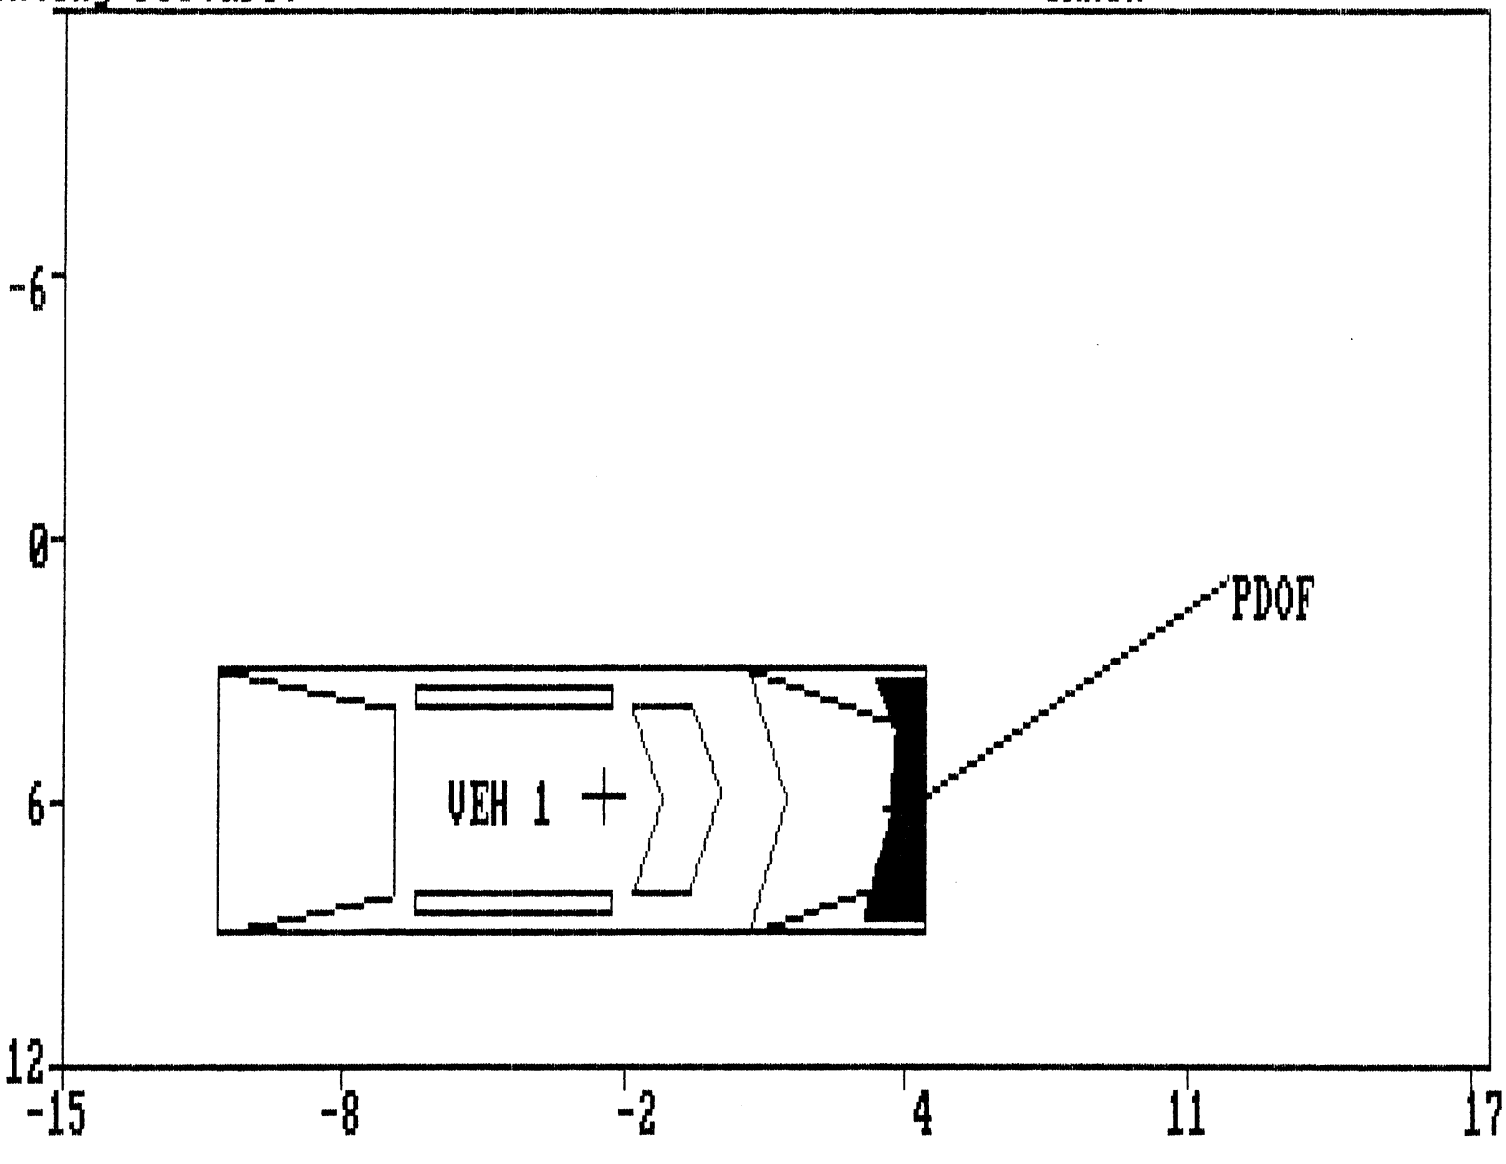
Printing Picture:

SPEED CHANGE (DAMAGE)
VEHICLE #1	
TOTAL	31 KPH (19 MPH)
LONGITUDINAL	-26 KPH (-16 MPH)
LATITUDINAL	18 KPH (11 MPH)
PDOF ANGLE	-35 DEGREES
ENERGY DISSIPATED = 118153 JOULES (87133 FT-LB)	
VEHICLE #2	
TOTAL	0 KPH (0 MPH)
LONGITUDINAL	0 KPH (0 MPH)
LATITUDINAL	0 KPH (0 MPH)
PDOF ANGLE	0 DEGREES
ENERGY DISSIPATED =	0 JOULES (0 FT-LB)
