CASE SUMMARY

NATIONAL ACCIDENT SAMPLING SYSTEM
CRASHWORTHINESS DATA SYSTEM

PSU 45 CASE NO. 209F TYPE OF ACCIDENT Hwy Truck - CAR / RNSR

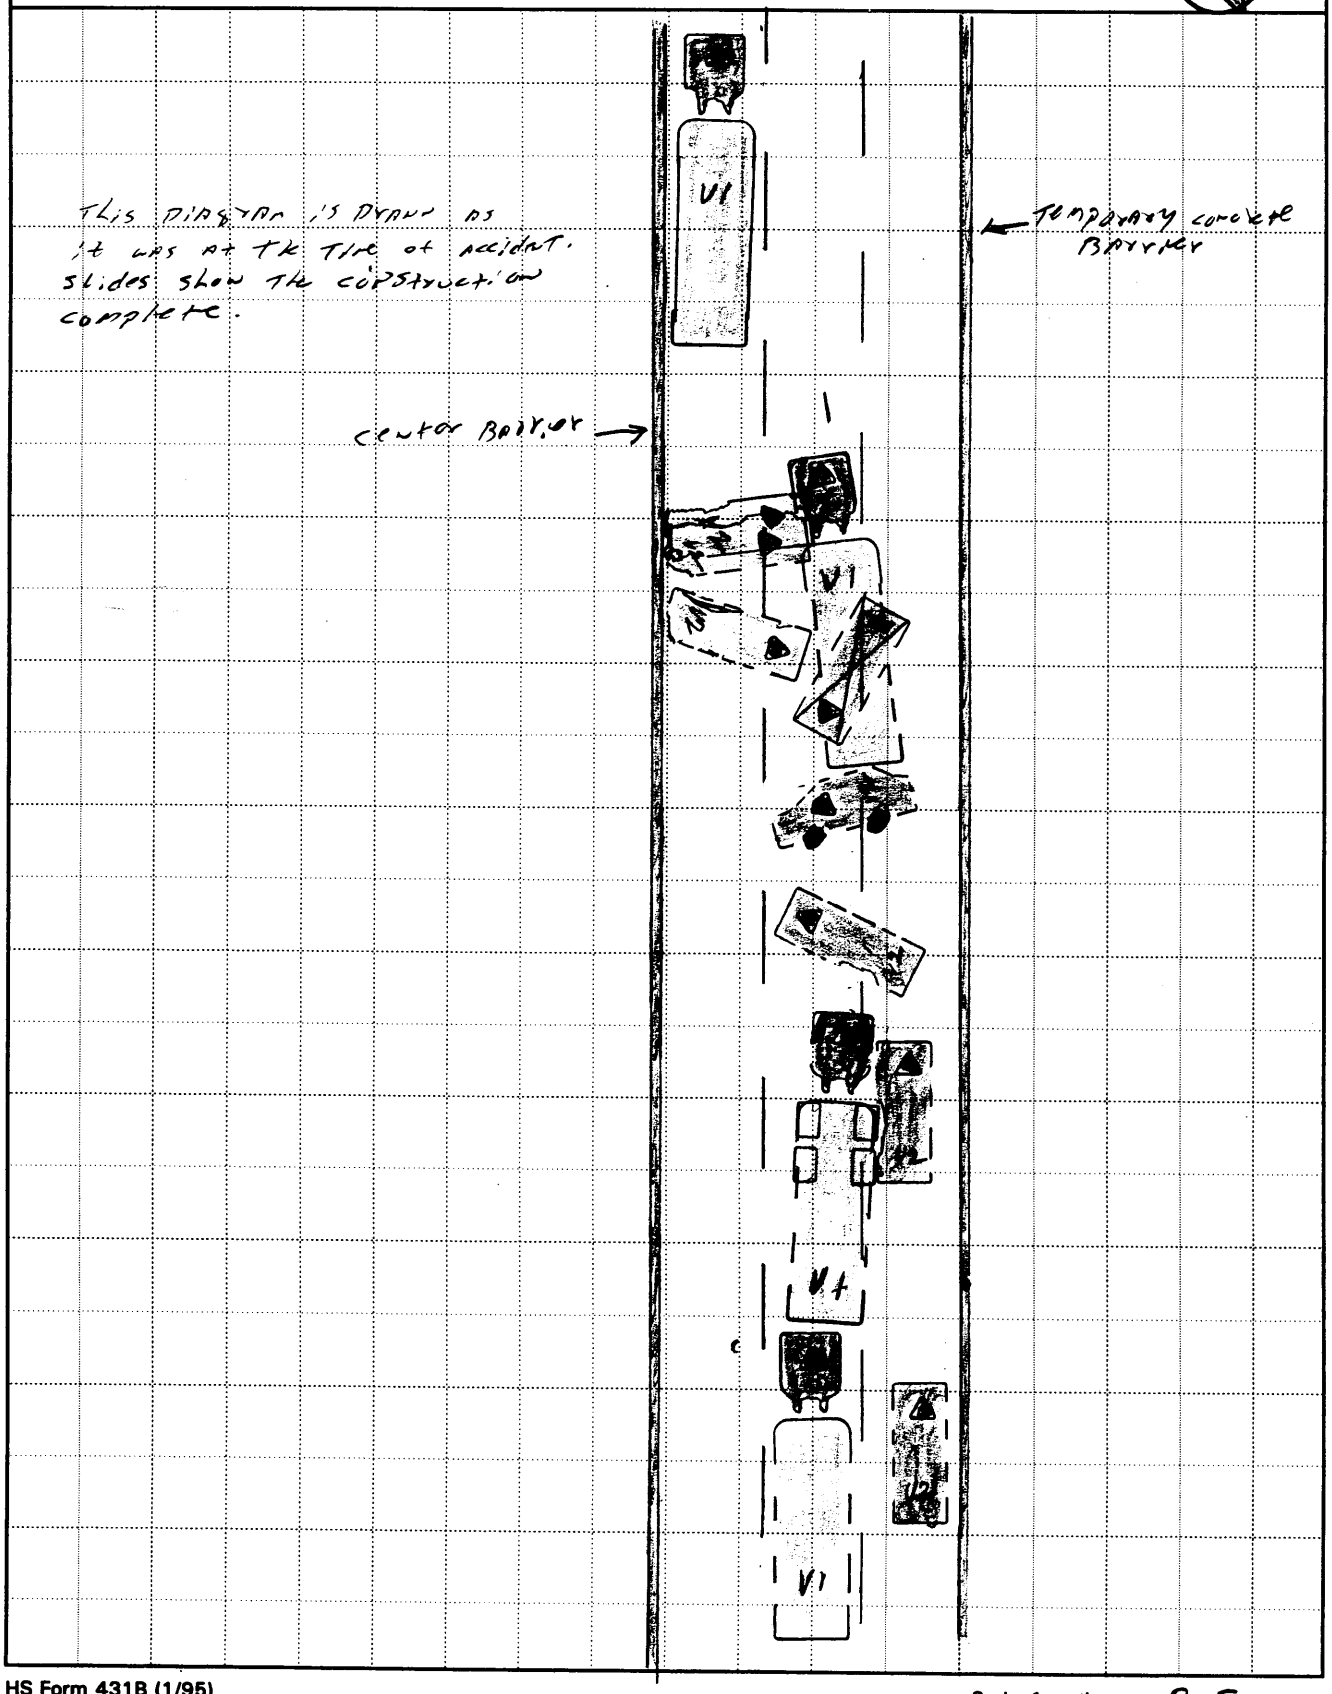
PSU No. 45 Case Number—Stratum 209F

Both Vehicles were eastbound on a major interstate highway, in dry daylight conditions. There was construction in the area, and three travel lanes were open. Their was a concrete barrier on each side of the eastbound lanes. V1 was in the middle lane, and V2 was in the outside lane. V1 attempted to change lanes to the right, and V1 right struck V2 left. V2 rotated CCW, and into a latteral slide. V2 then rolled to the right, still spinning. V2 back then struck the inside median barrier wall, as V2 was coming out of its roll and back up on its wheels. V2 came off of the barrier, and V2 front struck the back of the cab of V1. V2 came to rest facing south, near the point of 4th impact. V1 continued forward, and came to rest facing east, a few meters east of the point of its 2nd impact.

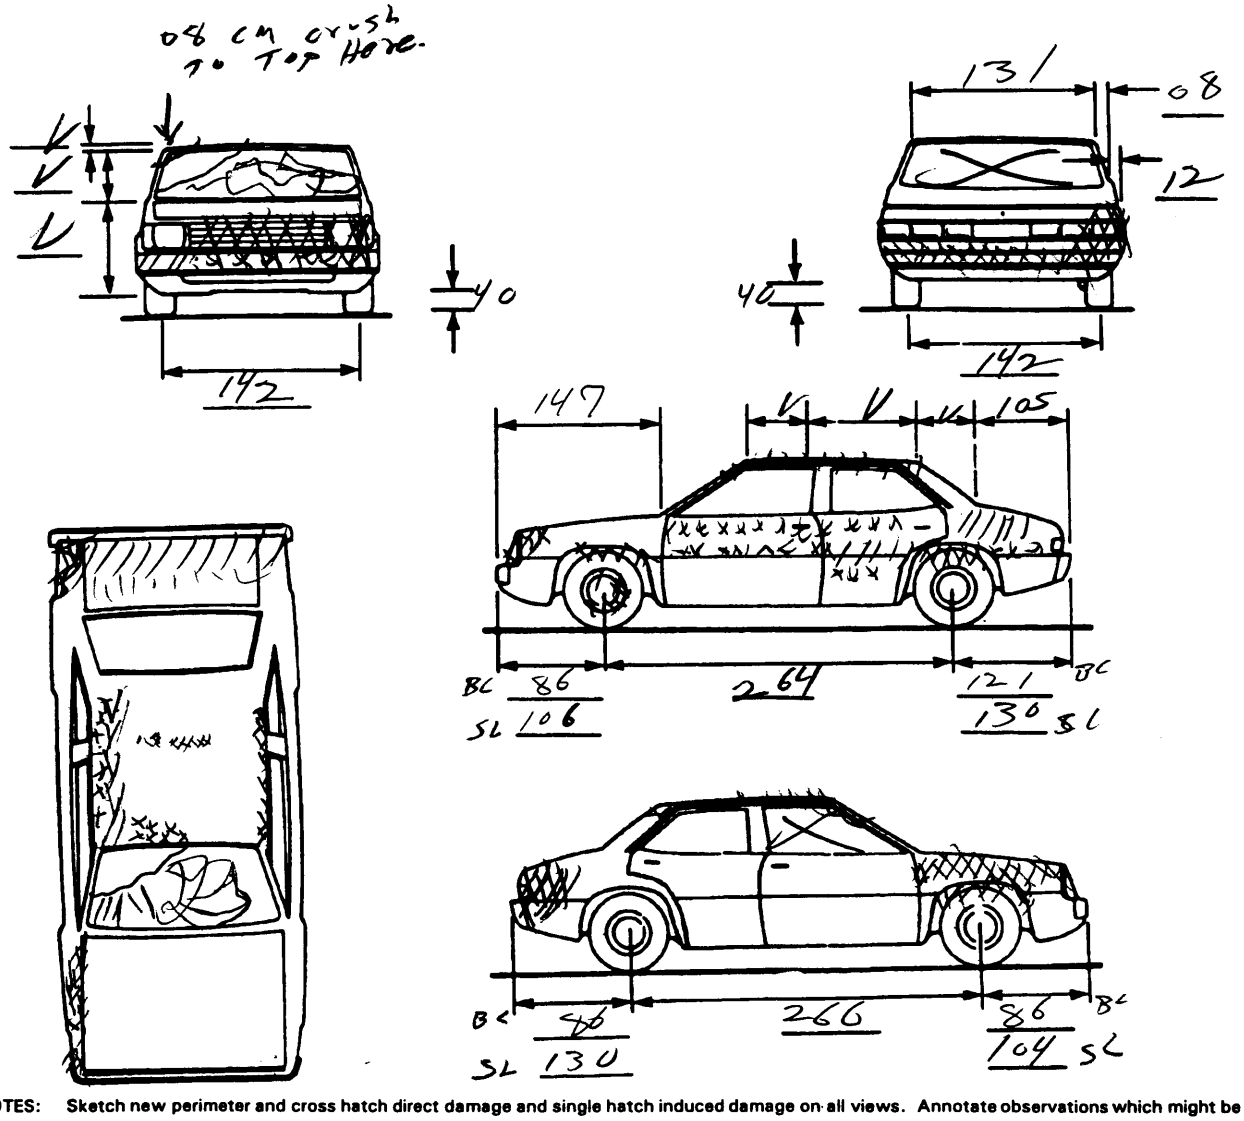
VEHICLE DAMAGE SKETCH

Specific Impact No.	Location of Direct Damage	Location of Field L	Location of Max Crush
03	ENTIRE BACK	BACK PLANE	AT C-6
04	LFBC TO RHF.	FRONTAL PLANE	AT C-1
01	LEFT SIDE	LEFT SIDE	N/A

NOTE: 03 IMPACT IS "OUT OF PLANE" DAMAGE

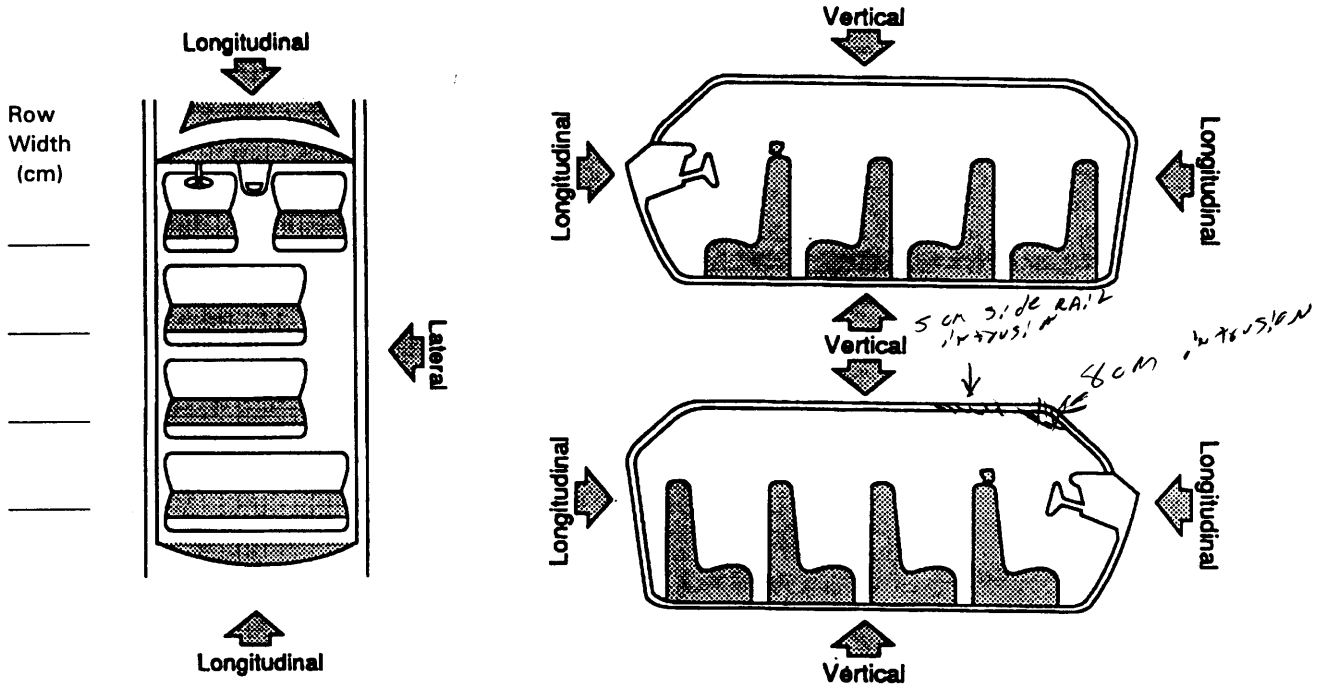
INTRUSION WORKSHEET

LOCATION OF INTRUSION	INTRUDED COMPONENT	(All Measurements Are In Centimeters) COMPARISON VALUE	—	INTRUDED VALUE	=	INTRUSION	DOMINANT CRUSH DIRECTION
13	A PILLAR	0	—	08	=	08	LATERAL OR VERT.
13	ROOF SIDE RAIL	0	—	05	=	05	VERTICAL
			—		=		
			—		=		
			—		=		
			—		=		
			—		=		
			—		=		
			—		=		
			—		=		
			—		=		
			—		=		
			—		=		
			—		=		
			—		=		
			—		=

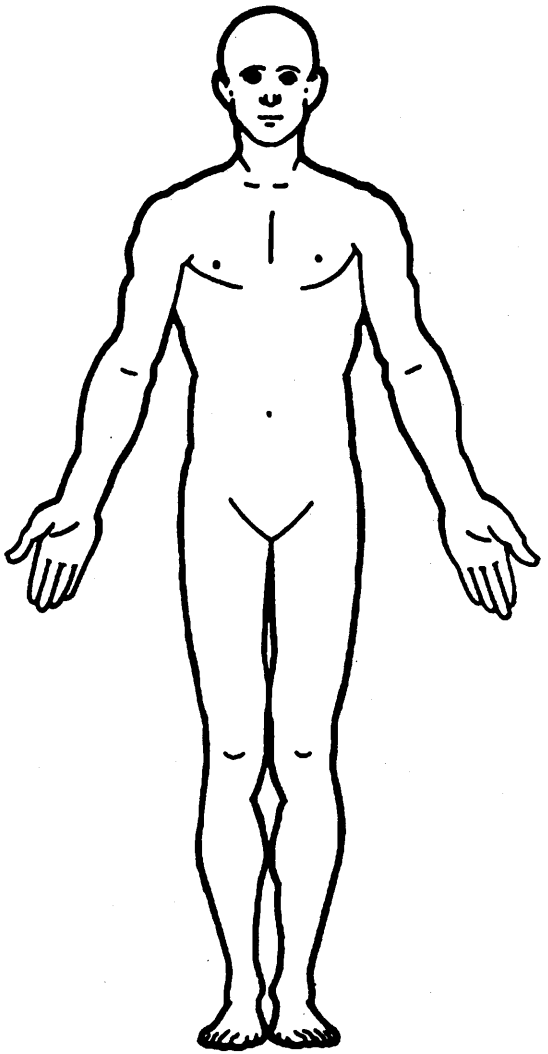
ER / RAD
NECK PAIN —
MUSCULOSKELETAL
STRAIN
