CASE SUMMARY

NATIONAL ACCIDENT SAMPLING SYSTEM
CRASHWORTHINESS DATA SYSTEM

PSU 79 CASE NO. 104J TYPE OF ACCIDENT Car/Compact Utility - Head-on

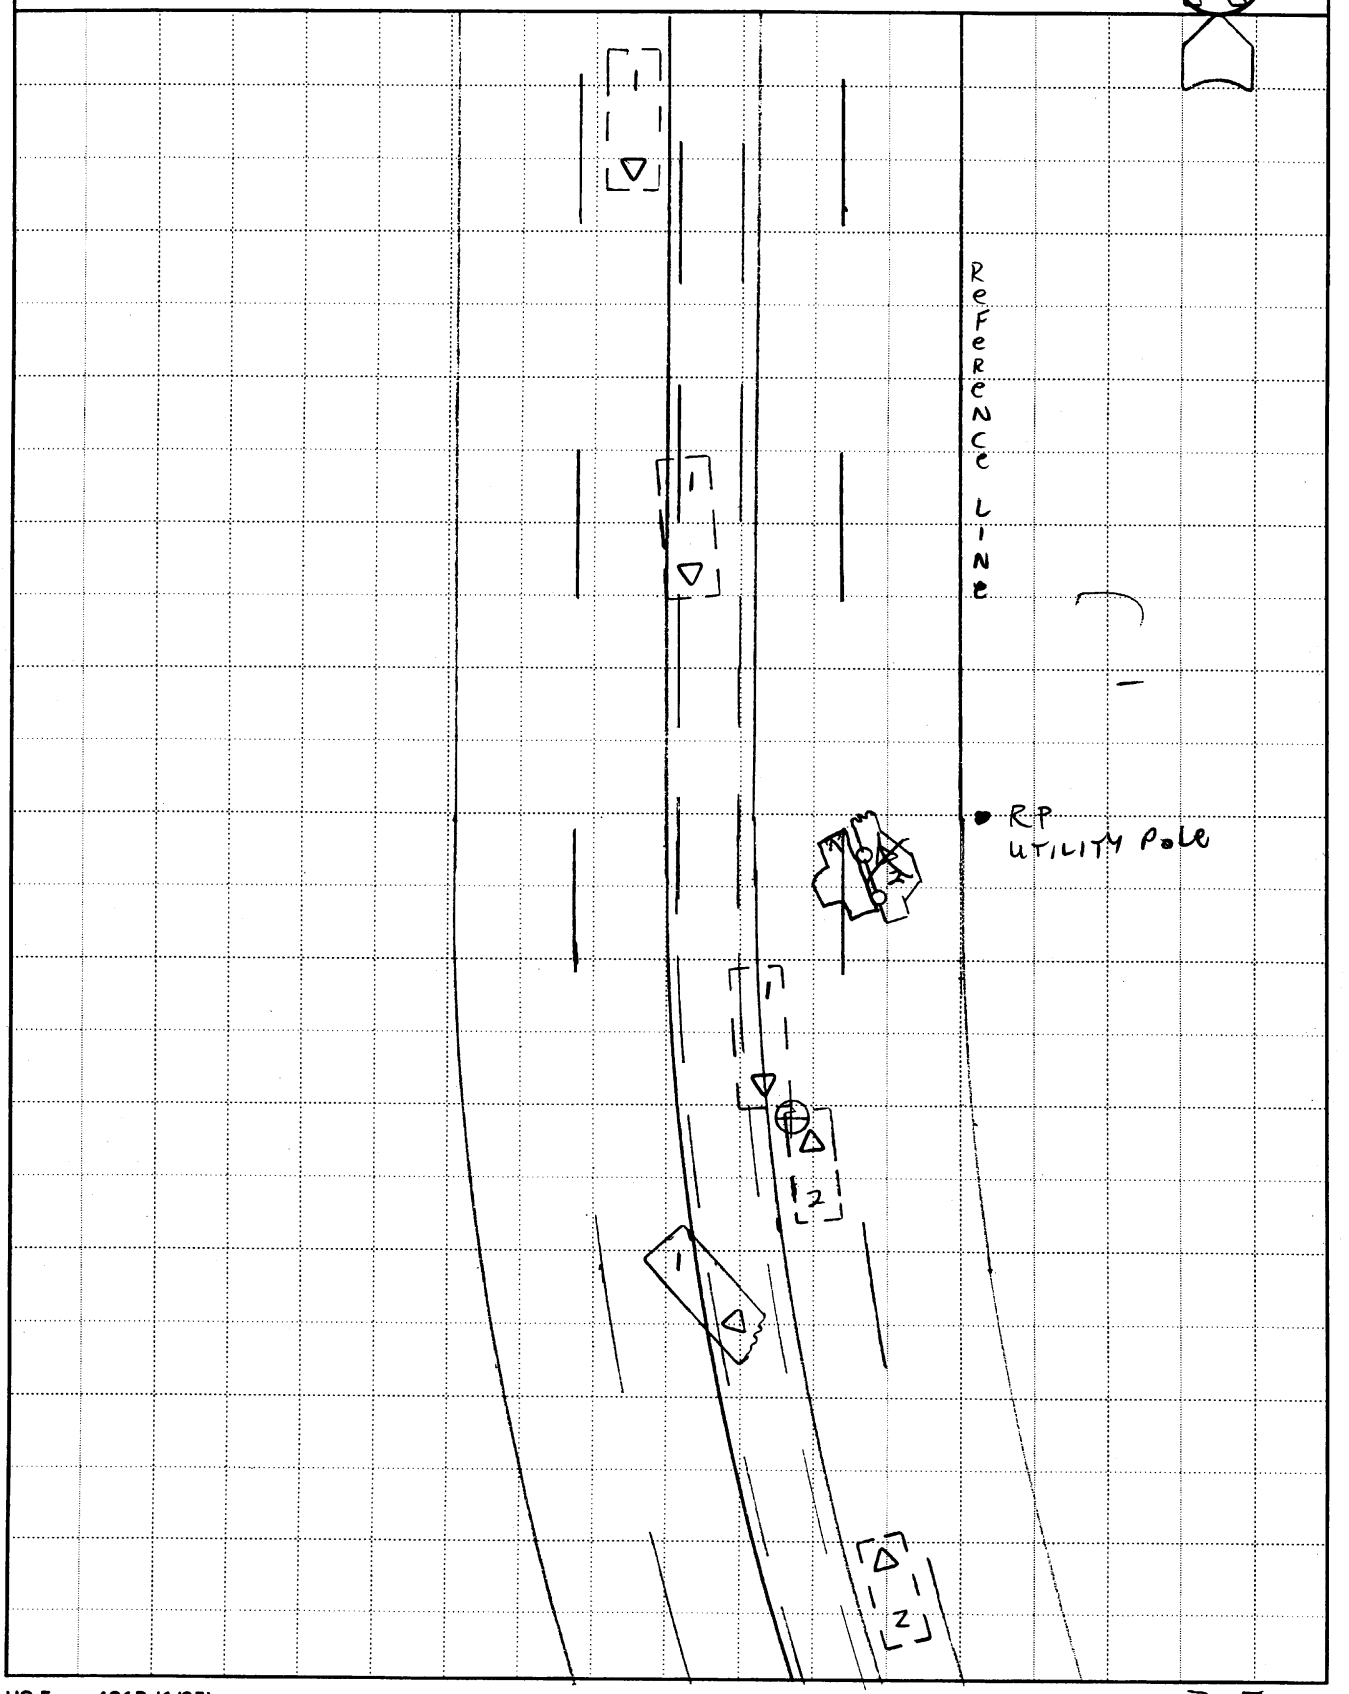
PSU No. 79 Case Number—Stratum 1043

V1 was heading south in the #2 lane of a 5-lane, undivided, asphalt roadway with a 5% downhill grade and a curve to the left. V2 was heading north in the #2 lane of the same roadway, with a 5% uphill grade and a curve to the right. As the vehicles approached, V1 crossed the double yellow lines and entered the northbound #2 lane, the front of V2 contacted an unknown plane of V1. This impact caused V2 to roll left one quarter turn and come to rest on the driver's side. Both vehicles were towed due to damage. The driver of V2 was entrapped and needed to be removed by rescue. The driver of V2 was transported and hospitalized with non-serious injuries. The driver of V1 was transported and hospitalized with serious injuries. The passenger of V1 was transported and released with serious injuries.
01

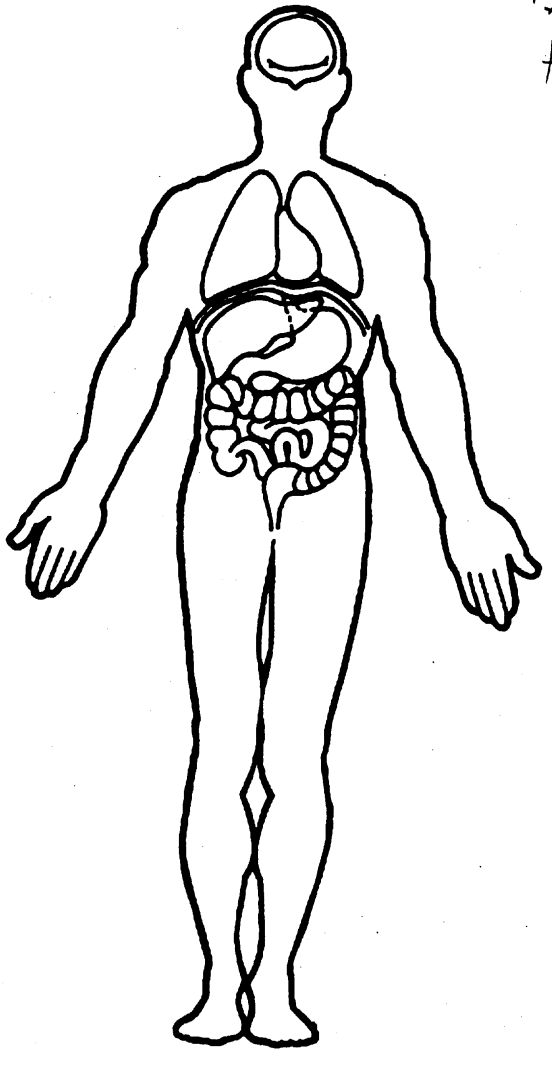
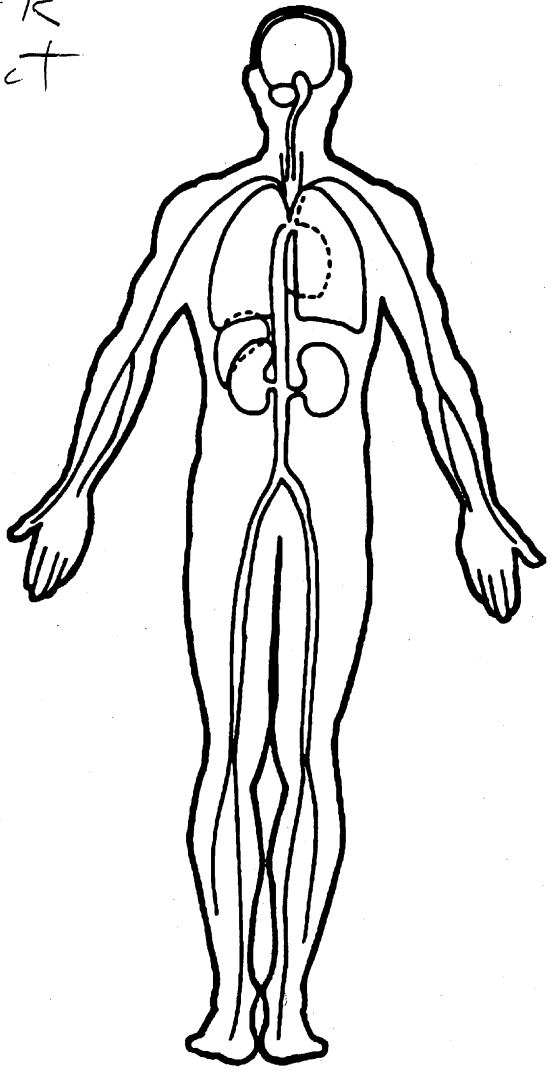
OFFICIAL INJURY DATA – INTERNAL INJURIES

Positive LOC
AO X ~~4~~ in ER
Head contact

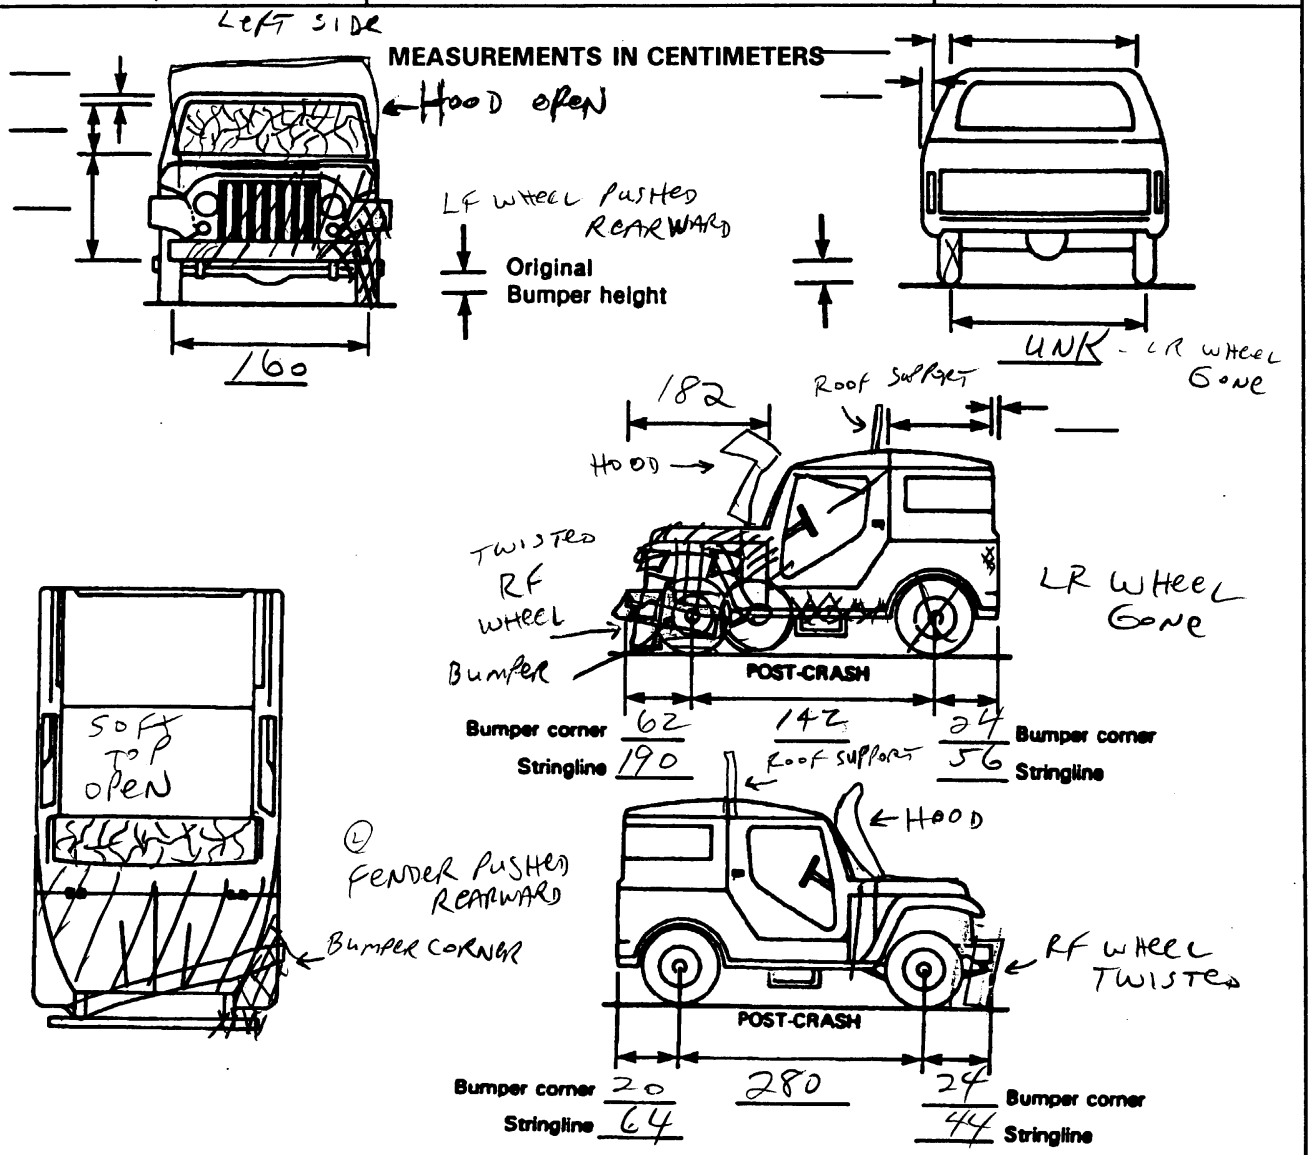
VEHICLE DAMAGE SKETCH

Specific Impact No.	Location of Direct Damage	Location of Field L	Location of Max Crush
01	BEGINS AT LF BUMPER CORNER	W/HOLE FRONT BUMPER	AT C-1
02	N/A	N/A	UNK

Specific Impact Number	Plane of Impact C-Measurements	Direct Damage Width (CDC)	Direct Damage Max Crush	Field L	C_1	C_2	C_3	C_4	C_5	C_6	±D
01	FRONT BUMPER	48	126	79	126	90	71	54	35	18	-42
	ADJUST *		+2		+2	+2	+2	+2	+2	+2	~
	RESULT	48	128	79	128	92	73	56	37	20	-42
02	N/A	UNK									
		NO	FREESPACE

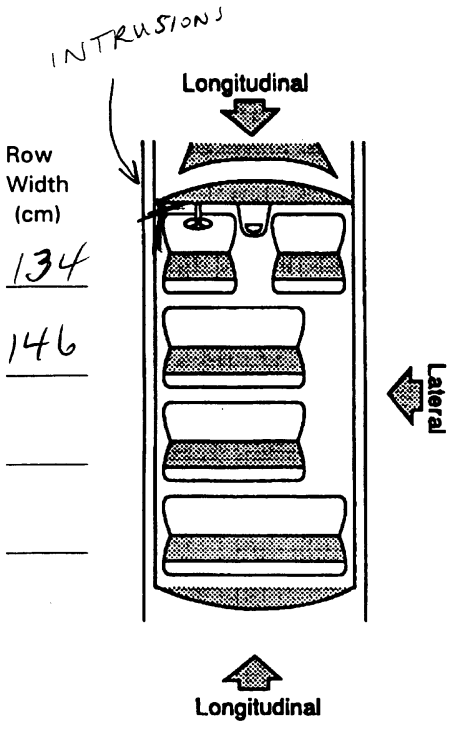
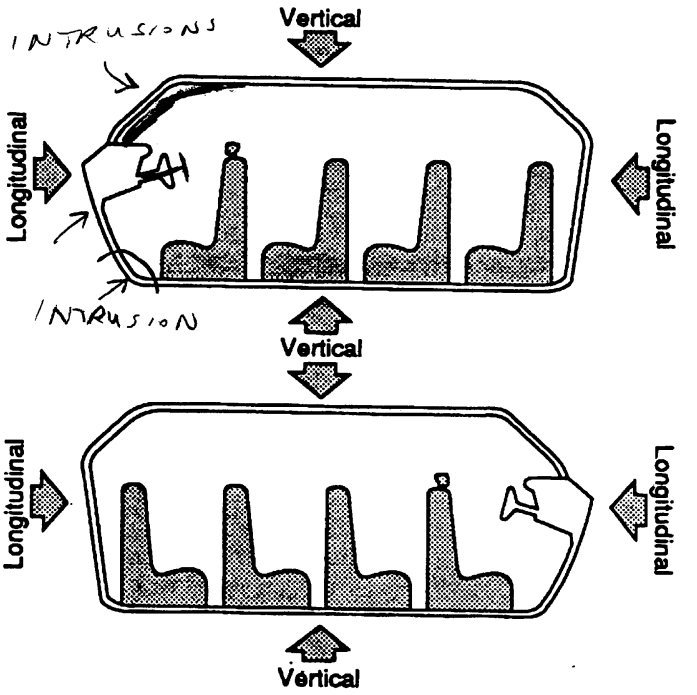
INTRUSION WORKSHEET

LOCATION OF INTRUSION	INTRUDED COMPONENT	(All Measurements Are In Centimeters) COMPARISON VALUE	–	INTRUDED VALUE	=	INTRUSION	DOMINANT CRUSH DIRECTION	
11	FLOOR	50	–	29	=	21	VERT	2
11	ROOF ROLL BAR	0	–	32	=	32	"	1
11	25 SEAT CUSHION	0	–	8	=	8	VERT	7
11	INST PANEL LEFT	95	–	85	=	10	LONG	6
11	DOOR PANEL	67	–	56	=	11	LAT	5
11	WINDSHIELD HEADER	32	–	20	=	12	VERT	4
11	A-PILLAR	89	–	80	=	9	LONG	
11	SIDE PANEL FORWARD OF A	70	–	56	=	14	LAT	3
11	STEERING ASSY	74	–	66	=	8	LONG	8
			–		=			
			–		=			
			–		=			
			–		=			
			–		=			
			–		=

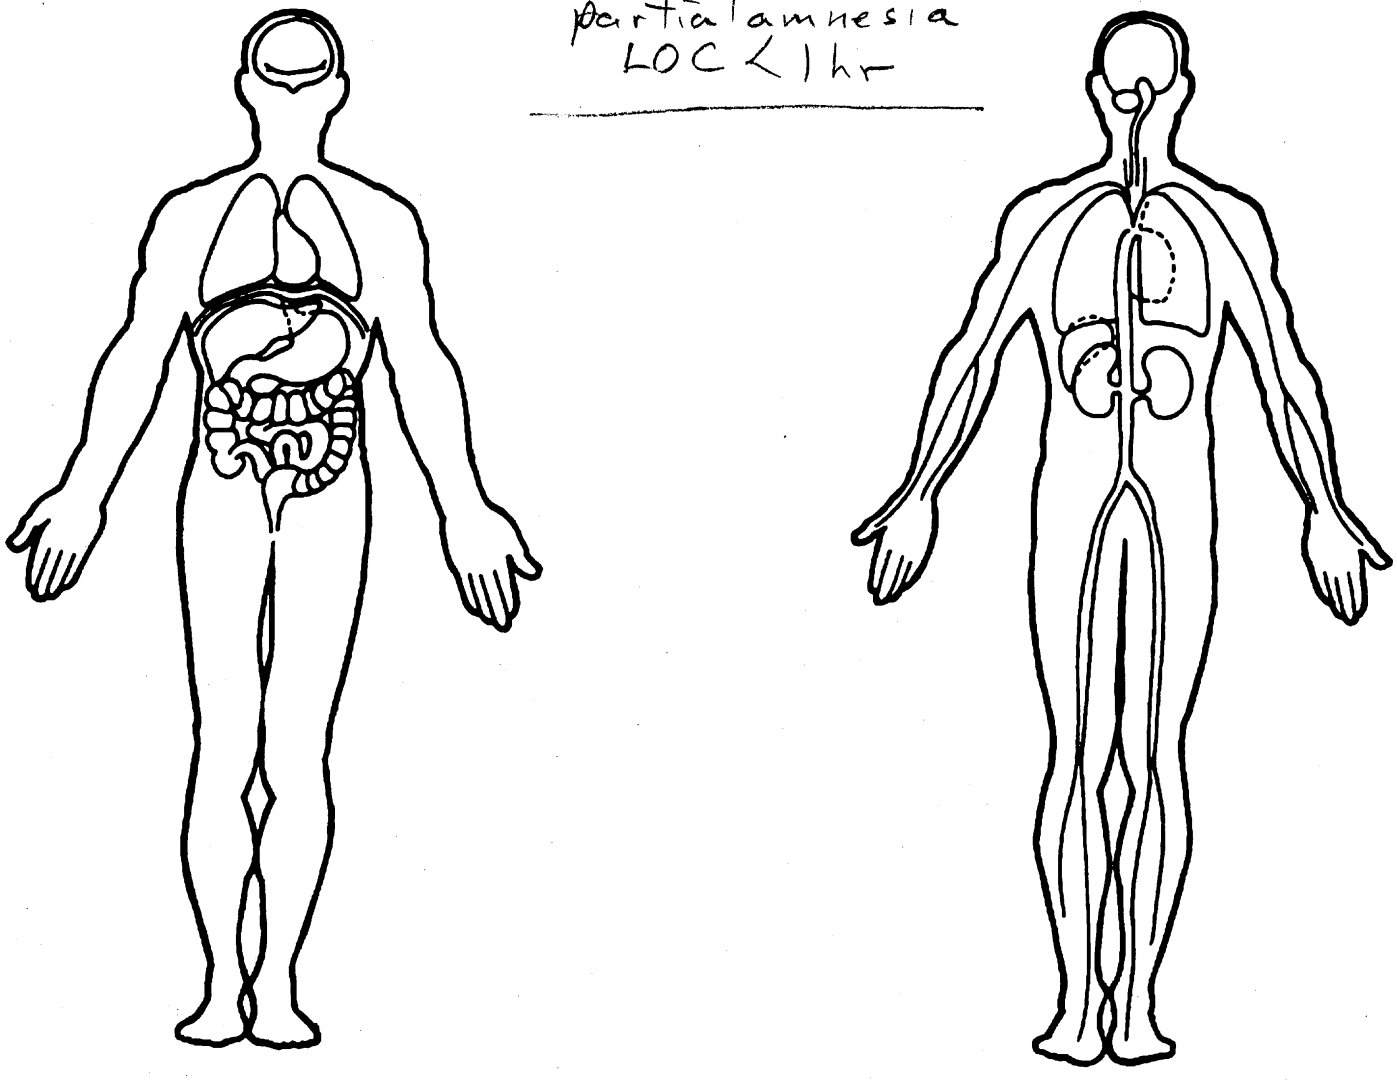
OFFICIAL INJURY DATA —INTERNAL INJURIES

Concussion
partial amnesia
LOC < 1 hr
