CASE SUMMARY

NATIONAL ACCIDENT SAMPLING SYSTEM
CRASHWORTHINESS DATA SYSTEM

PSU 05 CASE NO. 011A TYPE OF ACCIDENT CAR-Compact Pickup / Obtuse Angle

Veh. No	Class of Vehicle	Year/Make/Model	Most Severe Damage Based on Vehicle Inspection: Damage Plane	Severity Descr.	Component Failure
01	FULL SIZE	1993/PONTIAC/BONNEVILLE	LEFT	SEVERE	NONE
02	COMPACT PICKUP	1988/FORD/RANGER 4X4	FRONT	MODERATE	NONE

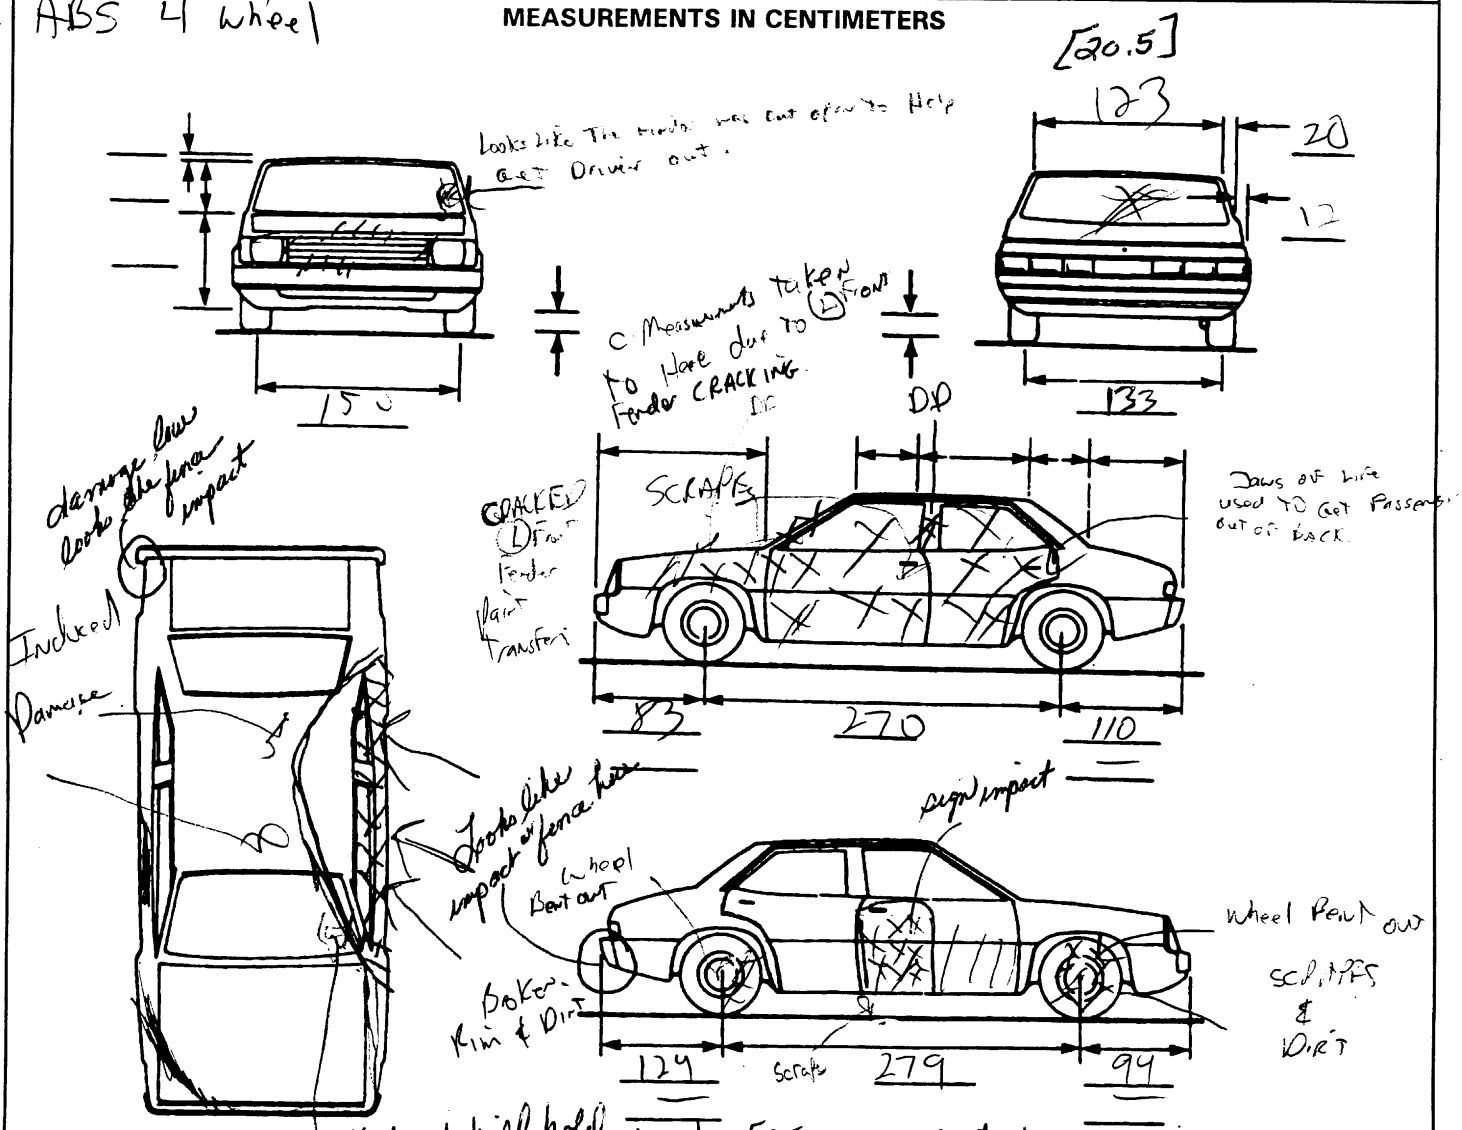
VEHICLE DAMAGE SKETCH

Windshield hold NOT by EMS since contact on A pillar

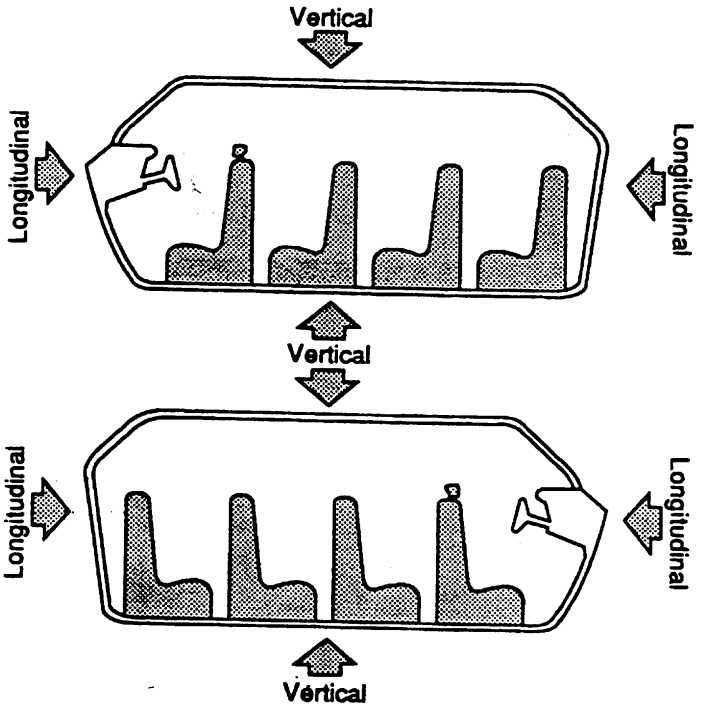
LOCATION OF INTRUSION	INTRUDED COMPONENT	COMPARISON VALUE	–	INTRUDED VALUE	=	INTRUSION	DOMINANT CRUSH DIRECTION
		(All Measurements Are In Centimeters)					
11	Door Panel	76	–	11	=	~~53~~ ~~65~~ ✓	LAT
11	A Pillar	65	–	46	=	19 ✓	
11	B Pillar	71	–	21	=	50 ✓	
11	SideRail	65	–	24	=	41 ✓	
11	Sill Lower	70	–	47	=	23 ✓	
11	Forward of A Pillar	65	–	61	=	4 ✓	
21	Door Panel	76	–	15	=	53 ~~61~~ ✓	
21	SideRail	65	–	34	=	31 ✓	
21	Sill	70	–	~~52~~	=	18 ✓	
21	C Pillar	67	–	61	=	2	LAT
~~0~~-12	Seat	71	–	51 to B-Pillar	=	20. ✓	LAT
2-2	Door panel		–		=	8	Lat
1-2	Door panel		–		=	65-53=12	Lat
			–		=		
			–		=

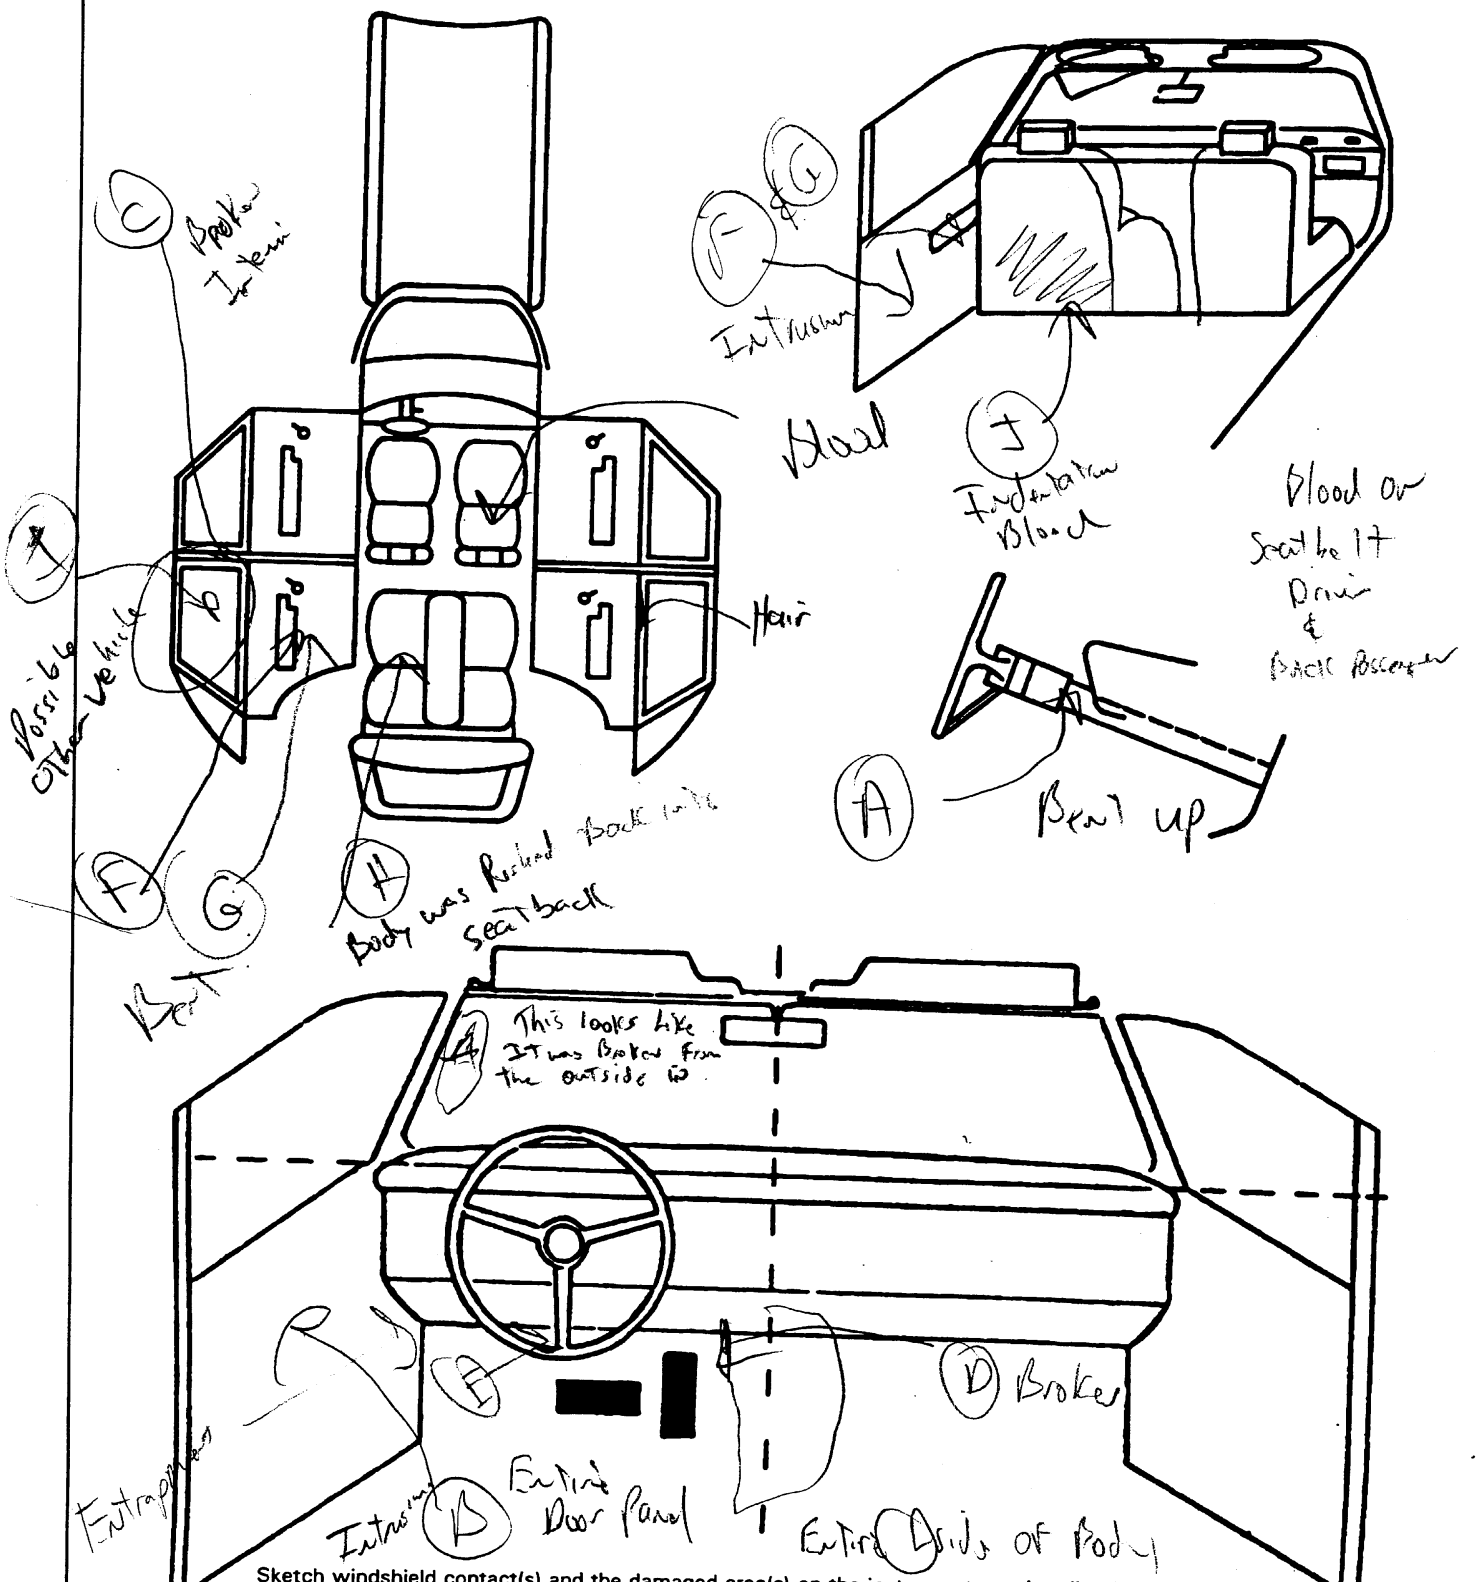
VEHICLE INTERIOR SKETCHES

Contact	Interior Component Contacted	Occupant No. If Known	Body Region If Known	Supporting Physical Evidence	Confidence Level of Contact Point
A	007	1	Knee/Thigh	Column Bent up	2
B	051	1	(L) Torso	Intrusion / Damaged Door Panel	2
C	054	1	(L) Shoulder	Broken Interior	3
D	252	1	(R) Knee	Broken Console	2
E	004	1	(L) Abd.	Bent Rim	2
F	052	2	(L) Torso/Hip	Intrusion / Indentation	2
G	051	2	(L) Torso	Intrusion / Indentation	2
H	151	2	Back	Indented	2
I	Unknown	2	(L) Side/upper	Possible Other vehicle	3
J	151	2	(R) Knee/leg	Indentation / Blood	2
K					
L					
M					
N

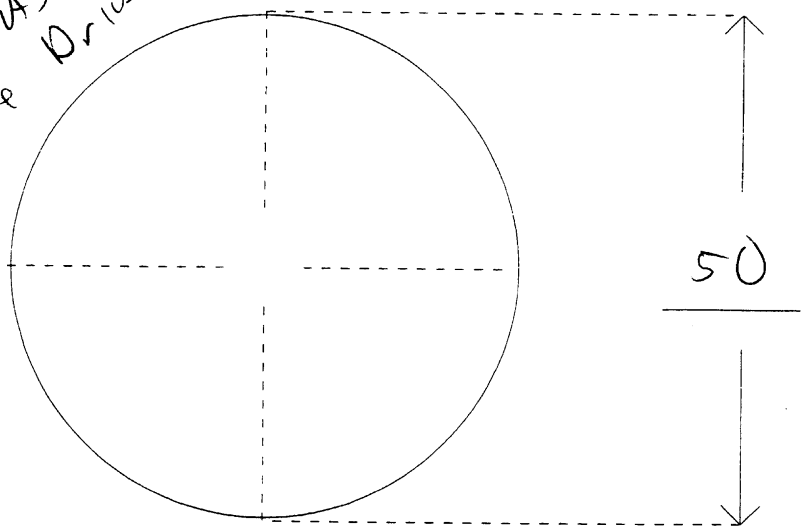
1. SKETCH DAMAGE AND CONTACT EVIDENCE ON DRIVER AIR BAG (Front)

AIR BAG WAS Deflected TO The Drivers - (R) Due To Intrusion By Door

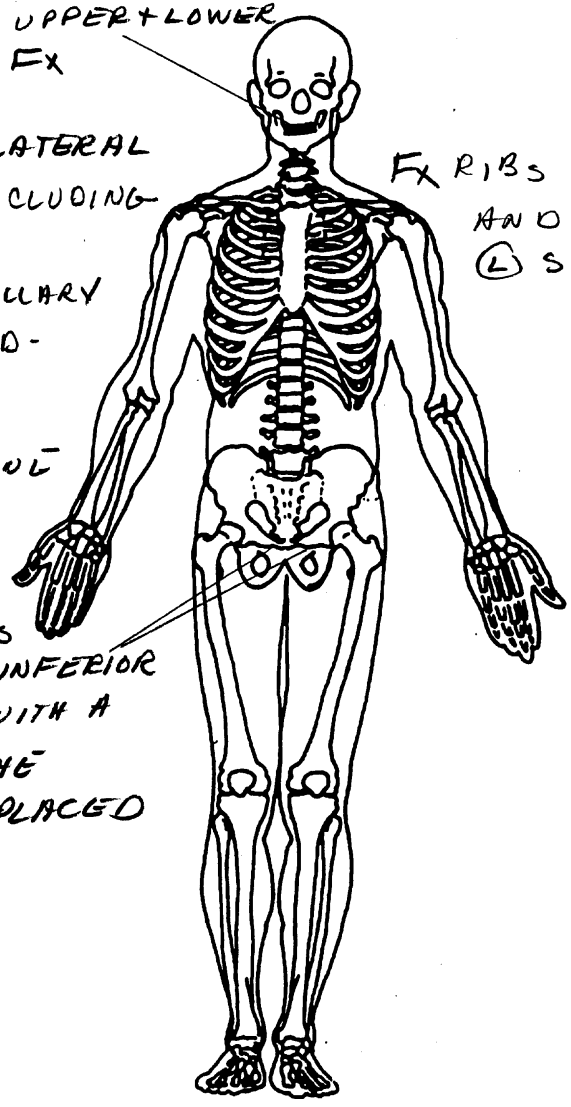
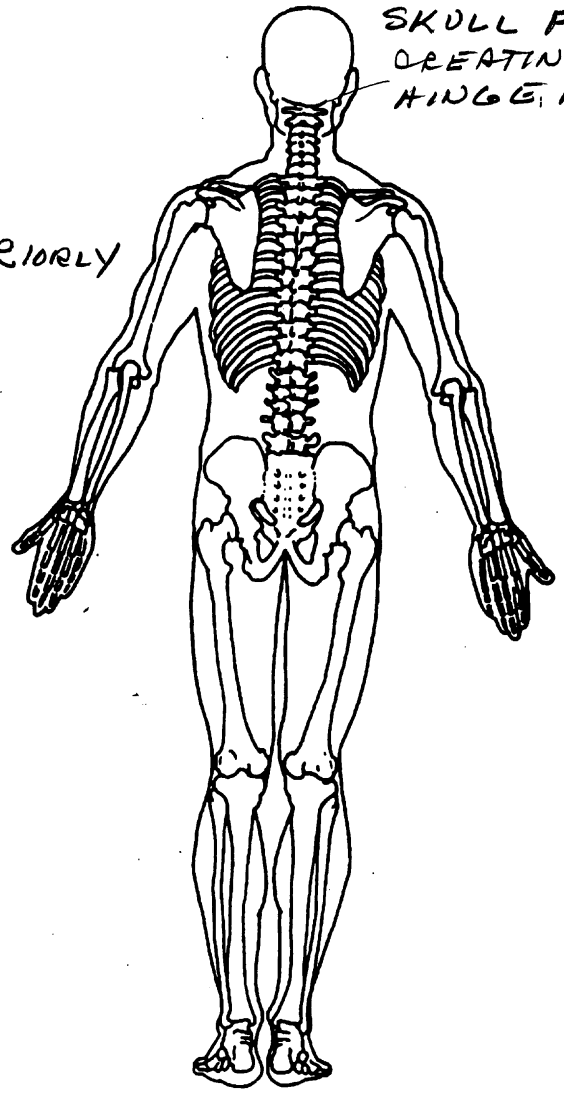
FX RIBS 1, 2, 3, 4 + 5 AND 5 + 10 + 12 (L) SIDE POSTERIORLY

MASSIVE BASILAR SKULL FX CREATING A HINGE FX

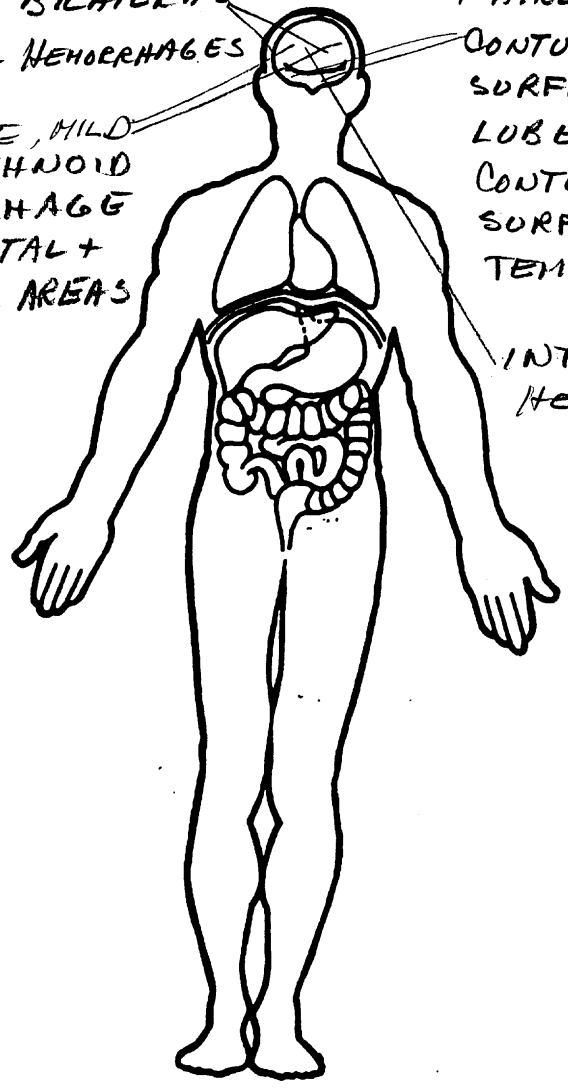
FAIRLY EXTENSIVE COUP CONTUSIONS ON THE ORBITAL SURFACE OF BOTH FRONTAL LOBES AND CONTRECOUP CONTUSIONS ON THE INFERIOR SURFACE OF THE TEMPORAL LOBES.

INTRAVENTRICULAR HEMORRHAGE

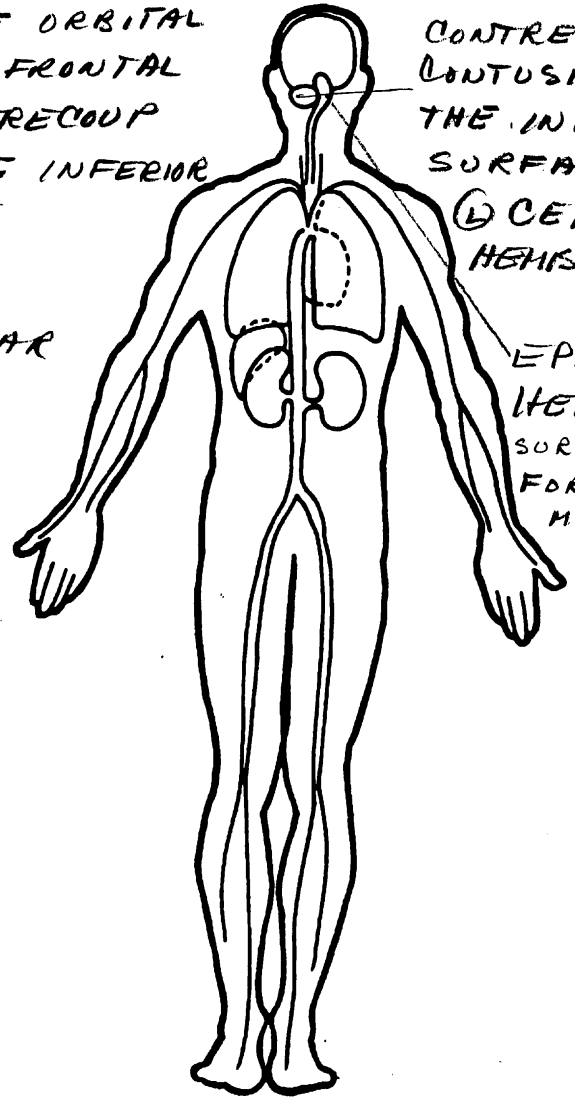
AUTOPSY

CONTRECOUP CONTUSIONS ON THE INFERIOR SURFACE OF (L) CEREBELLAR HEMISPHERE

EPIDURAL HEMORRHAGE SURROUNDING FORAMEN MAGNUM

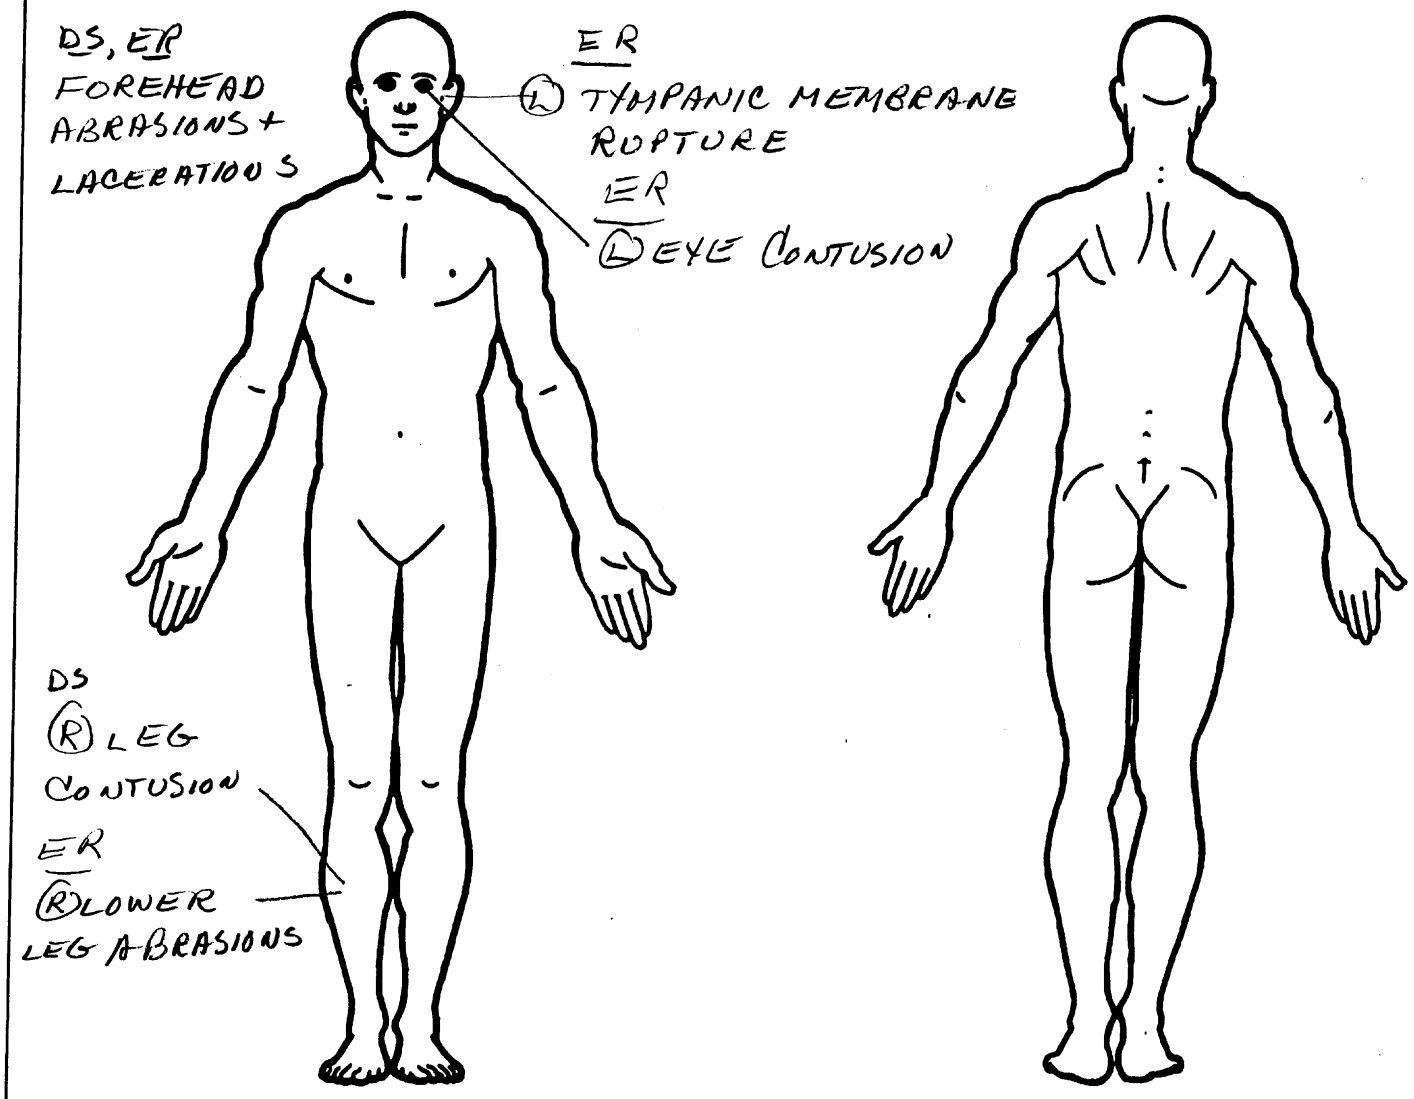
DS, ER; CONCUSSION; (+) LOC; AMNESTIC TO EVENTS OF ACCIDENT

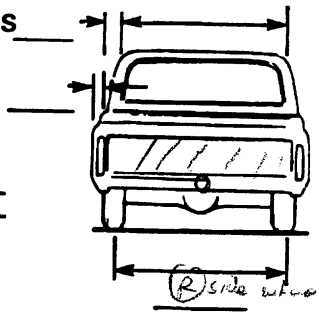
Original Bumper height

Bumper wide 15 11 cm

CAP top Dented

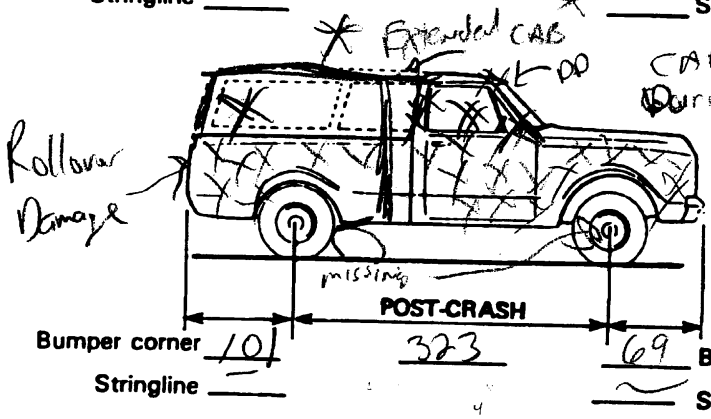
CAP SLID BACK During Accident

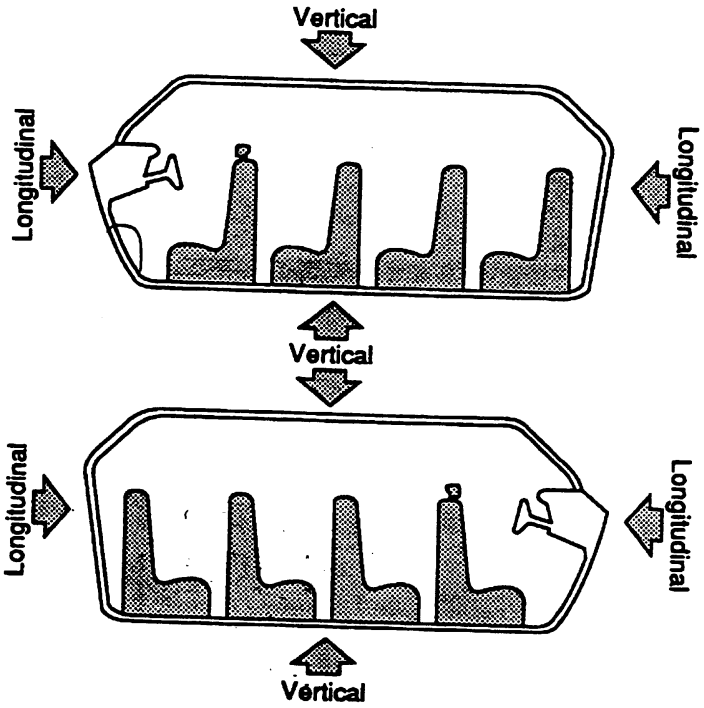
LOCATION OF INTRUSION	INTRUDED COMPONENT	(All Measurements Are In Centimeters) COMPARISON VALUE	–	INTRUDED VALUE	=	INTRUSION	DOMINANT CRUSH DIRECTION
11	Floor Pan	—	–	—	=	7	Vert
11	Toe Pan	—		—	=	6	Long
13	(R) Door Panel	—	–	—	=	3	LAT
21	Back Panel	—	–	—	=	3	Long
22	" "	—	–	—	=	5	Long
23	" "	—	–	—	=	2	Lw
			–		=		
			–		=		
			–		=		
			–		=		
			–		=		
			–		=		
			–		=		
			–		=		
			–		=

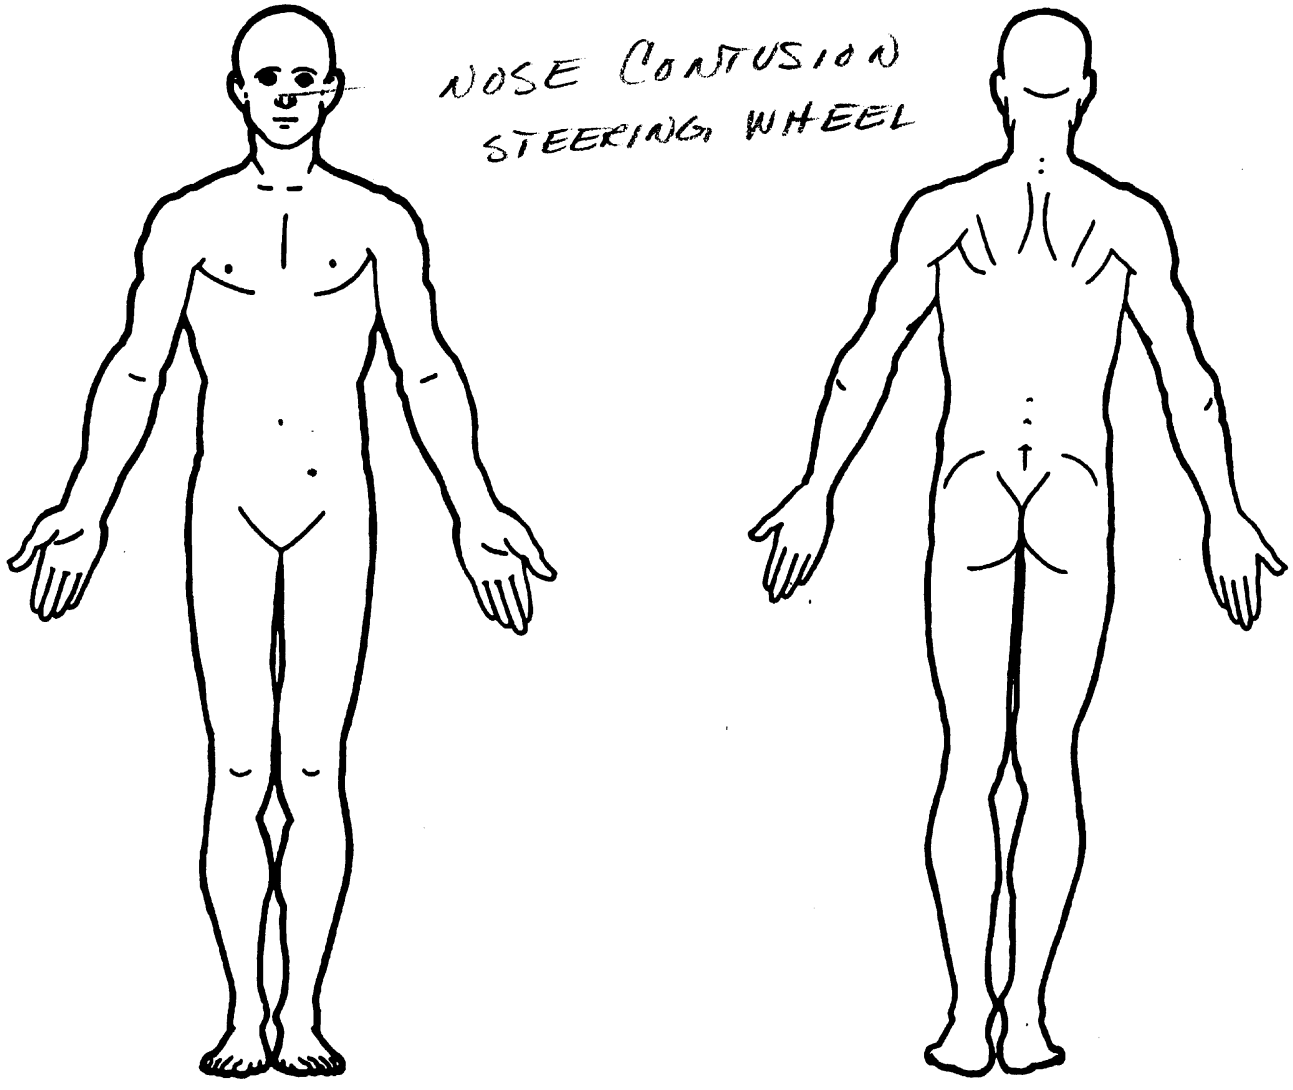
ER ⊖LOC

NOSE CONTUSION
STEERING WHEEL

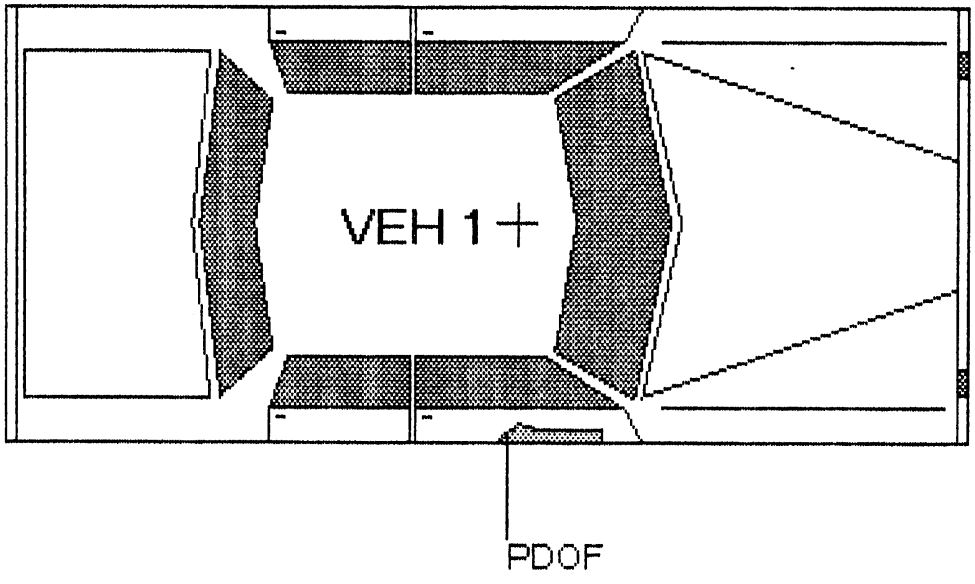
1993 Pontiac Bonneville SE

Vehicle #1	Vehicle #2
Vehicle Damage Known	Yes	Yes
Crush Length	54.0 cm (21 in)	0.0 cm (0 in)
C1	2.0 cm (1 in)	0.0 cm (0 in)
C2	8.0 cm (3 in)	0.0 cm (0 in)
C3	6.0 cm (2 in)	0.0 cm (0 in)
C4	5.0 cm (2 in)	0.0 cm (0 in)
C5	6.0 cm (2 in)	0.0 cm (0 in)
C6	5.0 cm (2 in)	0.0 cm (0 in)
D	-4.9 cm (-2 in)	0.0 cm (0 in)
D'	-5.0 cm (-2 in)	0.0 cm (0 in)

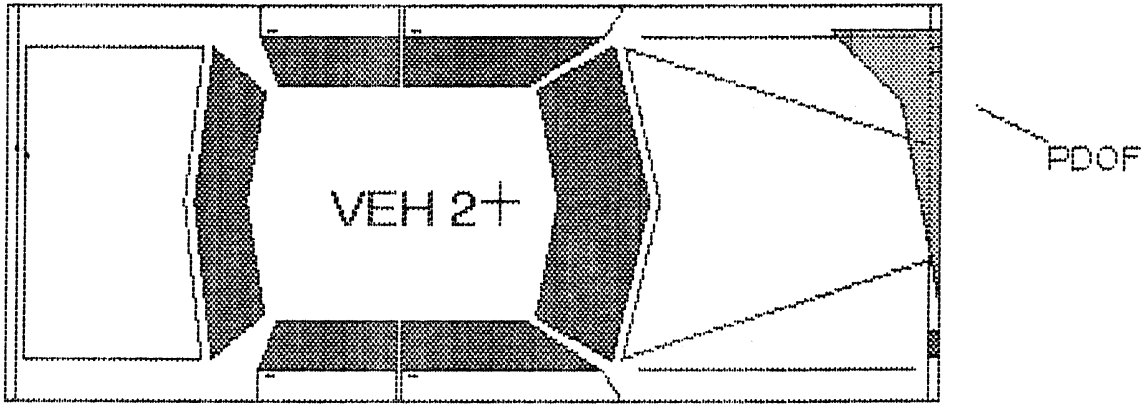
1988 Ford ranger

Vehicle #1	Vehicle #2
Vehicle Damage Known	Yes	Yes
Crush Length	197.0 cm (78 in)	148.0 cm (58 in)
C1	0.0 cm (0 in)	58.0 cm (23 in)
C2	56.0 cm (22 in)	20.0 cm (8 in)
C3	72.0 cm (28 in)	14.0 cm (6 in)
C4	84.0 cm (33 in)	6.0 cm (2 in)
C5	26.0 cm (10 in)	0.1 cm (0 in)
C6	0.0 cm (0 in)	0.1 cm (0 in)
D	12.0 cm (5 in)	0.0 cm (0 in)
D'	5.5 cm (2 in)	-41.3 cm (-16 in)

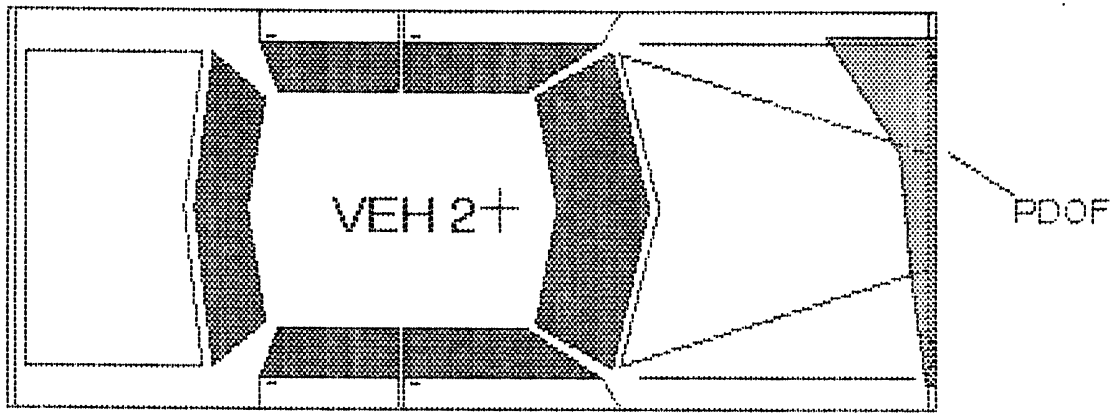
1988 Ford Pickup

Vehicle #1	Vehicle #2
Vehicle Damage Known	Yes	Yes
Crush Length	197.0 cm (78 in)	148.0 cm (58 in)
C1	0.0 cm (0 in)	58.0 cm (23 in)
C2	56.0 cm (22 in)	20.0 cm (8 in)
C3	72.0 cm (28 in)	14.0 cm (6 in)
C4	84.0 cm (33 in)	6.0 cm (2 in)
C5	26.0 cm (10 in)	0.0 cm (0 in)
C6	0.0 cm (0 in)	0.0 cm (0 in)
D	12.0 cm (5 in)	0.0 cm (0 in)
D'	5.5 cm (2 in)	-24.9 cm (-10 in)

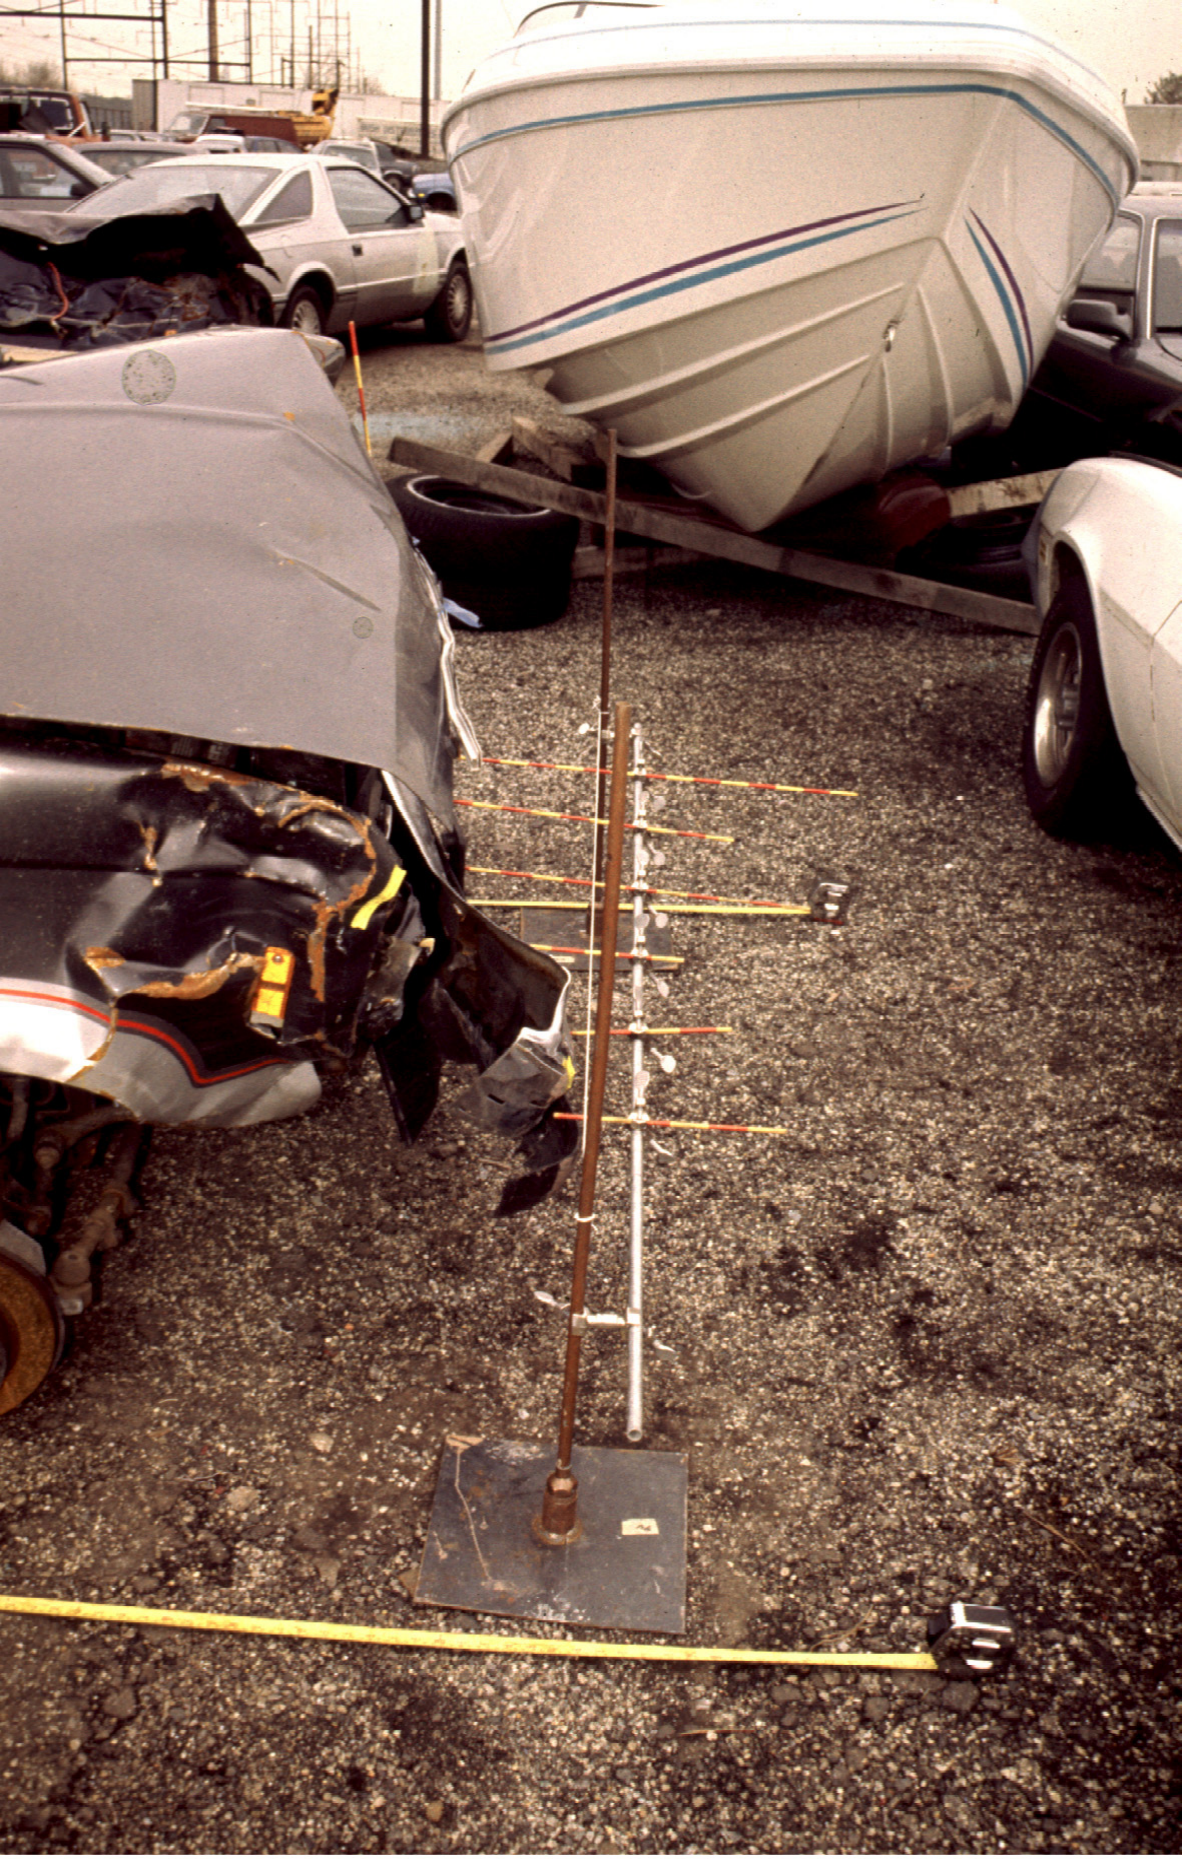
PSU 05-011A (1996) #86
Best Available

Slide No.	Vehicle No.	Direction of Picture	Description of Slide Subject Matter
1-3	1	N	Approach of V1
4-7	1	NE	V1 is Impacted By V2 and is Pushed into A sign,
			and Travels to Final Rest in a culvert.
8-10	1	SW	Lookback From Final Rest and original Path of travel
11-12	1	N	Sign Post Impacted By V1. shows Paint transfers.
			Looks like Damage to fence is from sign.
13-15	2	E	Approach of V2.
16-17	2	E	V2 Impacts with V1
18-20	2	E	V2 Then Rollover onto its (R) side.
21-23	2	W	Lookback from Final Rest & original Path of Travel.
24	2	—	Gouge mark from V2.
25	—	N	RP.
26-28	1	—	Front of V1, Looks like windshield was cut By Rescue to Help get Driver out of car.
29-35	1	—	Damage to (L) side of V1
36	1	—	BACK of V1
37-44	1	—	(R) side Damage of V1
45	1	—	Fuel Tank
46-82	1	—	Interior of V1 Including Intrusion, contact Points and
			Views of AIR BAG.
83	1	—	Close up of Rescue crew Damage To Door Locks
84-88	2	—	Frontal Damage To V2
