CASE SUMMARY

NATIONAL ACCIDENT SAMPLING SYSTEM
CRASHWORTHINESS DATA SYSTEM

PSU 48 CASE NO. 050K TYPE OF ACCIDENT _____

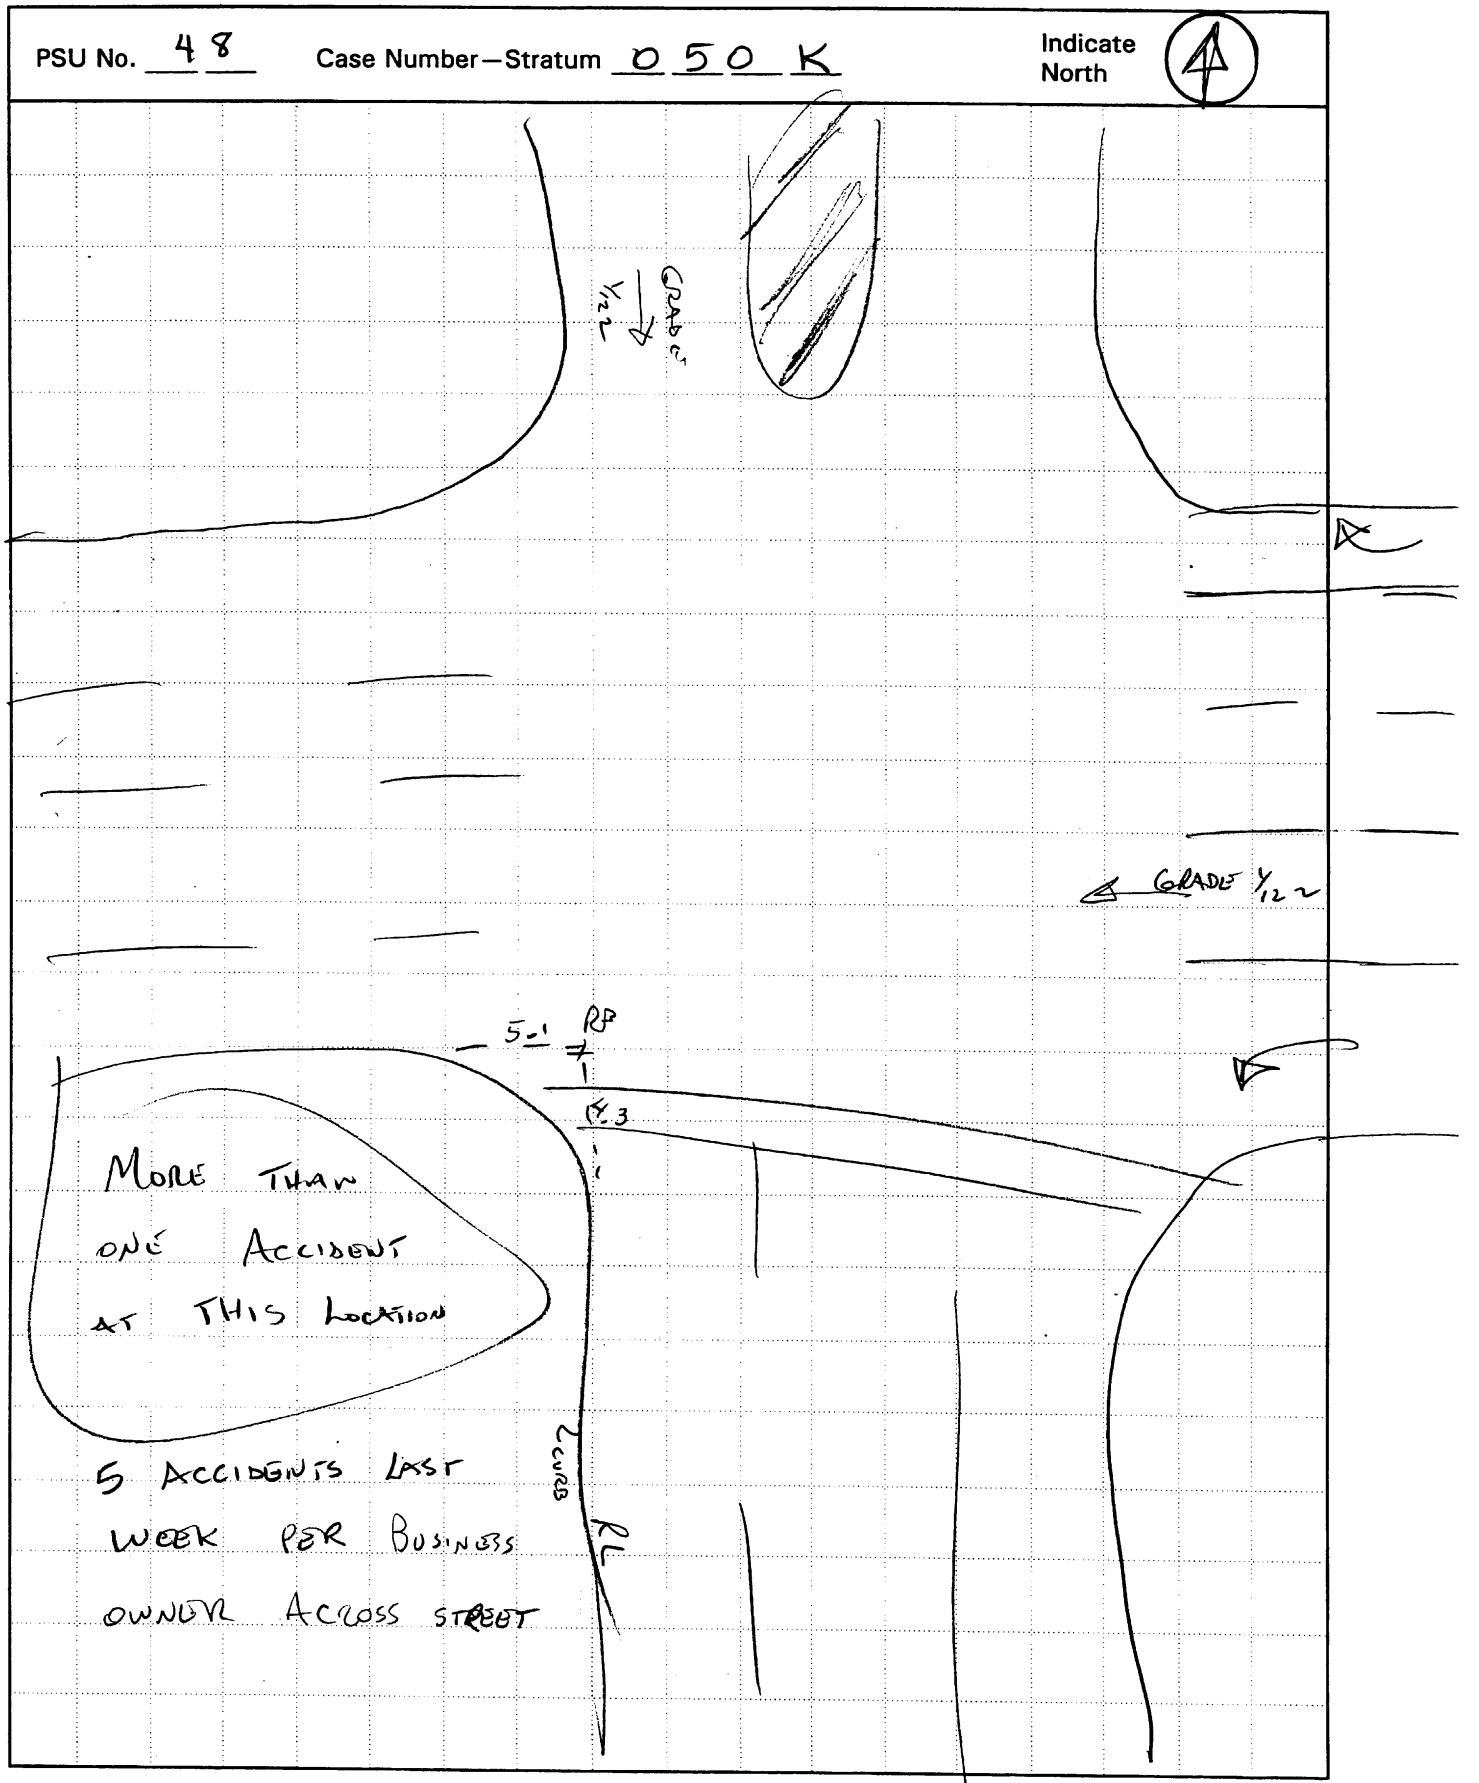
PSU No. 48 Case Number—Stratum 050 K

VEH. #1	VEH. #2	VEH. #3
Heading Angle	90	180	
Surface Type	ASPHALT		
Surface Condition	GOOD/DRY		
Coefficient of Friction	.75	.75	
Grade (v/h) Measurement (between impact and final rest)	+1/22	+1/22	
Grade (v/h) Measurement (at location of rollover initiation)	+1/22	N/A	
Grade (v/h) Measurement (at pre-crash location)	+1/22	+1/22

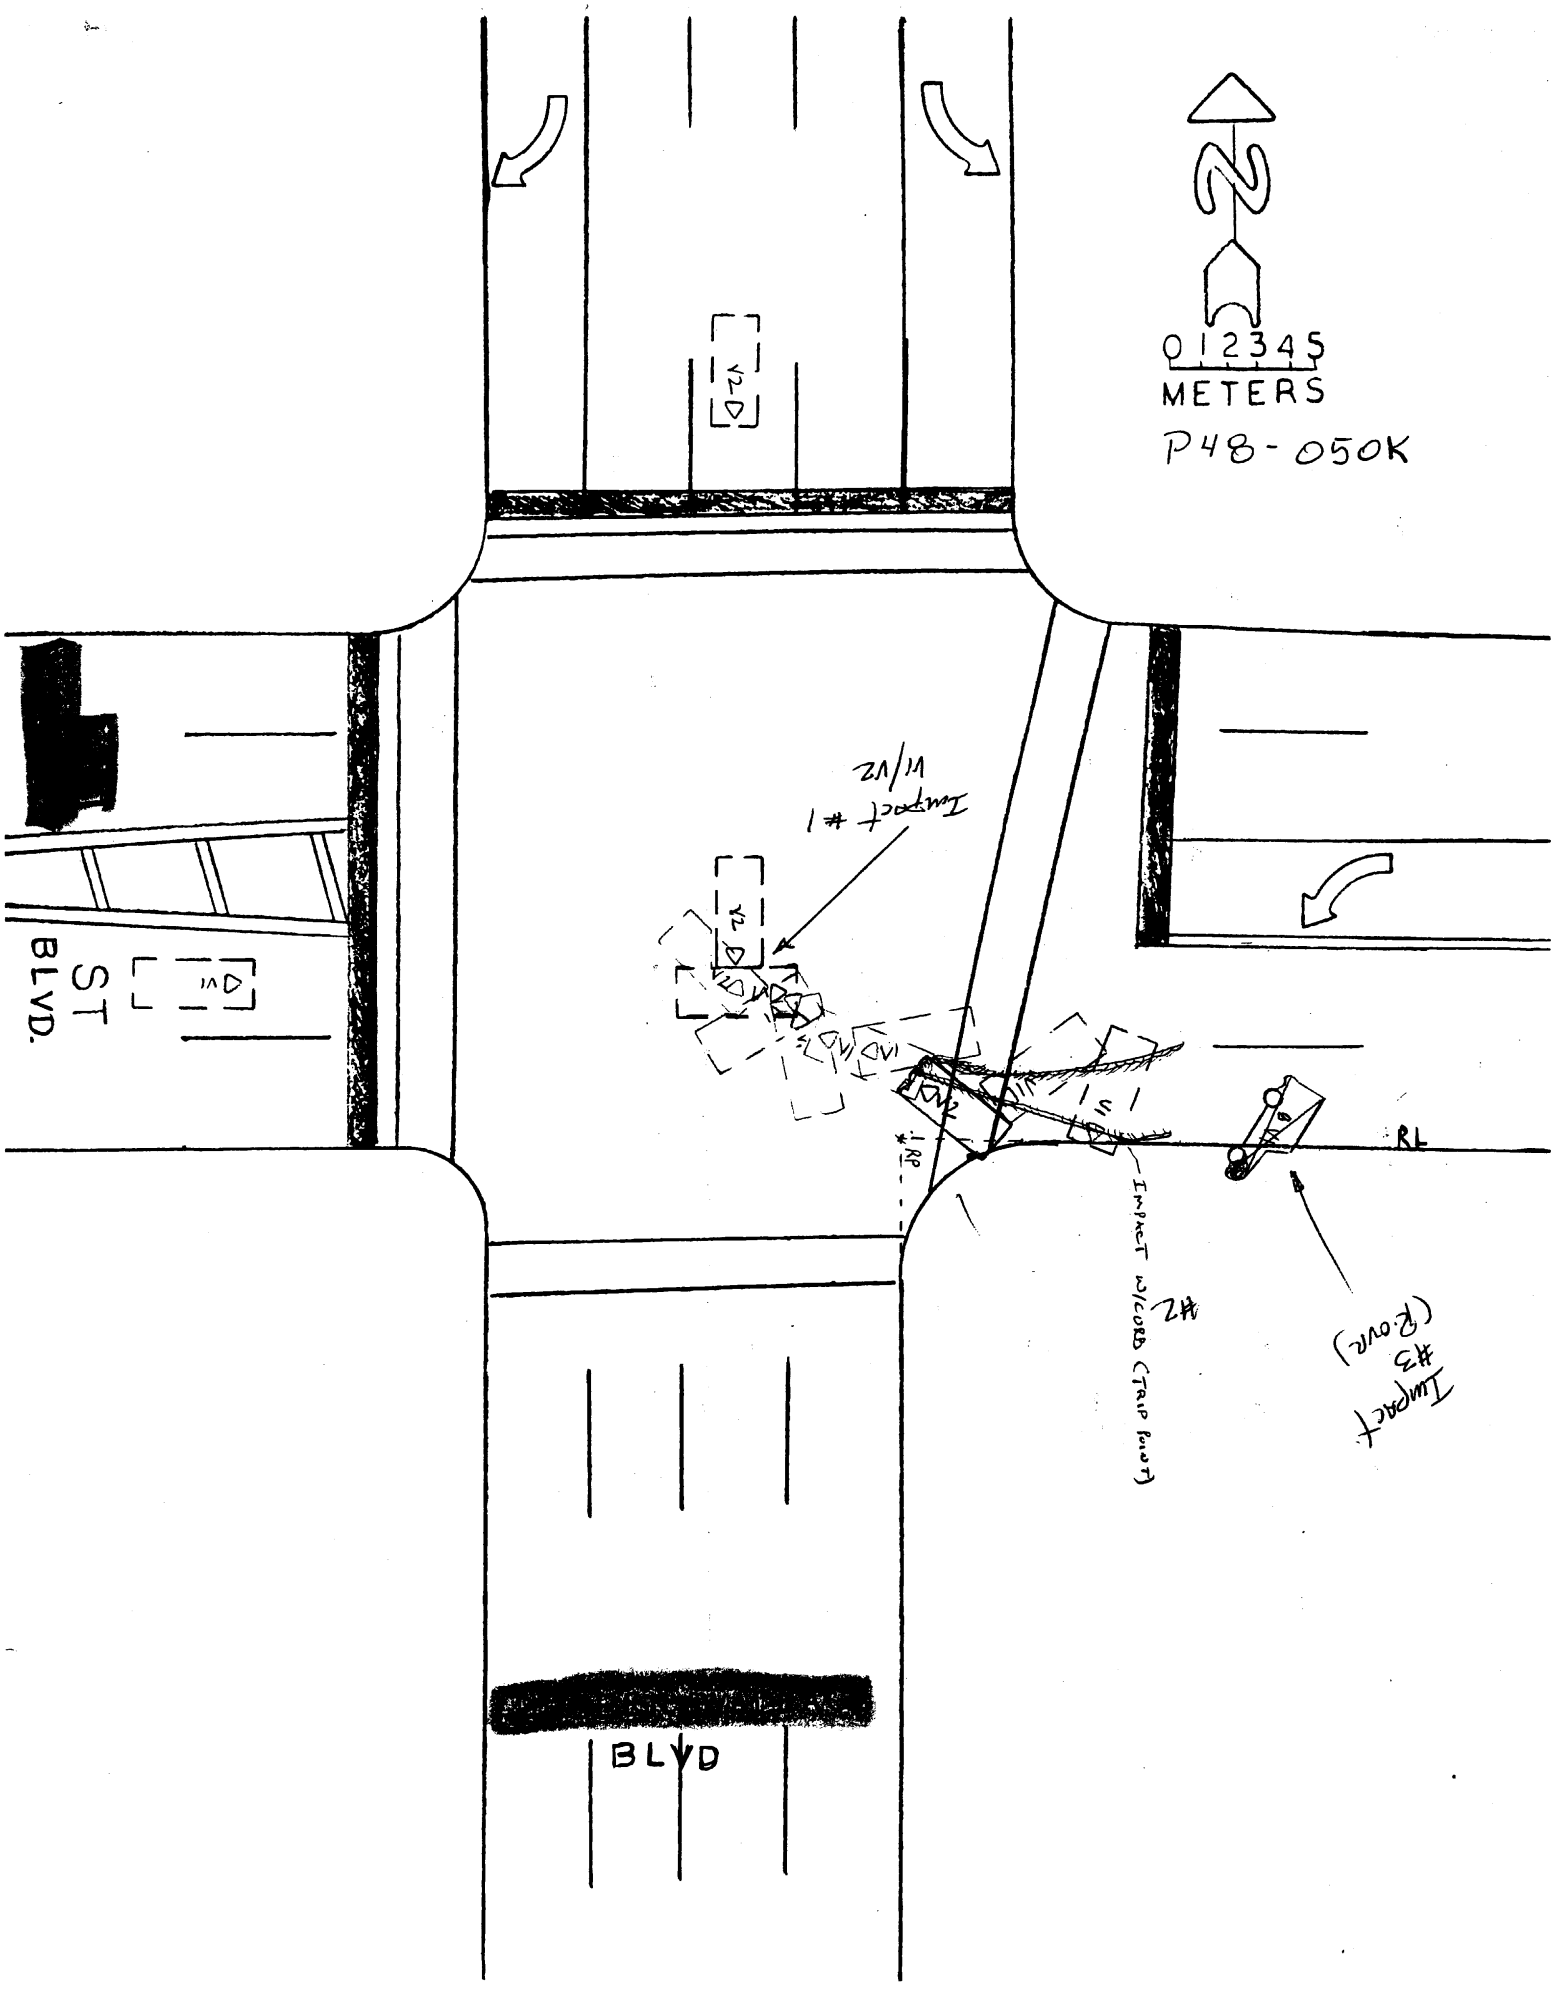
0 1 2 3 4 5
METERS
P48-050K
V2
V1
ST
BLVD.
BLVD
RL
Impact #1
V1/V2
Impact #2
w/cord (trip line)
Impact #3
(P.over)

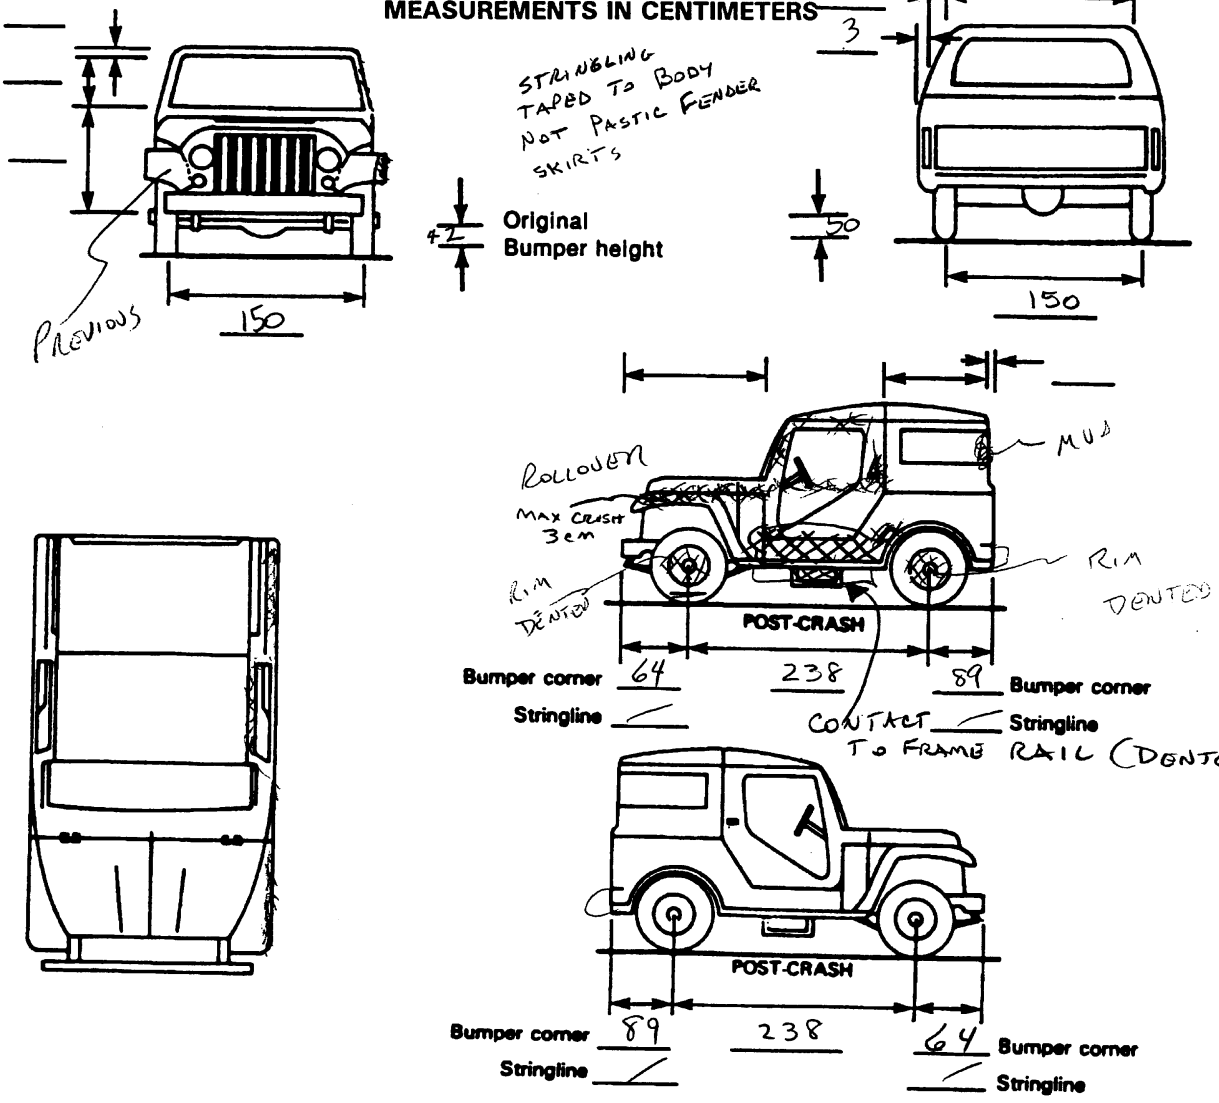
Specific Impact No.	Location of Direct Damage	Location of Field L	Location of Max Crush
1	STARTS 32 cm FRONT OF LR	SAME	C2
2	ENTIRE (L) SIDE	SAME	(L) FRONT FENDER

Specific Impact Number	Plane of Impact C-Measurements	Direct Damage Width (CDC)	Direct Damage Max Crush	Field L	C_1	C_2	C_3	C_4	C_5	C_6	±D
1	MID SIDE	155	10	155	4	10	8	7	4	0	+9
2	(L) SIDE	380	≈3		ROLLOVER

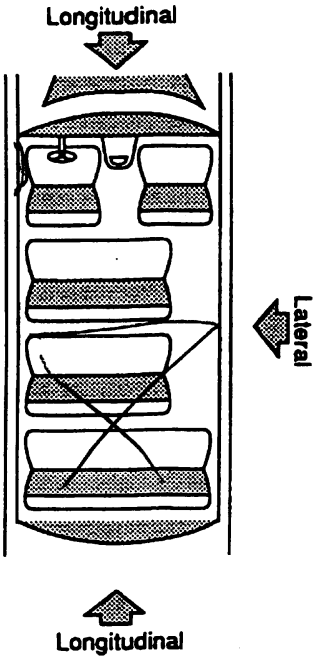
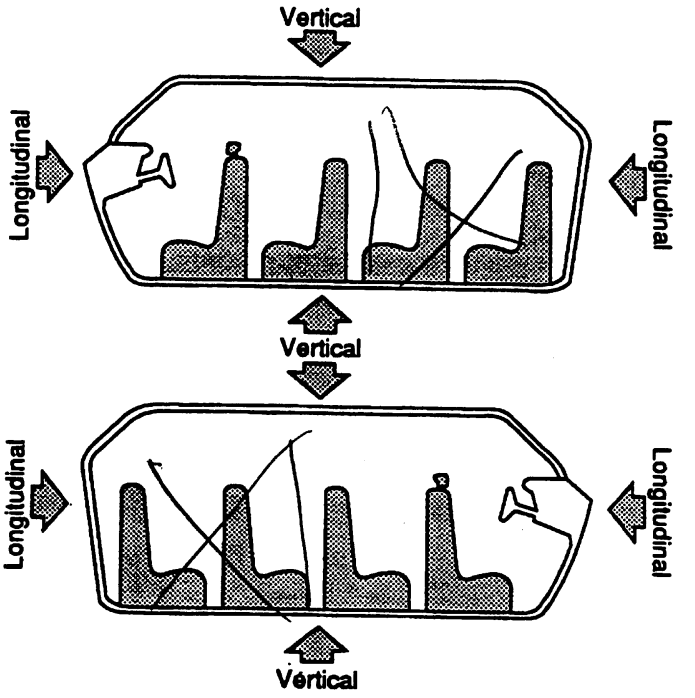
LOCATION OF INTRUSION	INTRUDED COMPONENT	(All Measurements Are In Centimeters) COMPARISON VALUE	—	INTRUDED VALUE	=	INTRUSION	DOMINANT CRUSH DIRECTION
LF	SILL	60	—	56	=	4	LAT
	DOOR	70	—	69	=	1	
			—		=		
			—		=		
			—		=		
			—		=		
			—		=		
			—		=		
			—		=		
			—		=		
			—		=		
			—		=		
			—		=		
			—		=		
			—		=

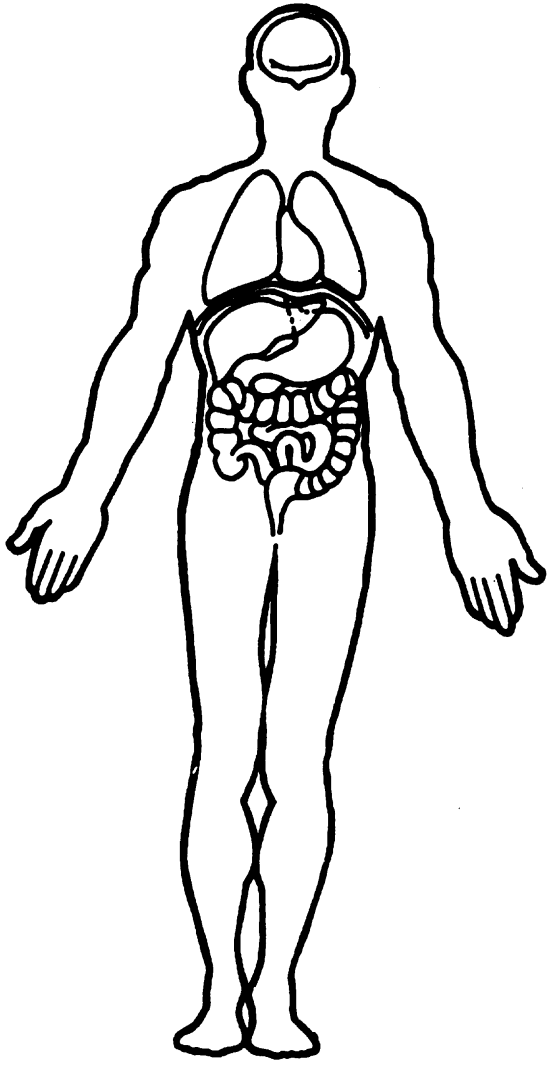
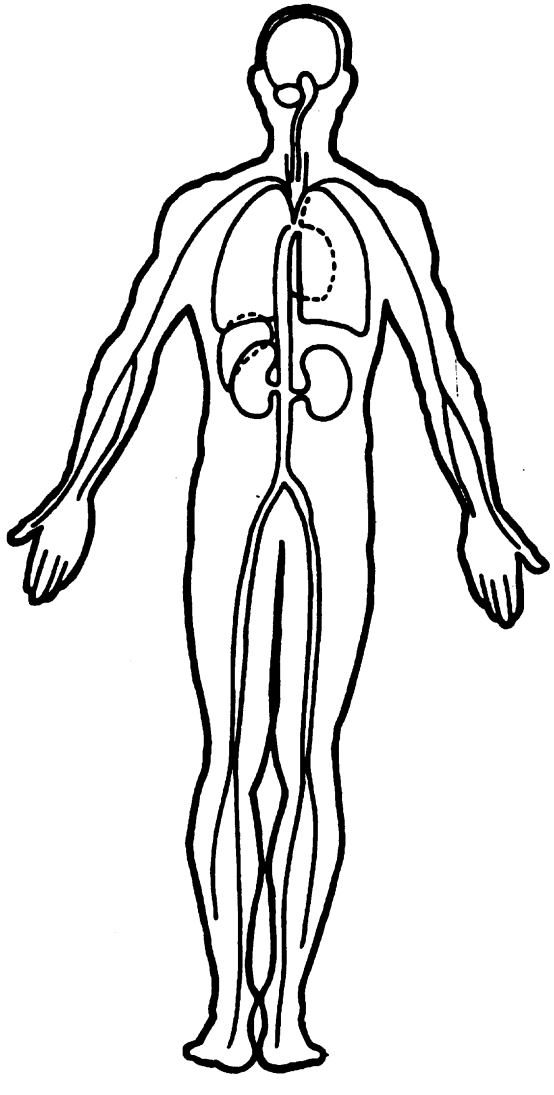
OFFICIAL INJURY DATA – INTERNAL INJURIES

Confused
amnesia
+ LOC

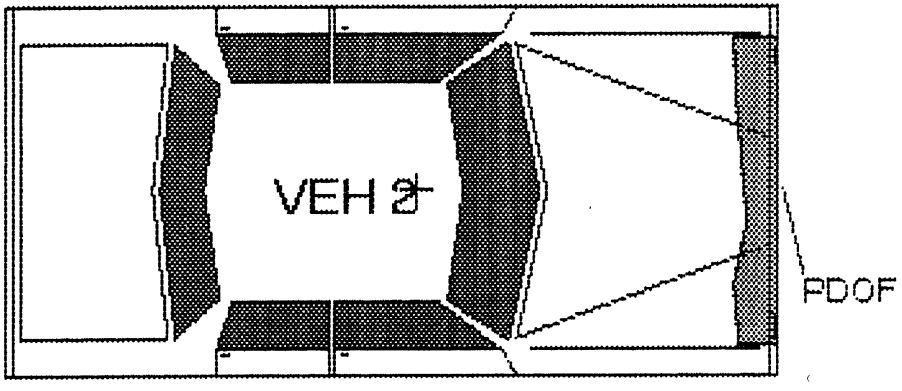
1987 HONDA CIVIC DX

Vehicle #1	Vehicle #2
Vehicle Damage Known	Yes	Yes
Crush Length	155.0 cm (61 in)	134.0 cm (53 in)
C1	4.0 cm (2 in)	22.0 cm (9 in)
C2	10.0 cm (4 in)	20.0 cm (8 in)
C3	8.0 cm (3 in)	18.0 cm (7 in)
C4	7.0 cm (3 in)	15.0 cm (6 in)
C5	4.0 cm (2 in)	22.0 cm (9 in)
C6	0.0 cm (0 in)	19.0 cm (7 in)
D	9.0 cm (4 in)	0.0 cm (0 in)
D'	-4.8 cm (-2 in)	-0.5 cm (-0 in)
