CASE SUMMARY

NATIONAL ACCIDENT SAMPLING SYSTEM
CRASHWORTHINESS DATA SYSTEM

PSU 78 CASE NO. 067J TYPE OF ACCIDENT _____

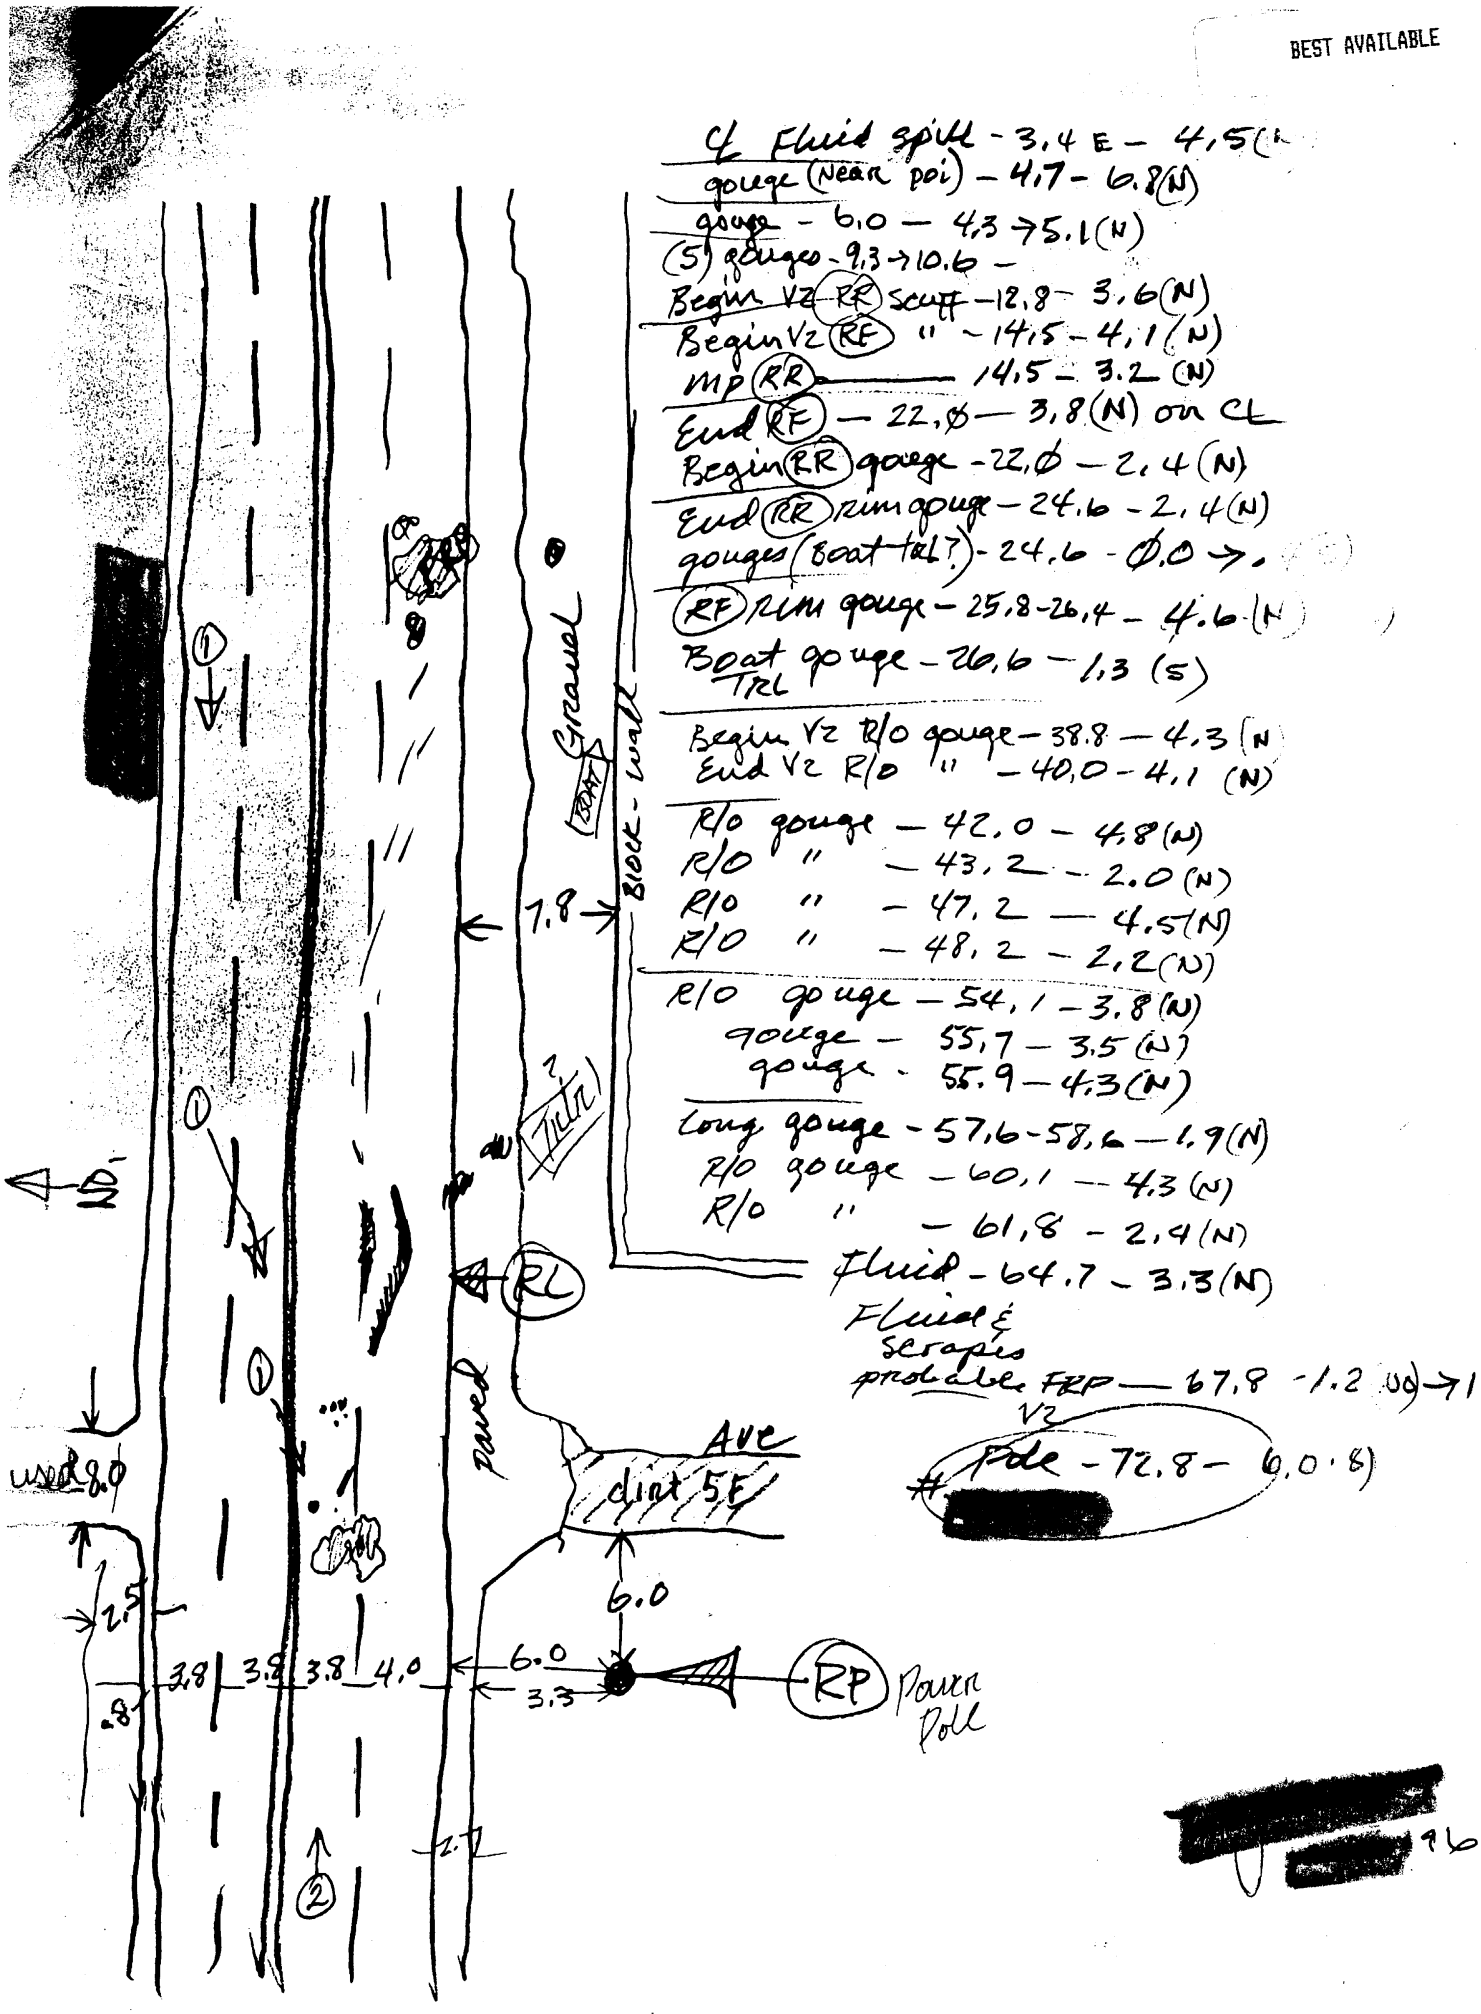
CL Fluid spill - 3.4 E - 4.5(N)
gouge (near poi) - 4.7 - 6.8(N)
gouge - 6.0 - 4.3 → 5.1(N)
(5) gouges - 9.3 → 10.6 -
Begin Vz (RR) scuff - 12.8 - 3.6(N)
Begin Vz (RF) " - 14.5 - 4.1(N)
MP (RR) ——— 14.5 - 3.2 (N)
End (RF) - 22.0 - 3.8(N) on CL
Begin (RR) gouge - 22.0 - 2.4(N)
End (RR) rim gouge - 24.6 - 2.4(N)
gouges (boat trl?) - 24.6 - 0.0 →
(RF) RIM gouge - 25.8-26.4 - 4.6(N)
Boat TRL gouge - 26.6 - 1.3 (S)

Begin Vz R/O gouge - 38.8 - 4.3(N)
End Vz R/O " - 40.0 - 4.1 (N)

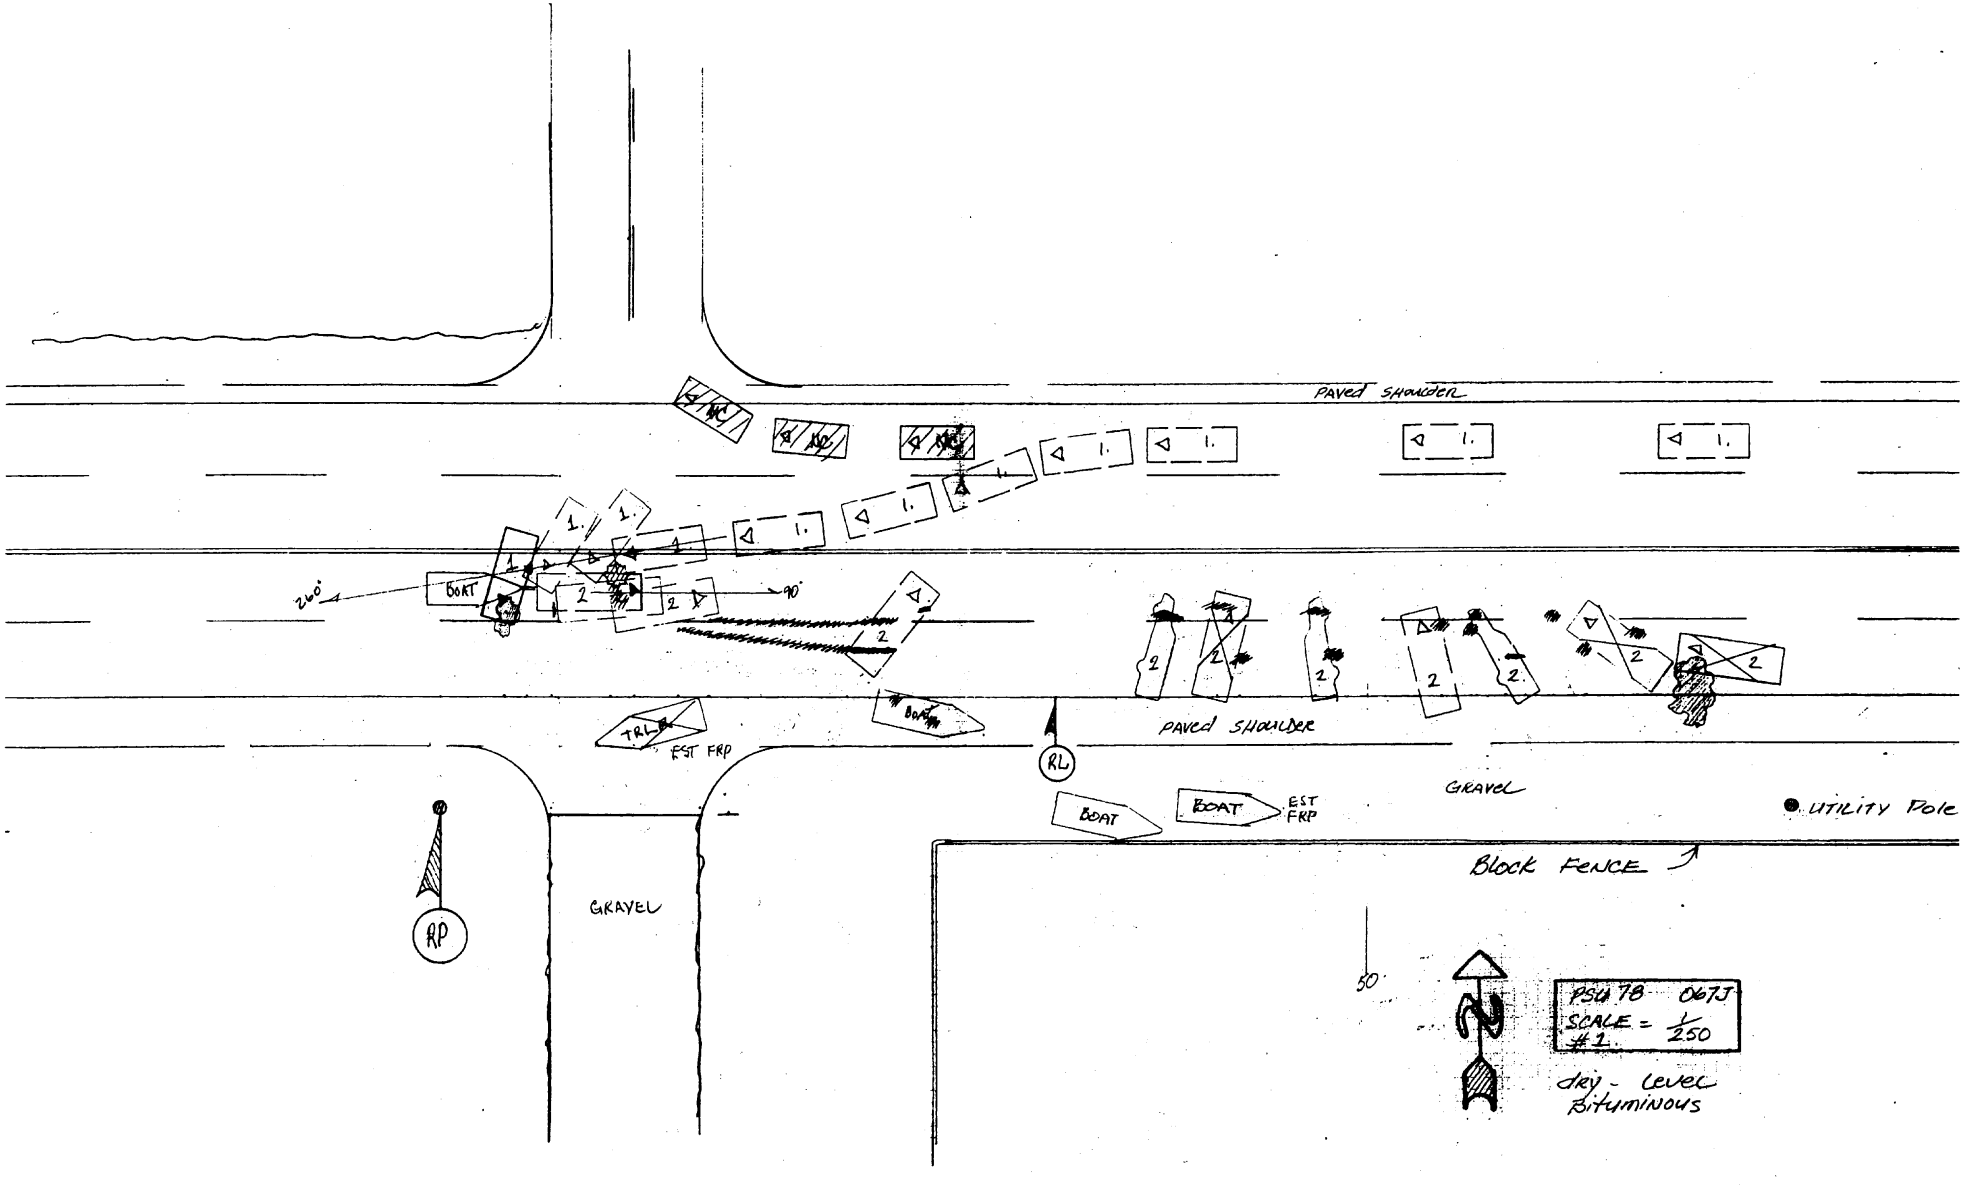
PAVED SHOULDER
BOAT
240°
90°
TRL
EST FRP
BOAT
PAVED SHOULDER
RL
BOAT
BOAT
EST FRP
GRAVEL
UTILITY POLE
BLOCK FENCE
RP
GRAVEL
50'
PSU 78 067J
SCALE = 1/250
#1
dry - level Bituminous

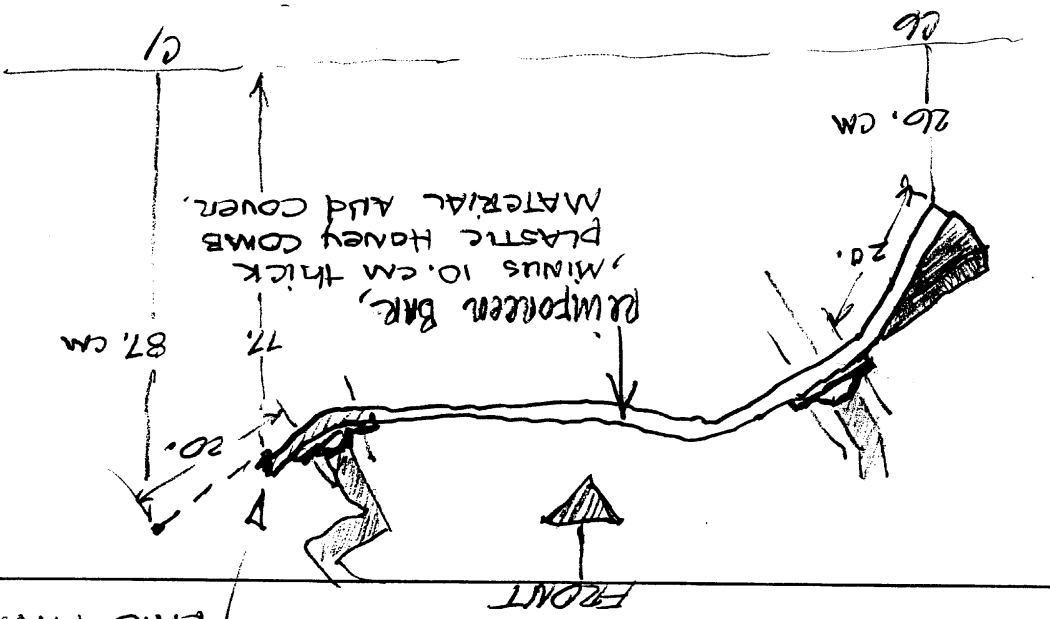
VEHICLE DAMAGE SKETCH

REAR Broken-off AT Frame
Rail ATTACHMENT point

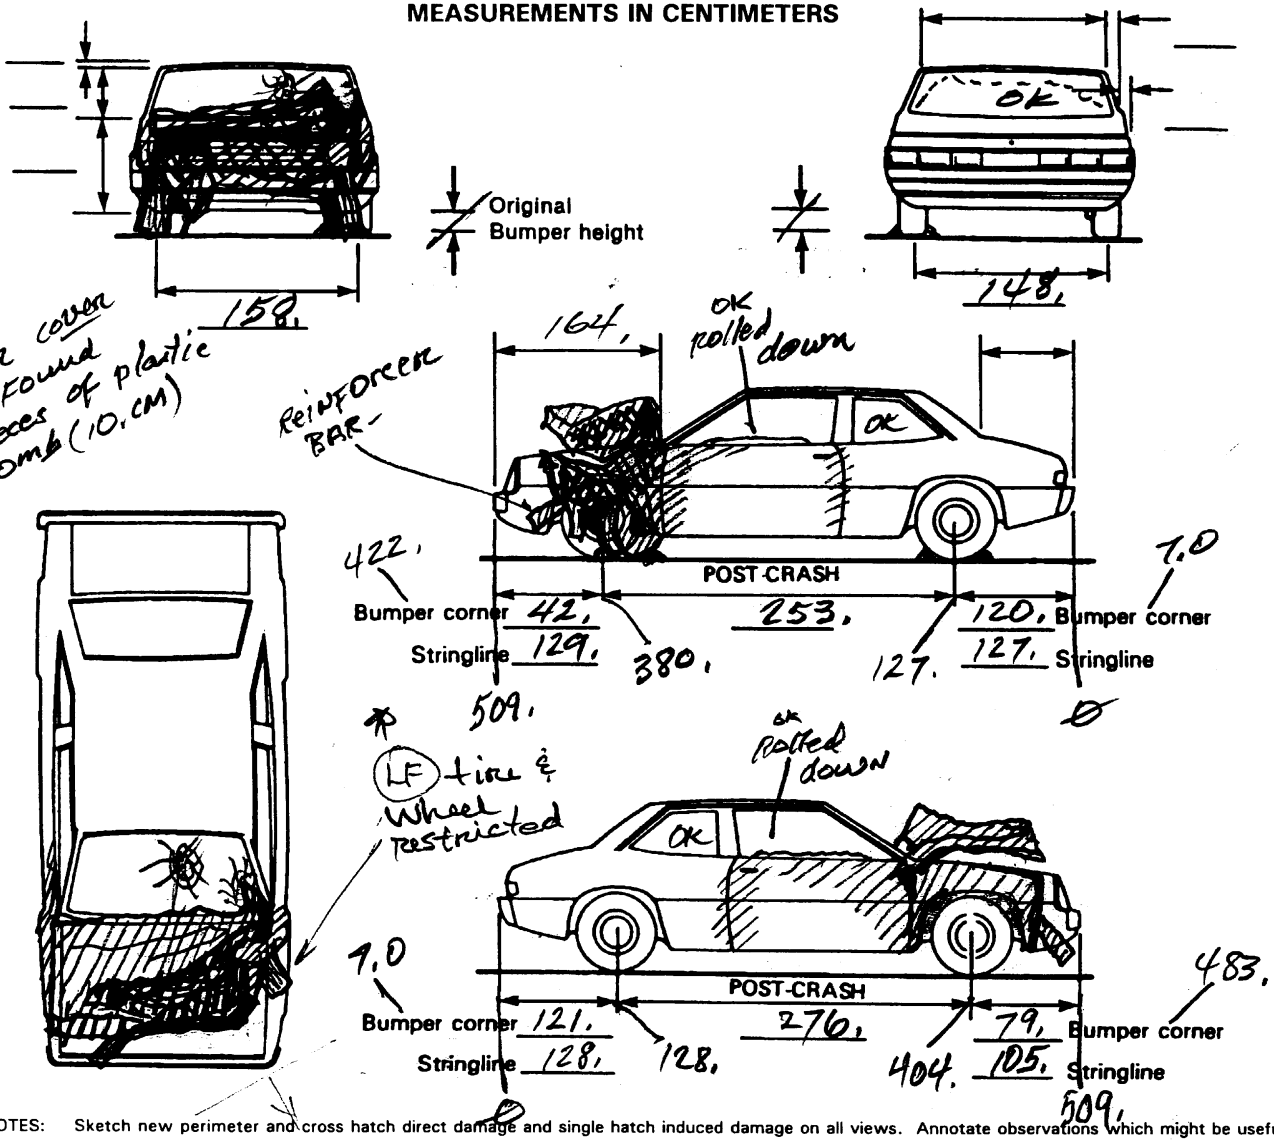
Bumper cover gone - found some pieces of plastic Honeycomb (10. cm) Thick

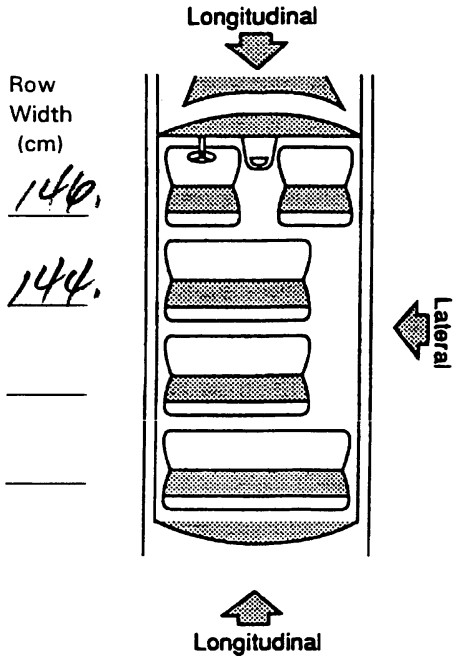
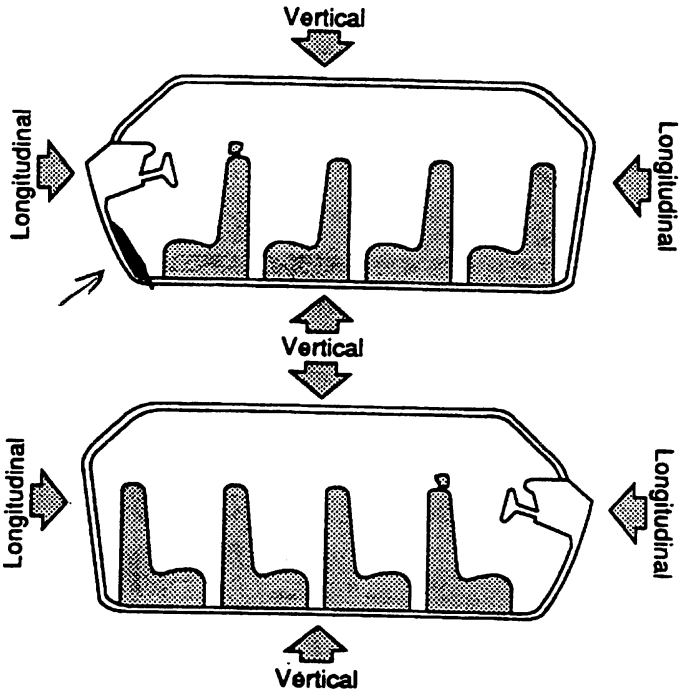
INTRUSION WORKSHEET

LOCATION OF INTRUSION	INTRUDED COMPONENT	(All Measurements Are In Centimeters) COMPARISON VALUE	—	INTRUDED VALUE	=	INTRUSION	DOMINANT CRUSH DIRECTION
11	TOE PANEL	160.	—	152.	=	8.	LONG.
			—		=		
			—		=		
			—		=		
			—		=		
			—		=		
			—		=		
			—		=		
			—		=		
			—		=		
			—		=		
			—		=		
			—		=		
			—		=		
			—		=		
			—		=

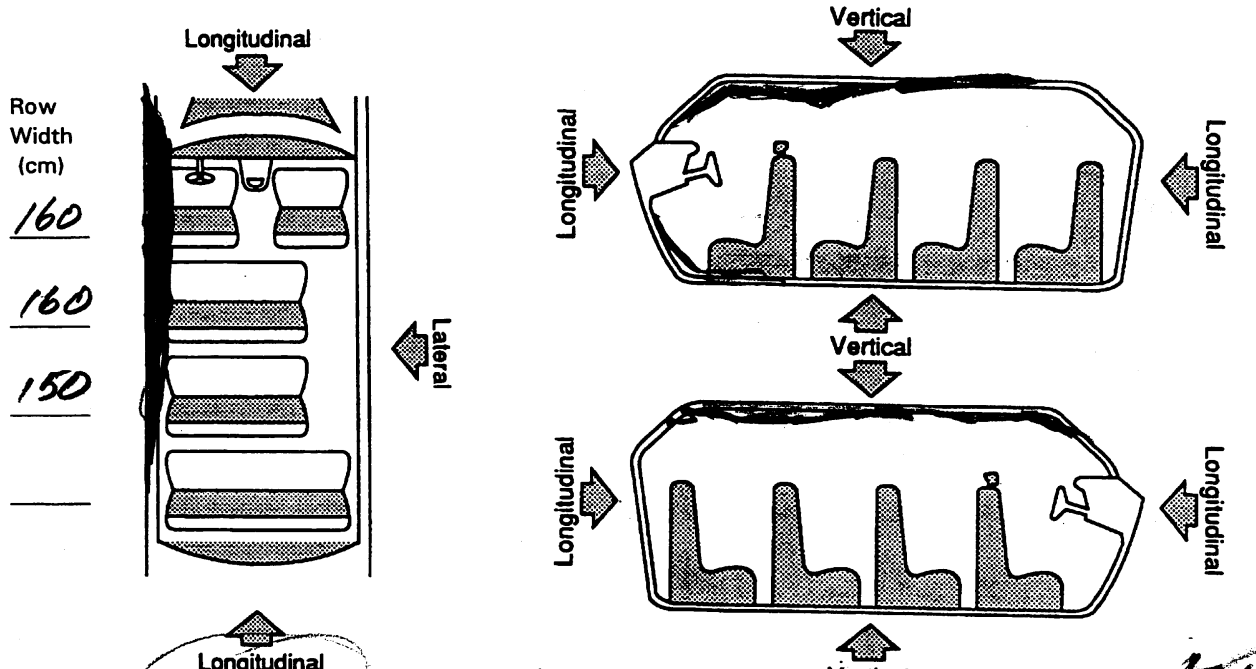
INTRUSION WORKSHEET

21 B-pillar 80, 60, 20. ~~V~~ Lat (1.)

LOCATION OF INTRUSION	INTRUDED COMPONENT	(All Measurements Are In Centimeters) COMPARISON VALUE	–	INTRUDED VALUE	=	INTRUSION	DOMINANT CRUSH DIRECTION	
11	A-pillar	109.	–	99.	=	10,	V	4
	header	110.	–	100.	=	10,	V	5
	side rail	109.	–	99,	=	10,	V	6
	door	80.	–	70.	=	10,	Lat	7.
	~~4~~ panel	58,	–	54,	=	4.	Lat	
~~21~~	~~B-pillar~~	~~109~~	–	~~98.~~	=	~~11.~~	~~V~~	
	side panel	80.	–	66,	=	14.	Lat	2.
11	roof	86.	–	75.	=	11,	V	3.
21	Roof	86.	–	77.	=	9.	V	8.
	side rail	109	–	100.	=	9,	V	9.
33	side rail	109.	–	105.	=	4.	V	
	C-pillar	109.	–	106.	=	3,	V	
	roof	86.	–	80.	=	6,	V	
23	B-Pillar	109.	–	103.	=	6,	V	
	Side Rail	109.	–	102.	=	7,	V	10.

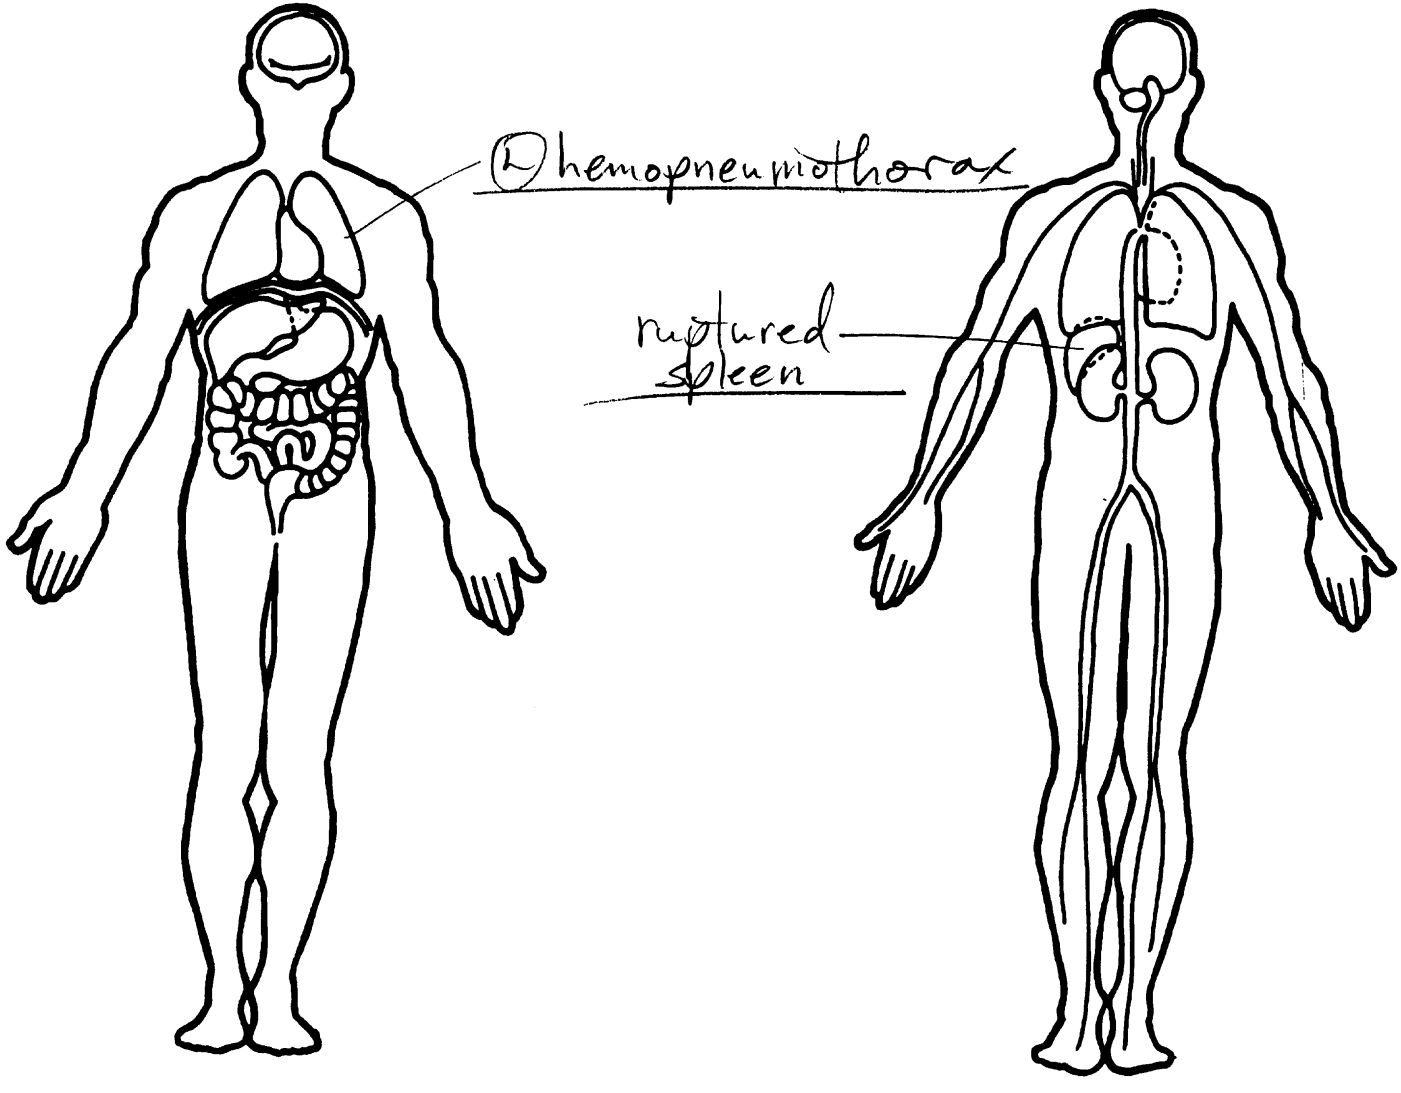
OFFICIAL INJURY DATA – INTERNAL INJURIES

Responsive to ~~pain~~ ~~stimuli~~ only | GCS = 8

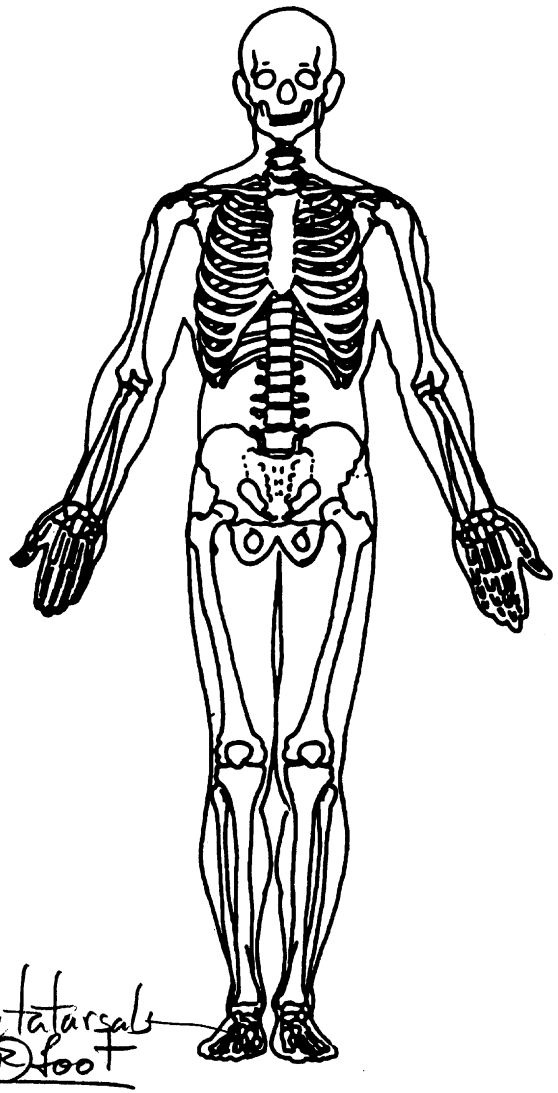
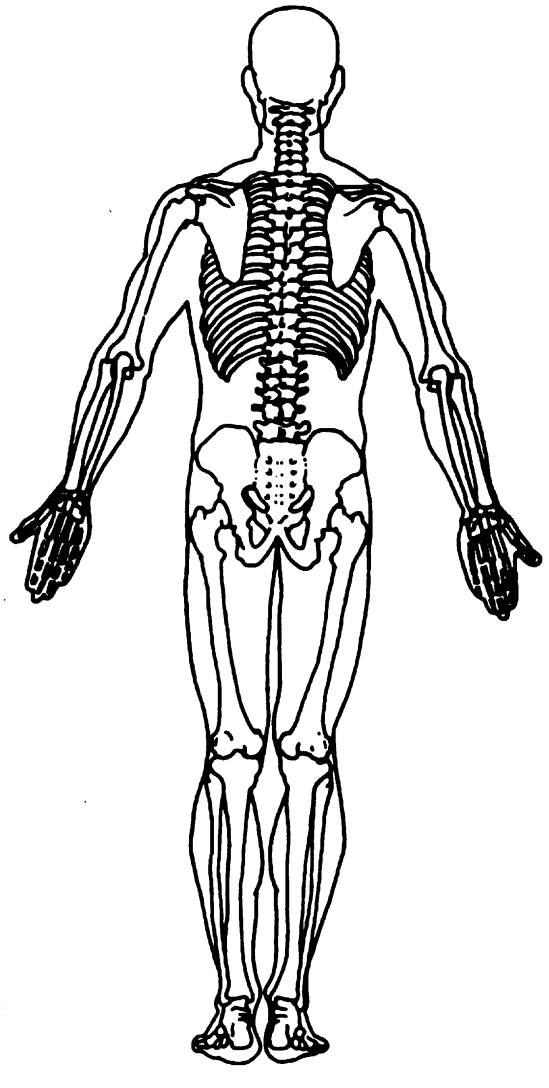
OFFICIAL INJURY DATA — SKELETAL INJURIES

fx metatarsals 3,4 (R) foot

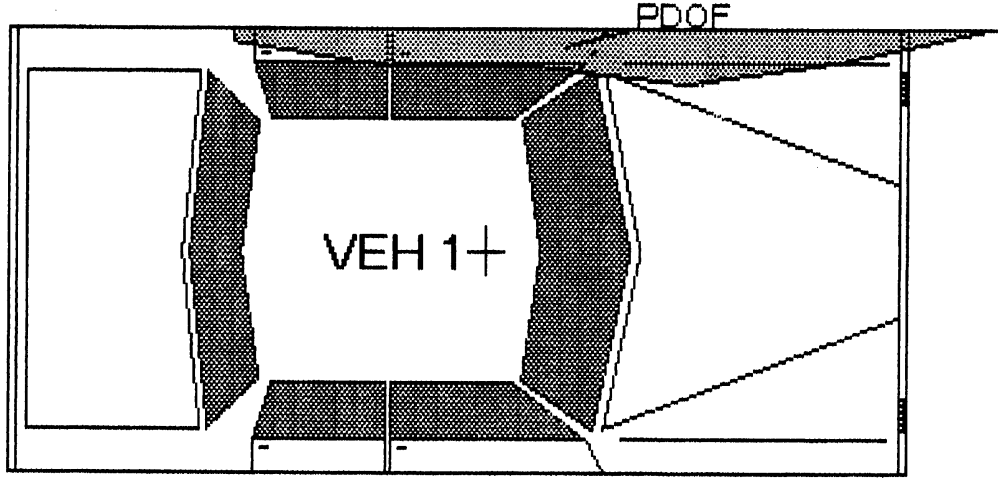
1995 GMC SAFARI

Vehicle #1	Vehicle #2
Vehicle Damage Known	Yes	Yes
Crush Length	408.0 cm (161 in)	0.0 cm (0 in)
C1	5.0 cm (2 in)	0.0 cm (0 in)
C2	16.0 cm (6 in)	0.0 cm (0 in)
C3	17.0 cm (7 in)	0.0 cm (0 in)
C4	25.0 cm (10 in)	0.0 cm (0 in)
C5	15.0 cm (6 in)	0.0 cm (0 in)
C6	0.0 cm (0 in)	0.0 cm (0 in)
D	45.0 cm (18 in)	0.0 cm (0 in)
D'	41.8 cm (16 in)	0.0 cm (0 in)
