**National Highway  
Traffic Safety  
Administration**

# CASE SUMMARY

PSU 49 CASE NO. 075E TYPE OF ACCIDENT Car/Light truck - Angle (Multiple impacts)

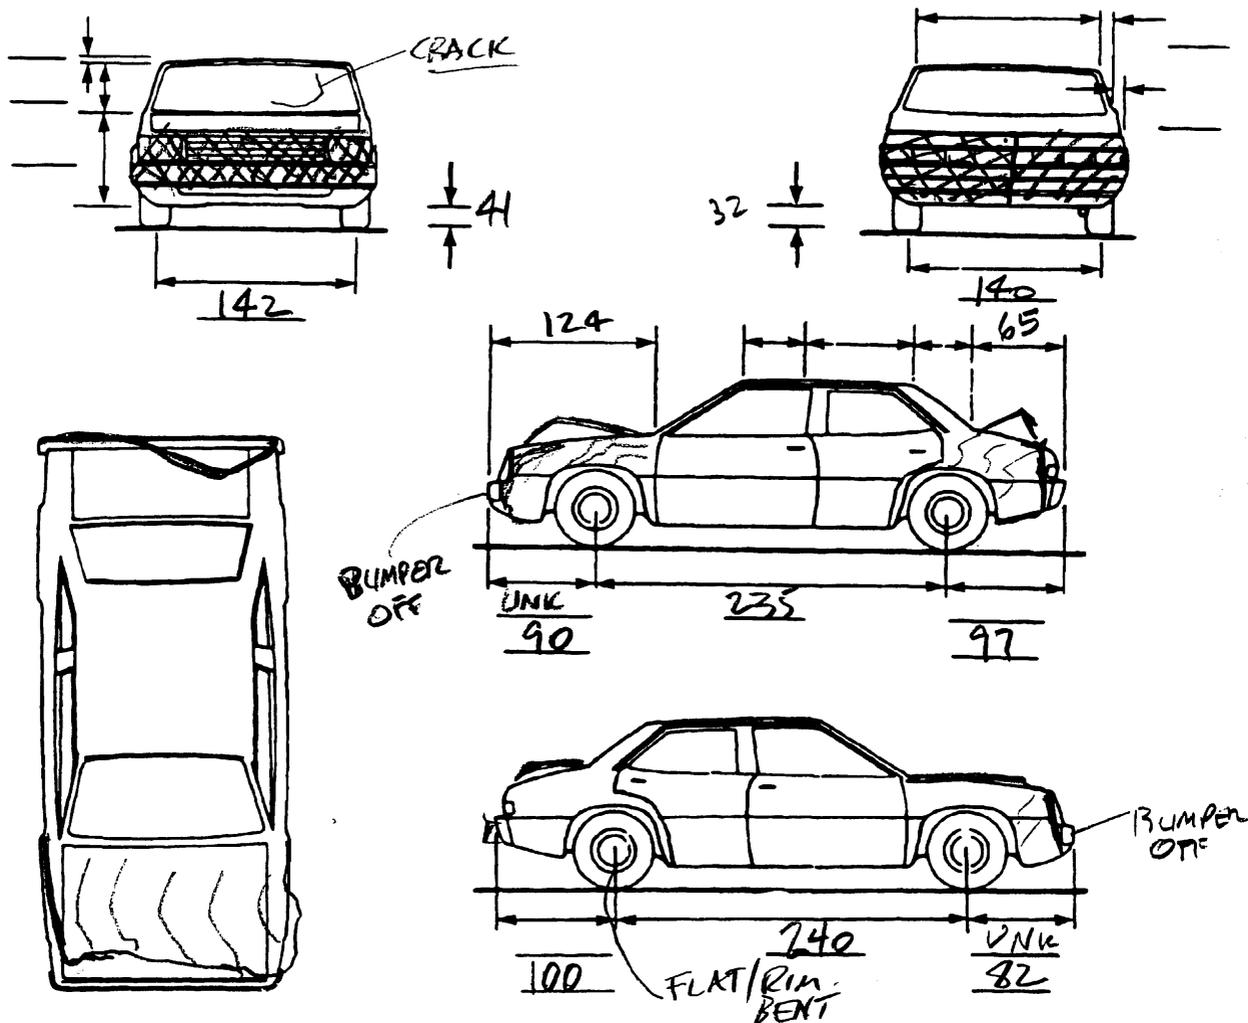
### VEHICLE DAMAGE SKETCH

**NOTES:** Sketch new perimeter and cross hatch direct damage and single hatch induced damage on all views. Annotate observations which might be useful in reconstructing the accident (e.g., grass in tire bead, direction of striations, scuff on sidewalls, etc.). If pulling trailer, sketch type of trailer and damage received on the back of this page.

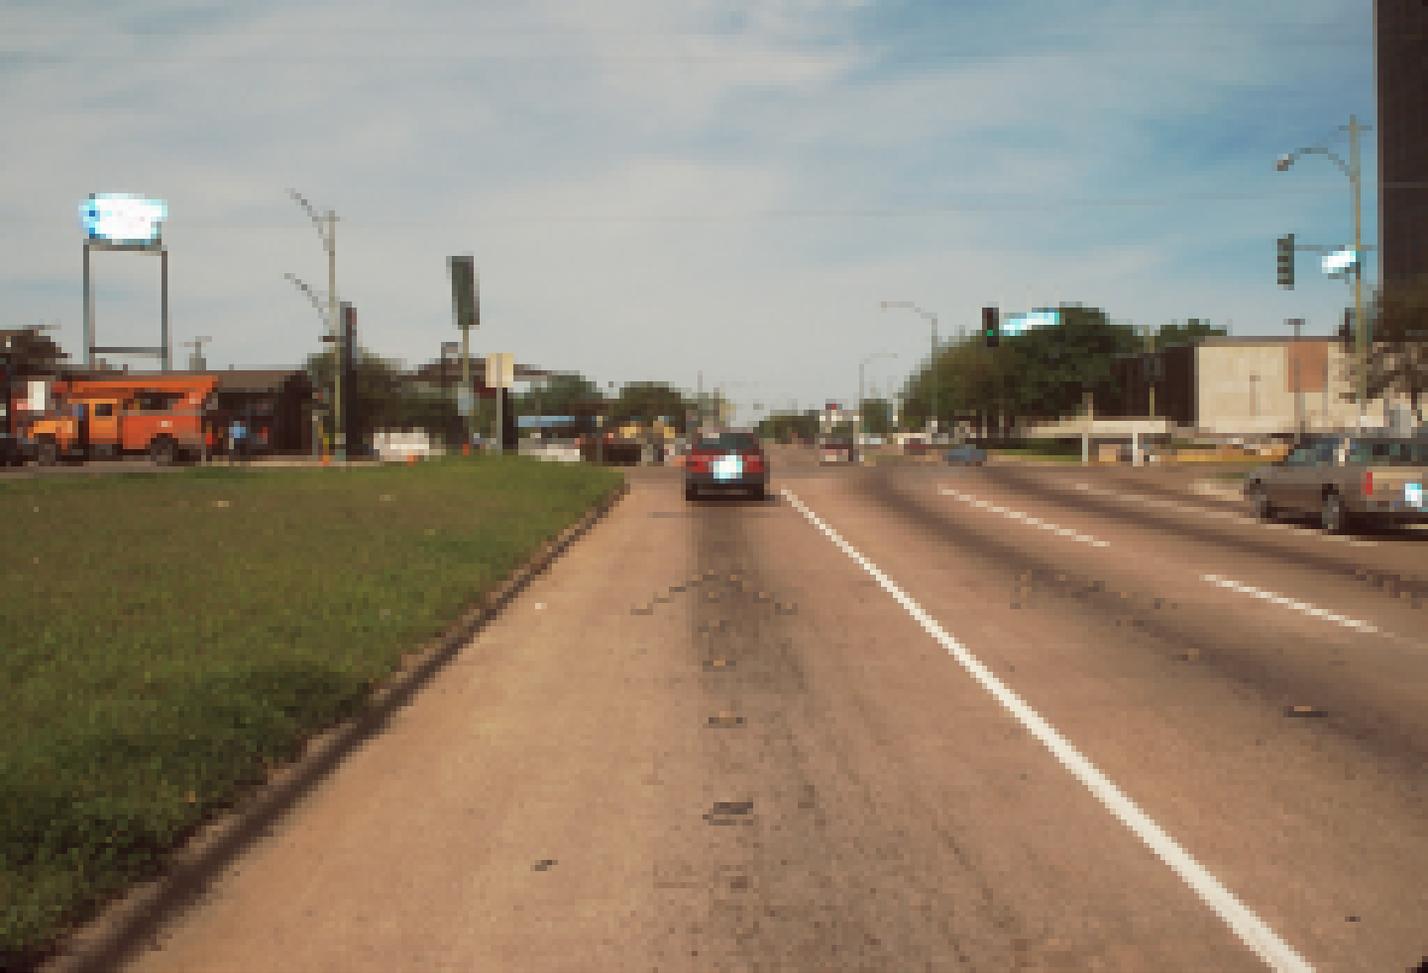
PSU 49-075E (1994) #1

Slide No.	Vehicle No.	Direction of Picture	Description of Slide Subject Matter
1-2	1	W	Pre-impact travel path of V1 - car in photos is disabled
3	1	S/W..	Path into impact with V2
4	1	S/W	V1 at impact with V2
5	1	E	V1 at impact with V3 (impact #2 for V1) and path to impact with curb
6	1	E	V1 at impact with curb (impact #3 for V1) and final rest
7-8	1	N&S	Closeups of curb impact
9	1	N/E	Opposite view from beyond impacts with V2 and V3
10-11	1	W	Opposite views from beyond curb impact and final rest
12-13	2	E	Pre-impact travel path of V2
14-15	2	E	Path into impacts
16-18	2	E	V2 at impact with V1, rollover and final rest
19	2	W	V2 opposite view from beyond impacts and final rest
20-21	3	E	Pre-impact travel path of V3
22	3	E	V3 at impact with V1
23-25	3	E	Post-impact travel path and final rest area
26-27	3	W	V3 opposite views from beyond impact and final rest
28-50	1		Exterior views showing damage to front from impact with V2, back from impact with V3 and right rear tire/wheel from impact with curb

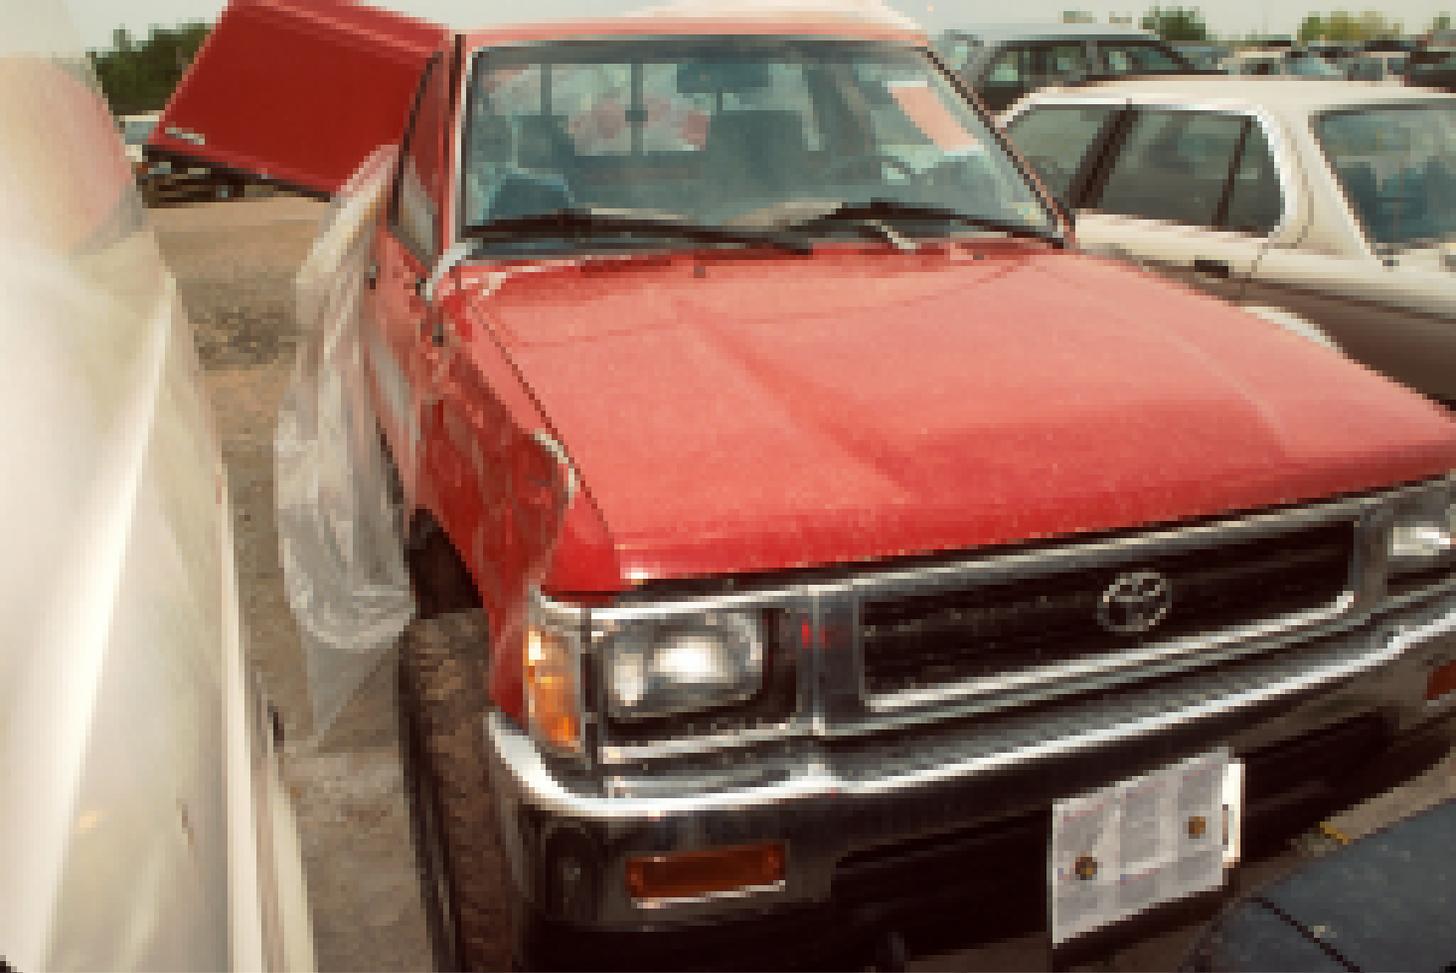
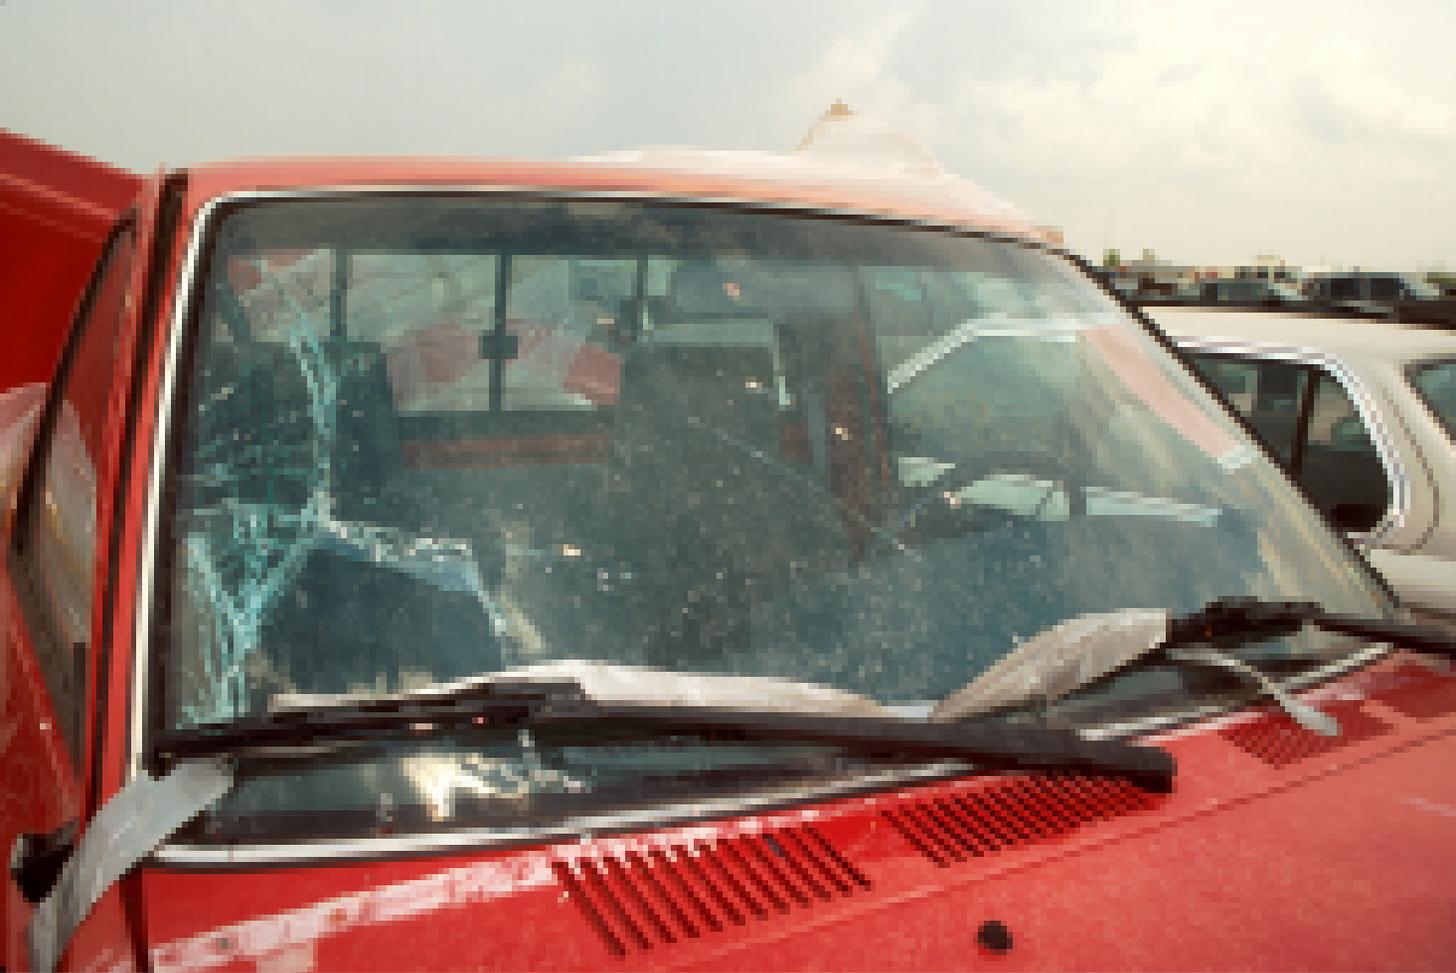
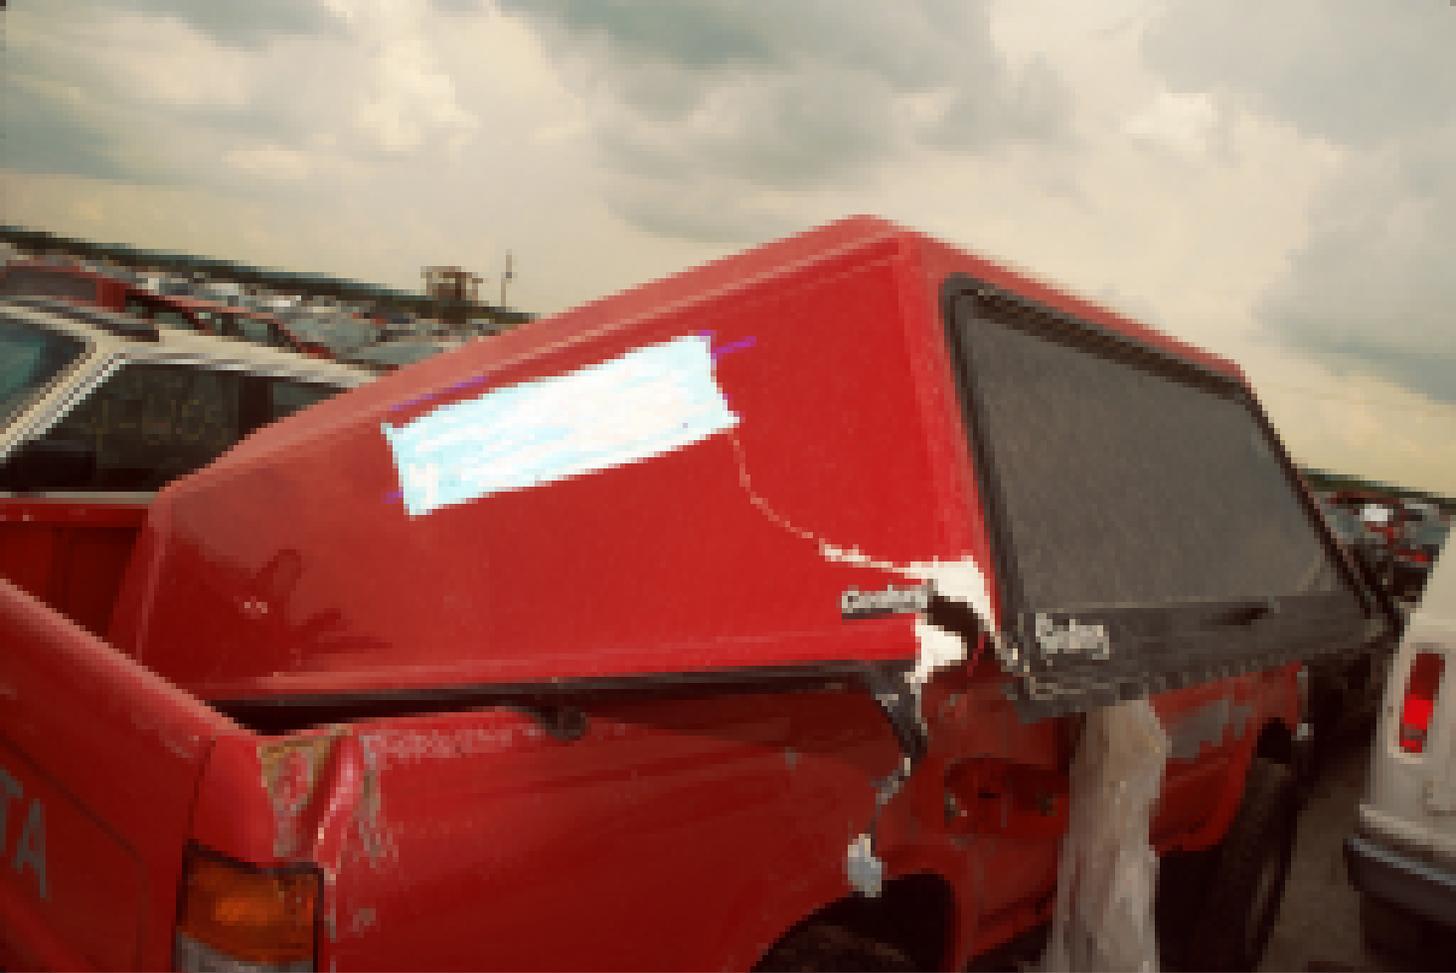
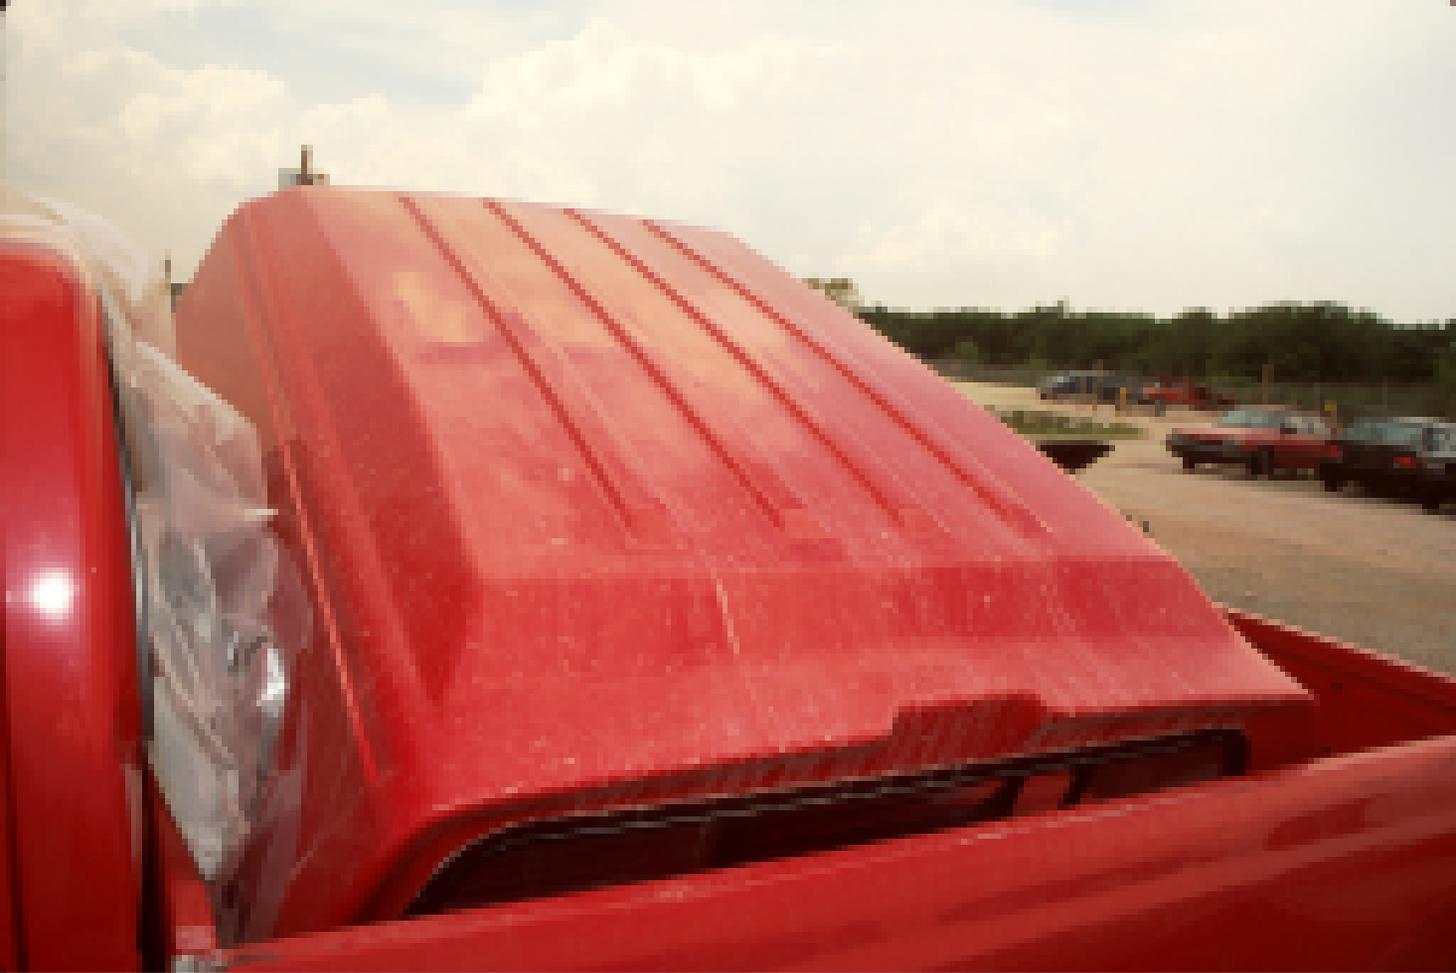
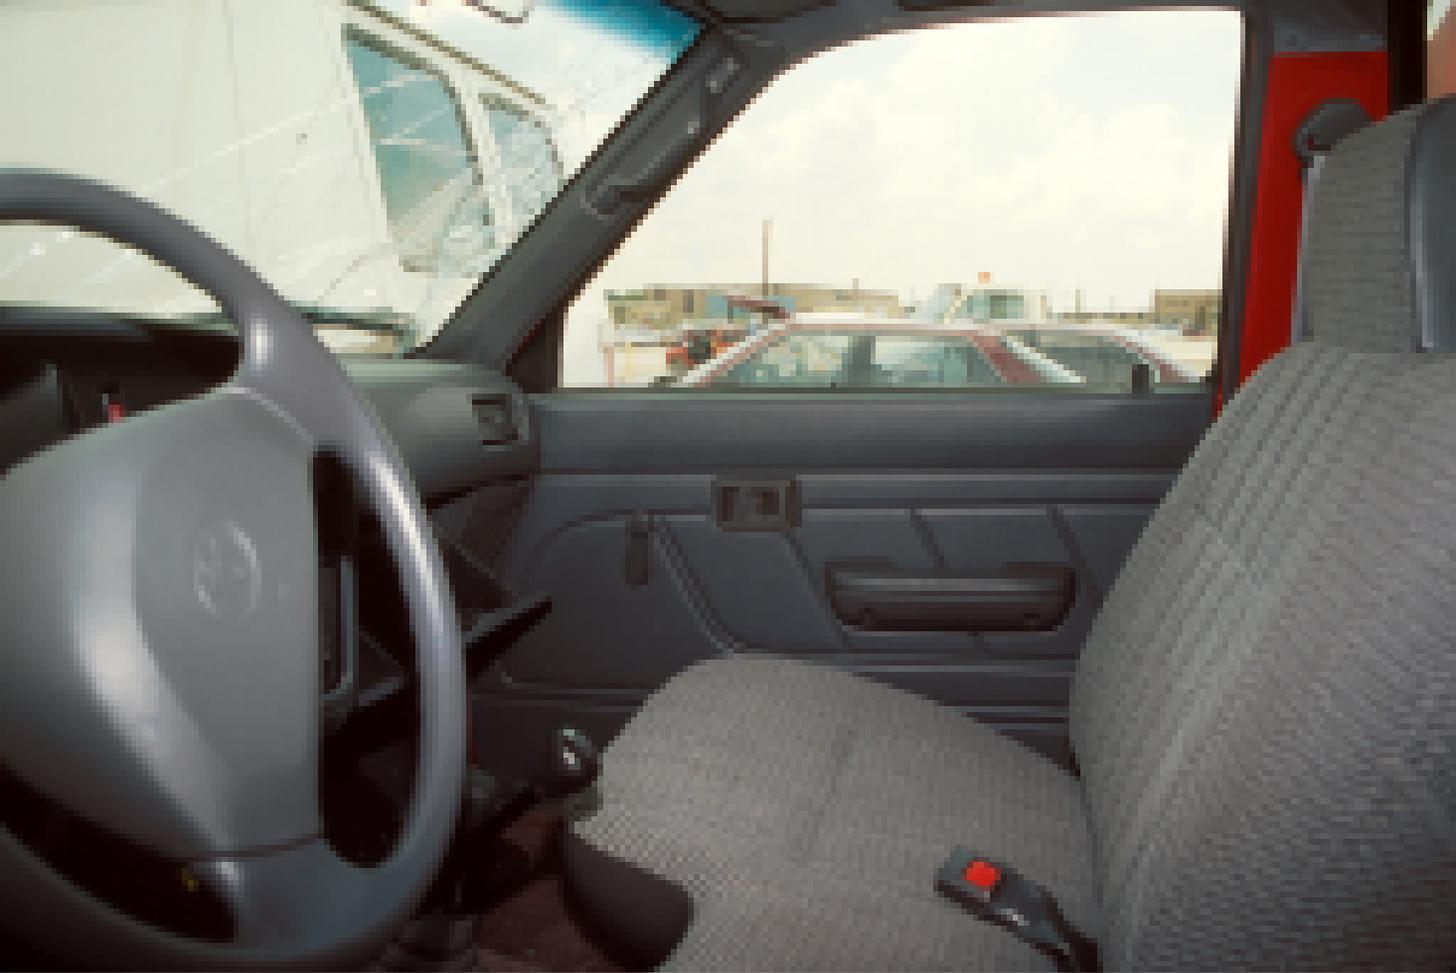
51-66	1		Interior views
67-90	2		Exterior views showing damage to the left side from impact with V1 and right side from rollover
91-104	2		Interior views showing possible occupant contact points
105-109	3		Exterior views - under repair
110-125	3		Interior views
