**National Highway  
Traffic Safety  
Administration**

# CASE SUMMARY

PSU 49 CASE NO. 075E TYPE OF ACCIDENT Car/Light truck - Angle (Multiple impacts)

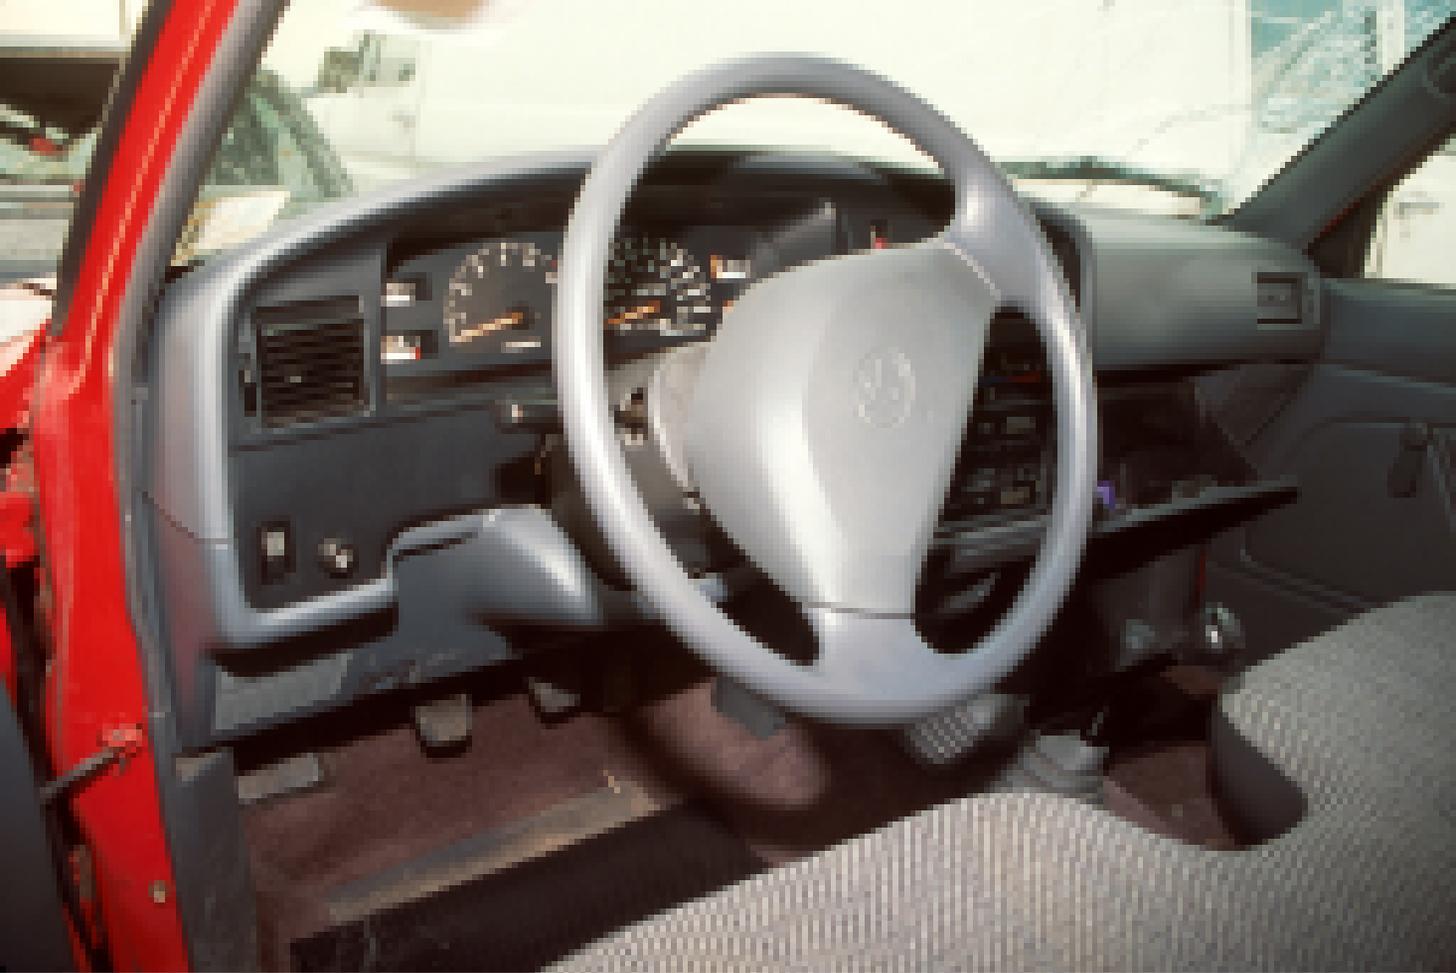
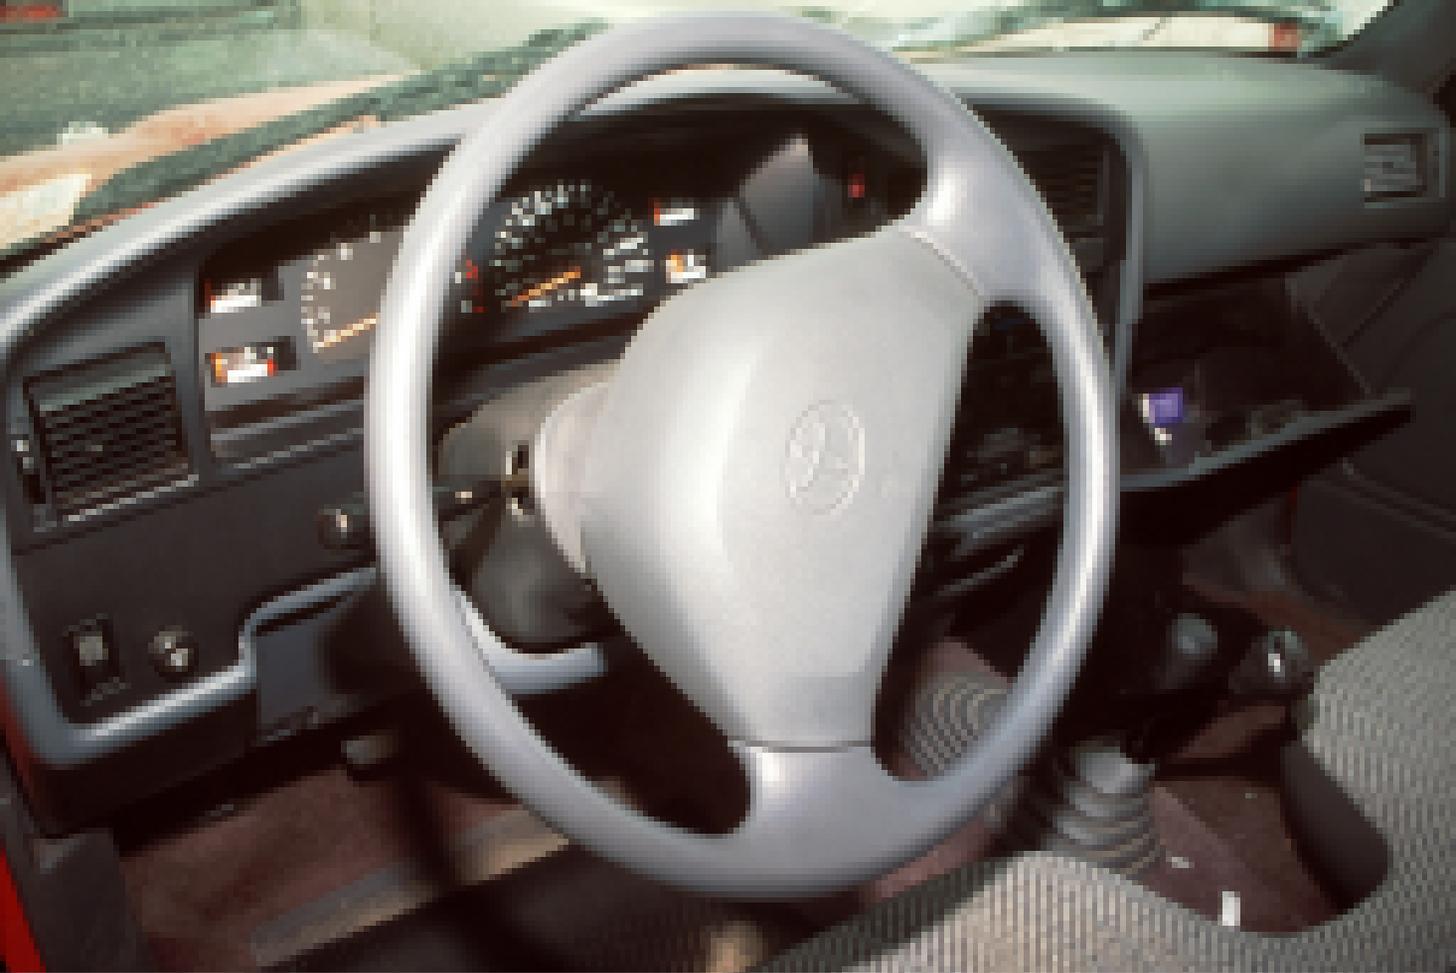
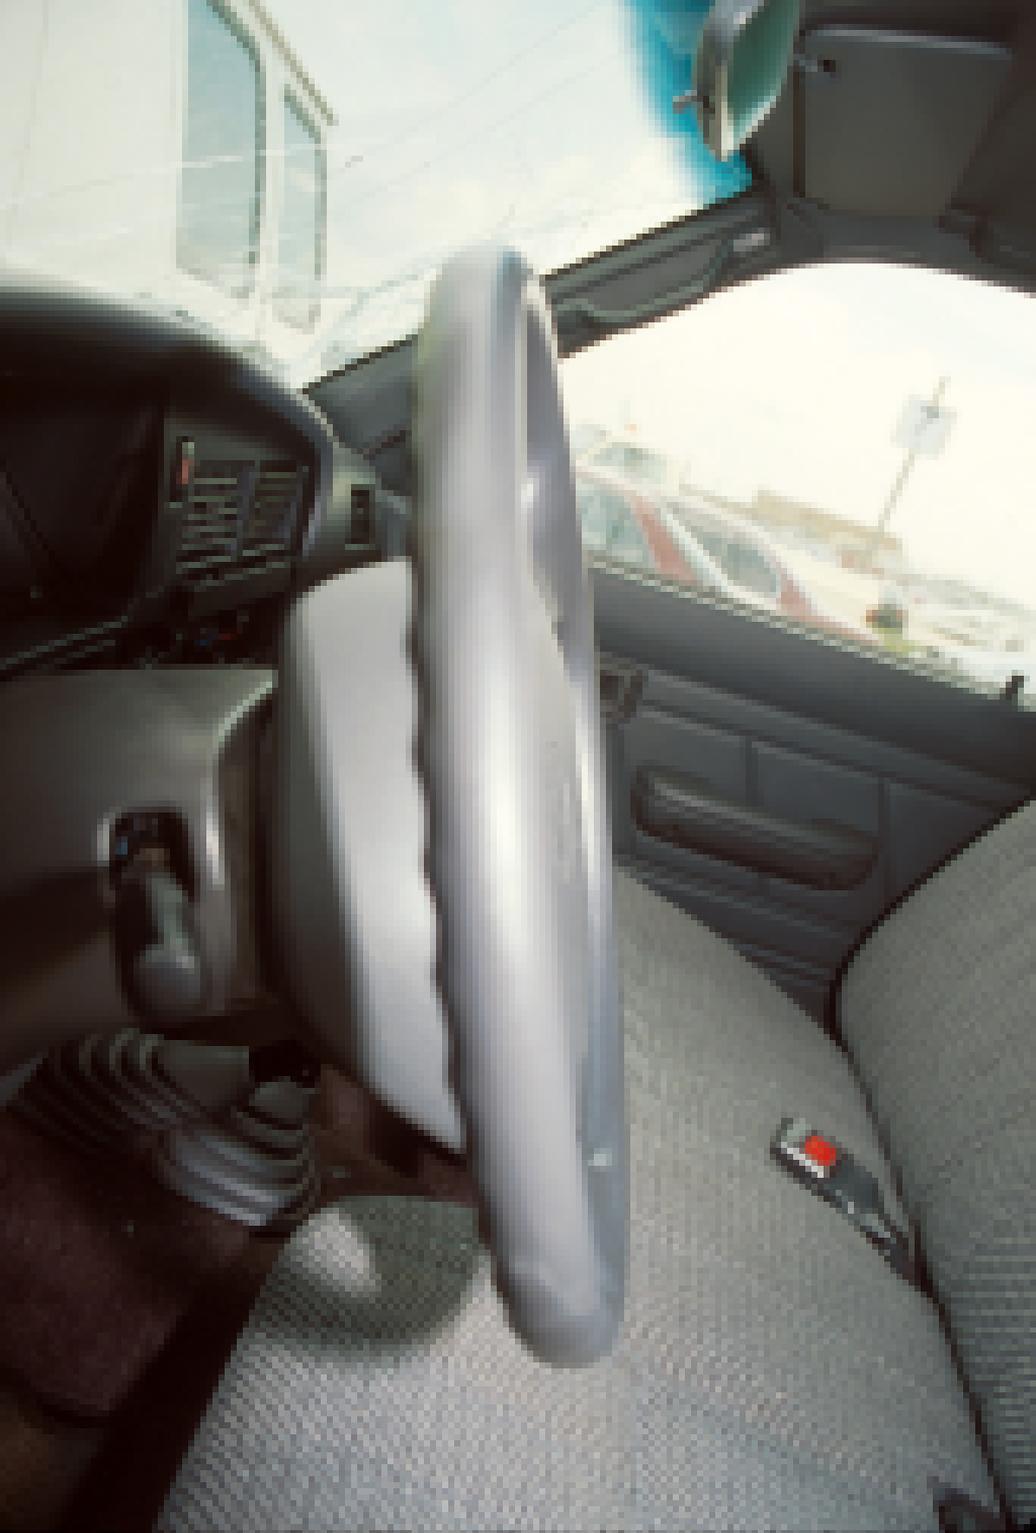
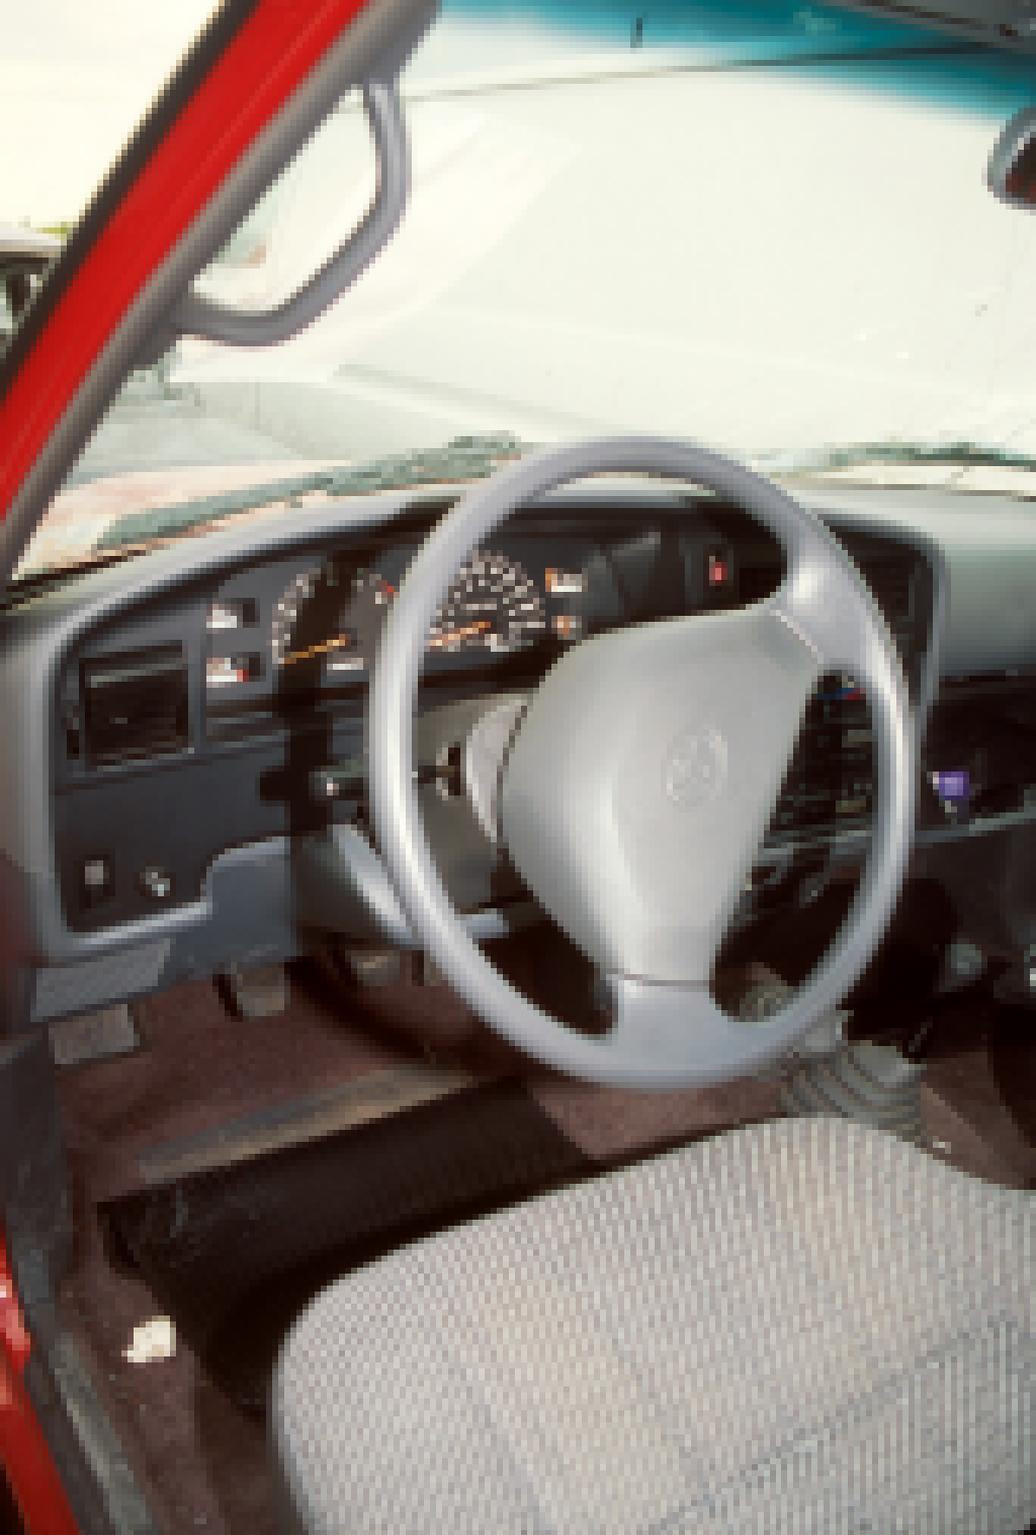
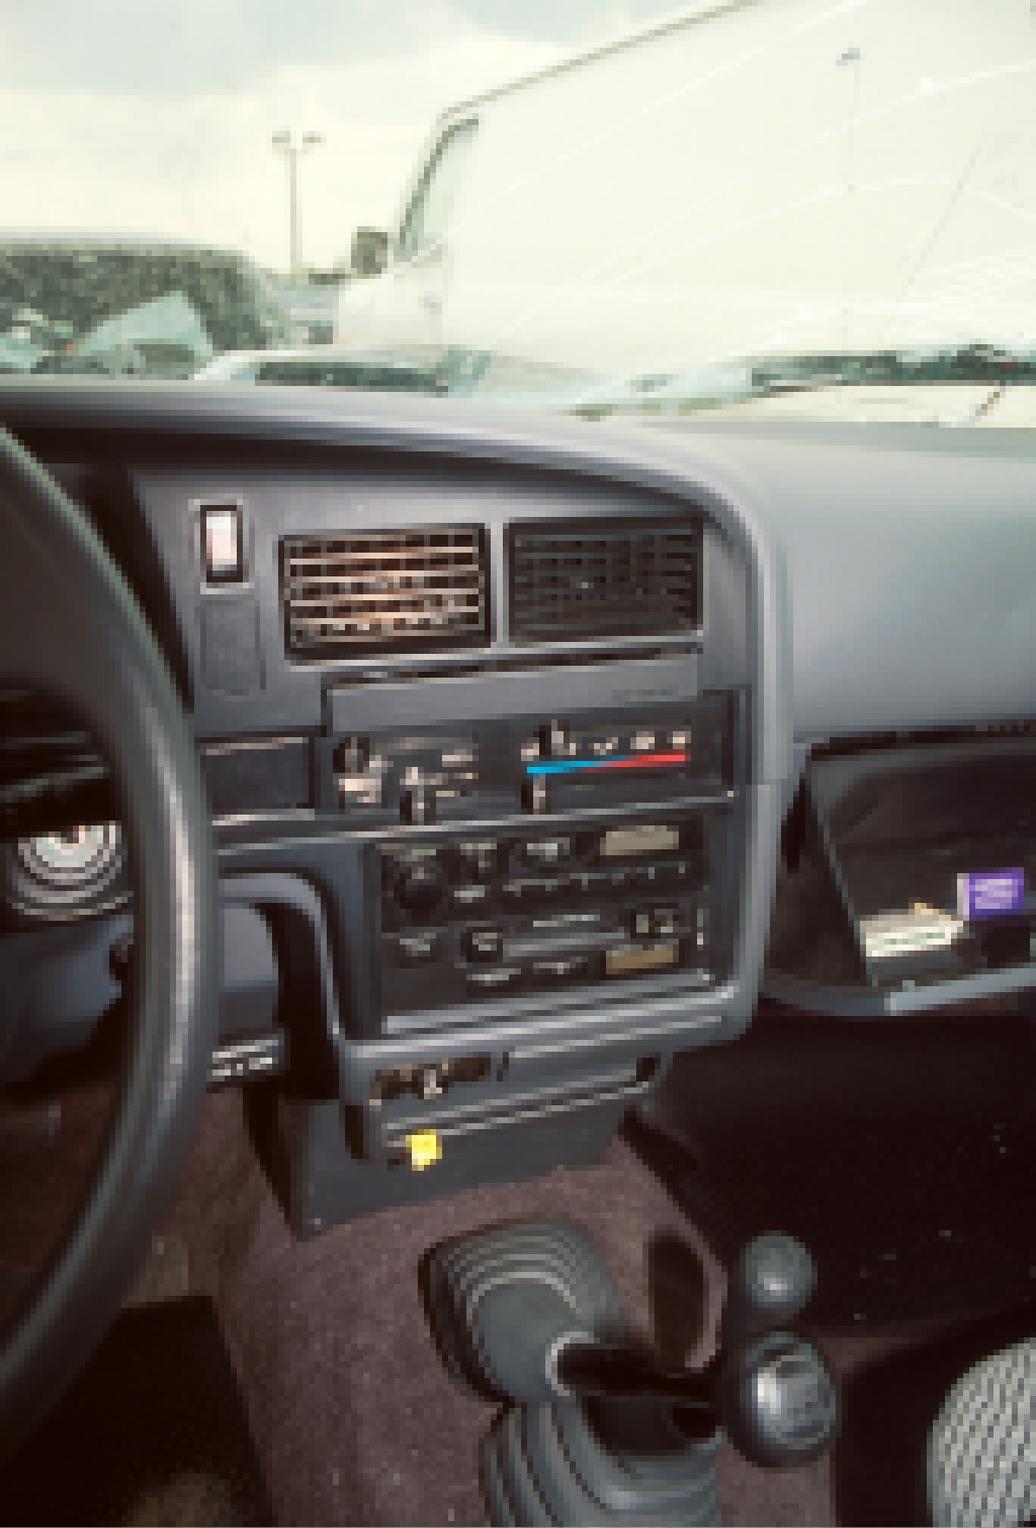
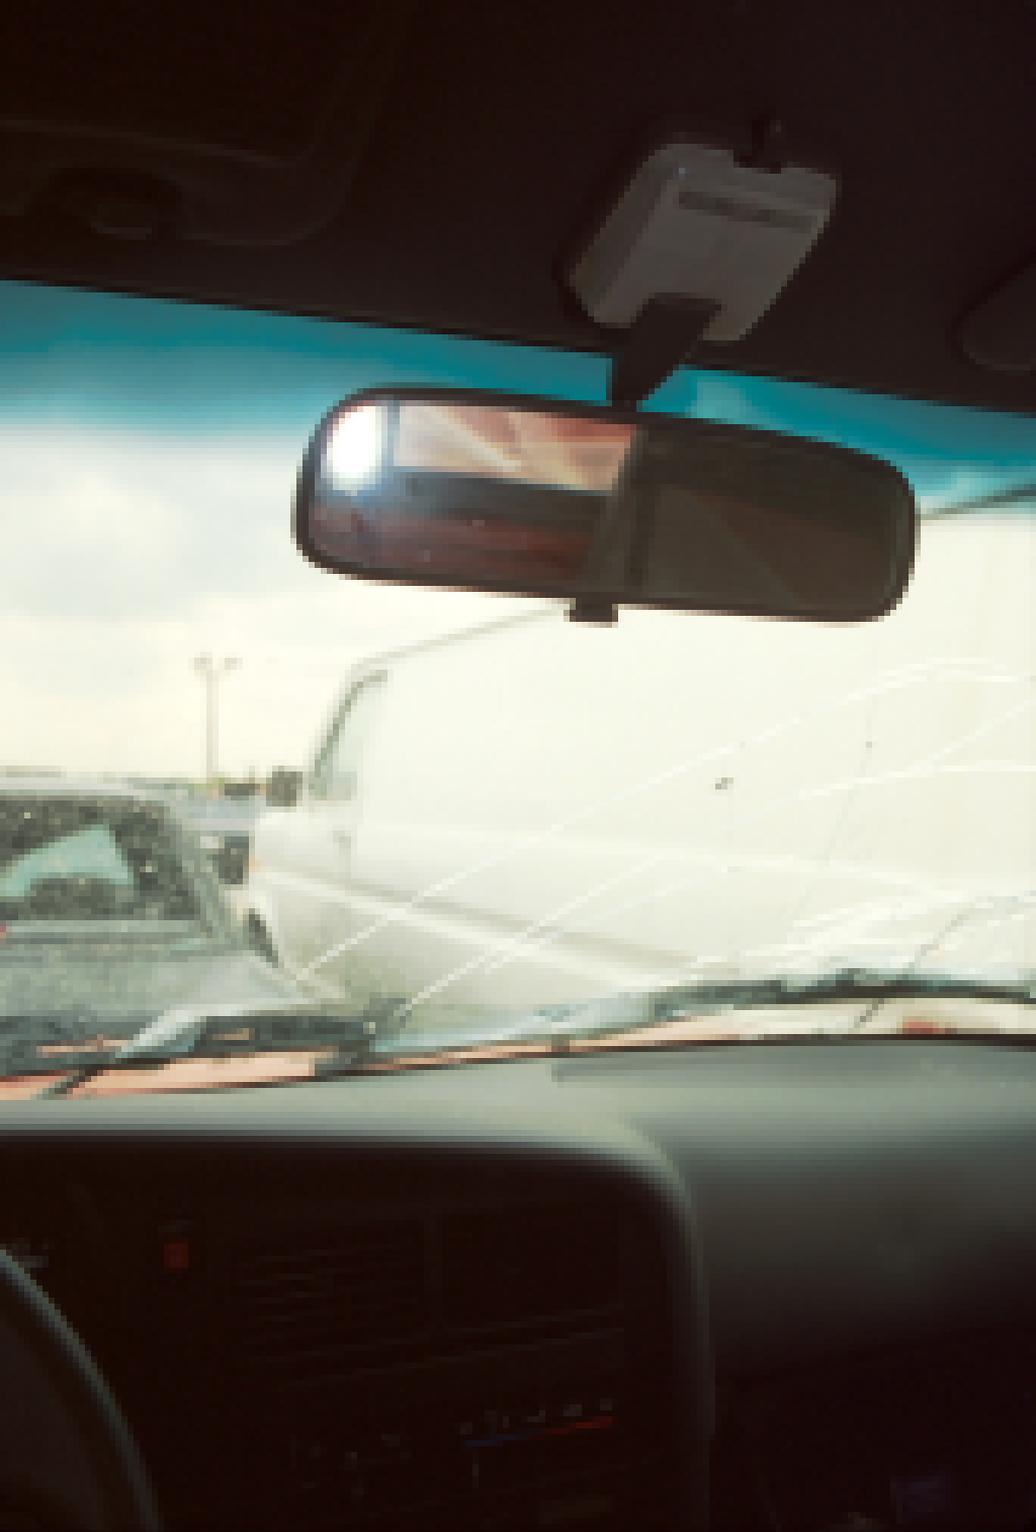
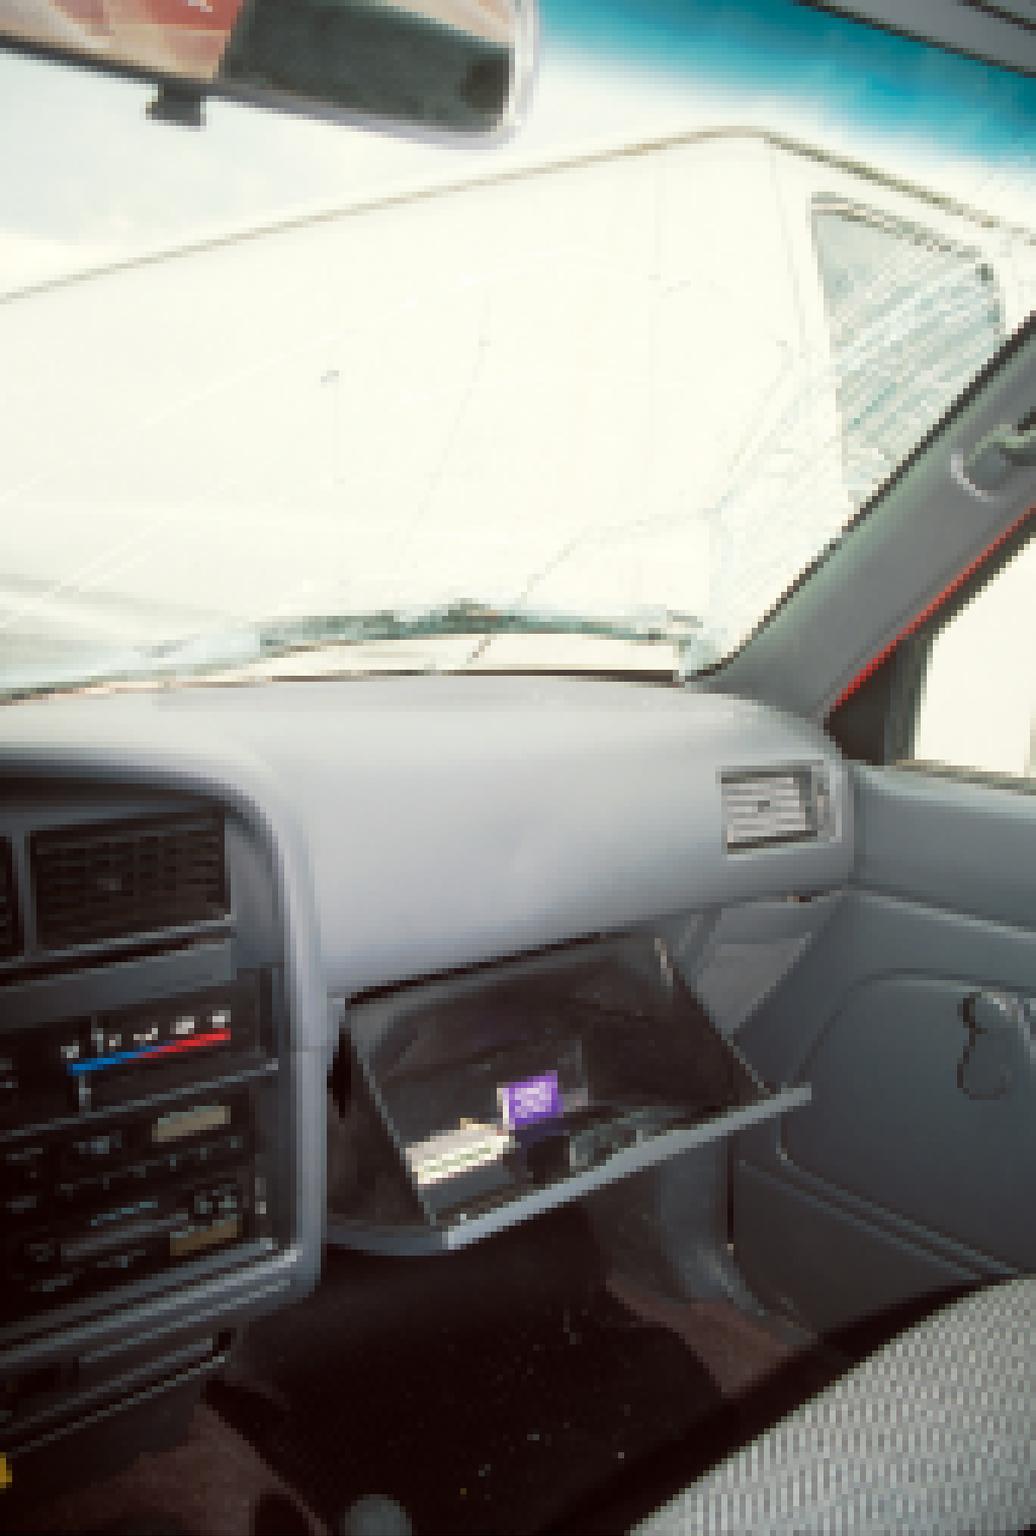
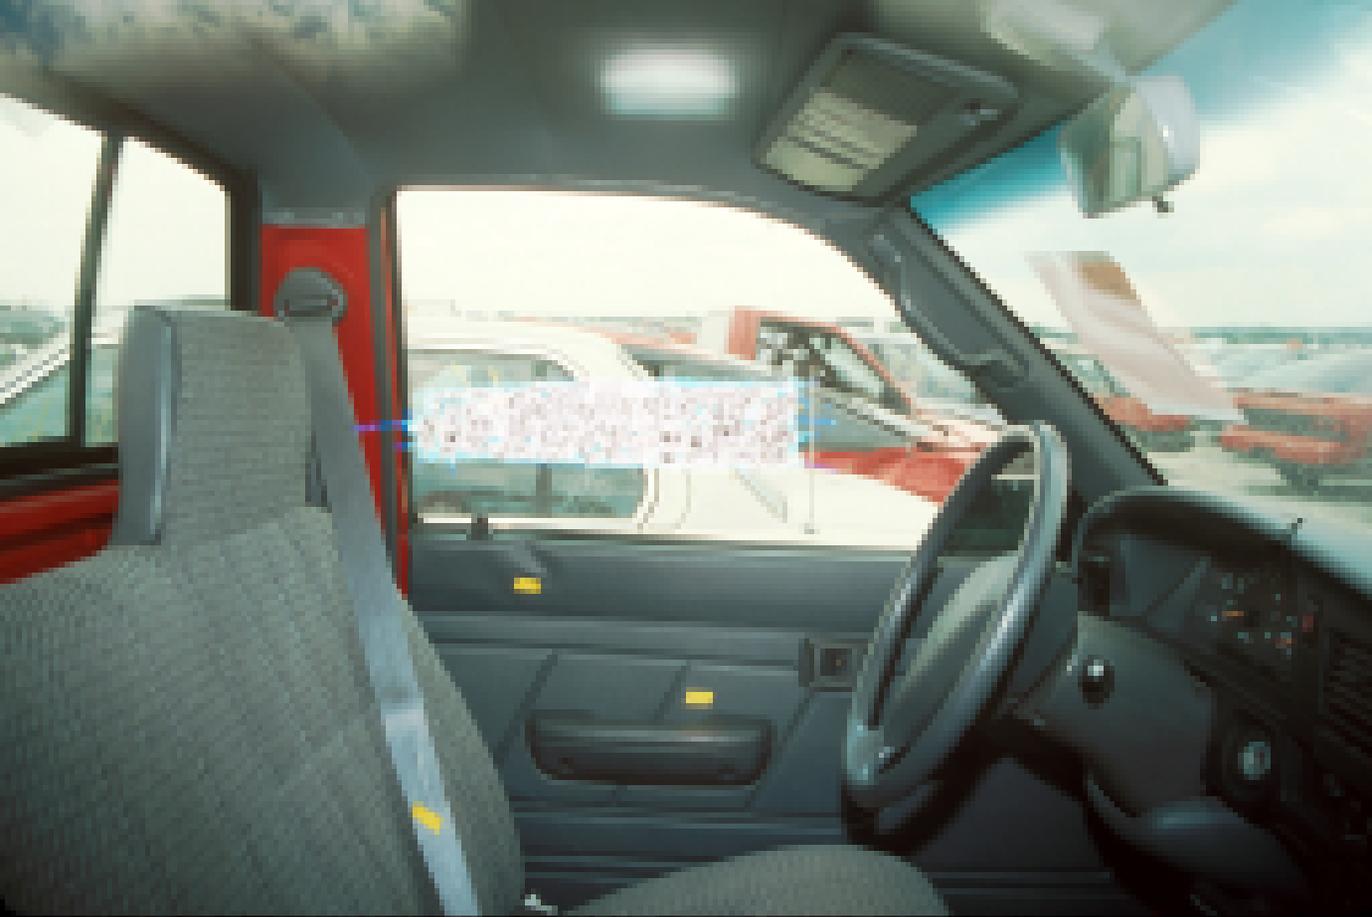
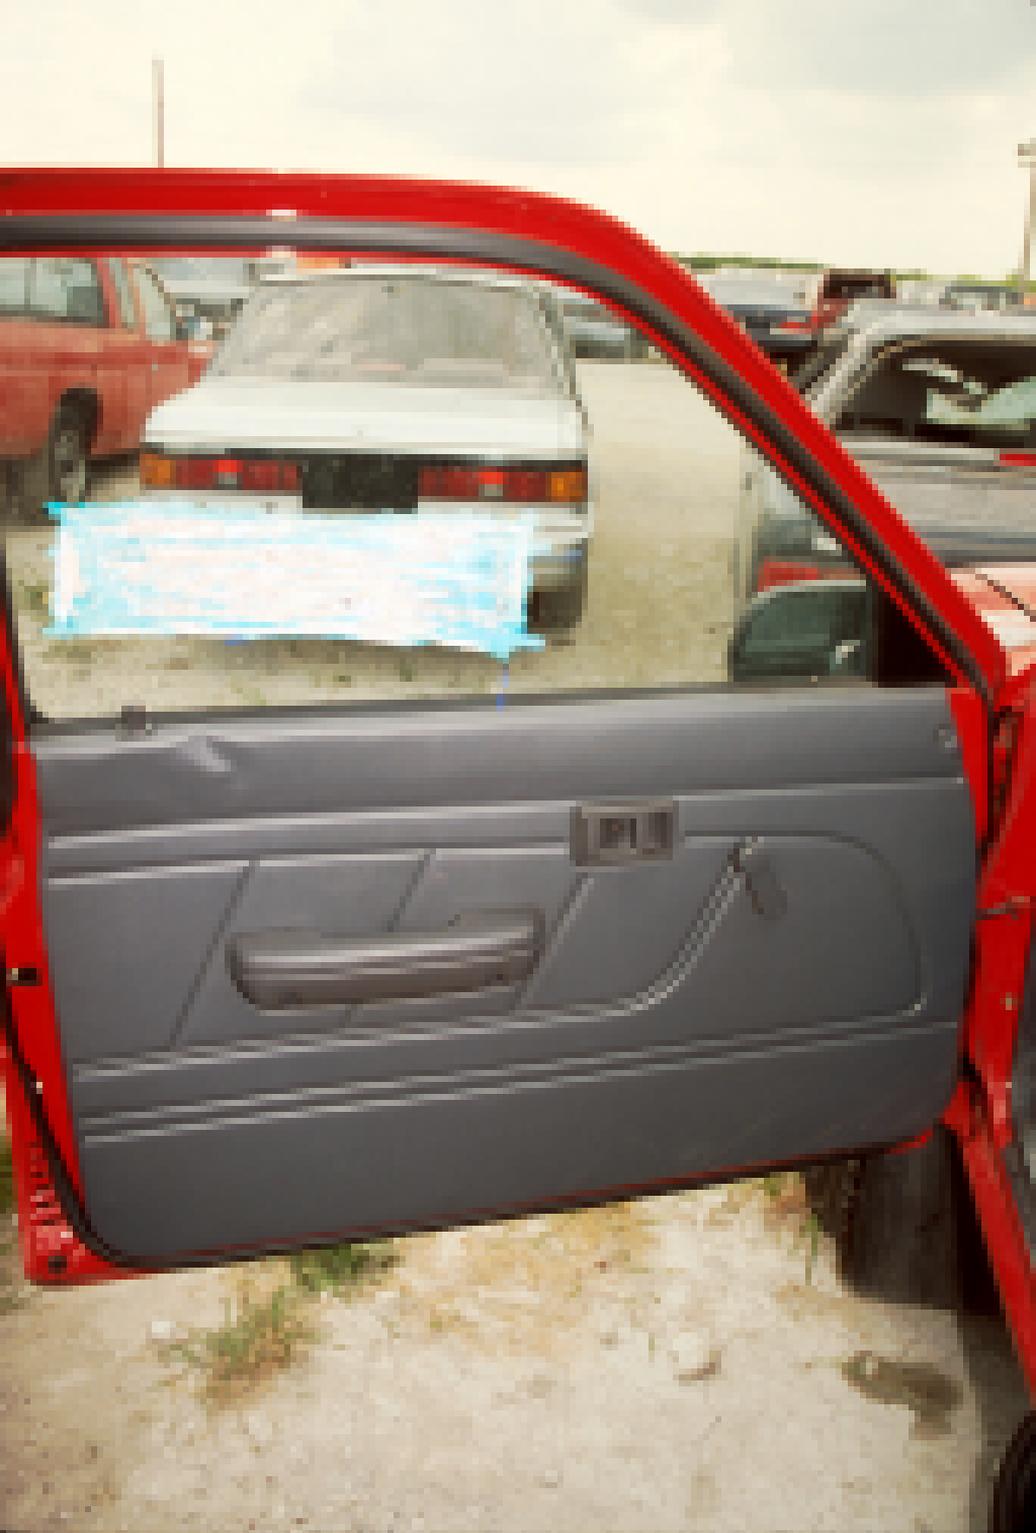
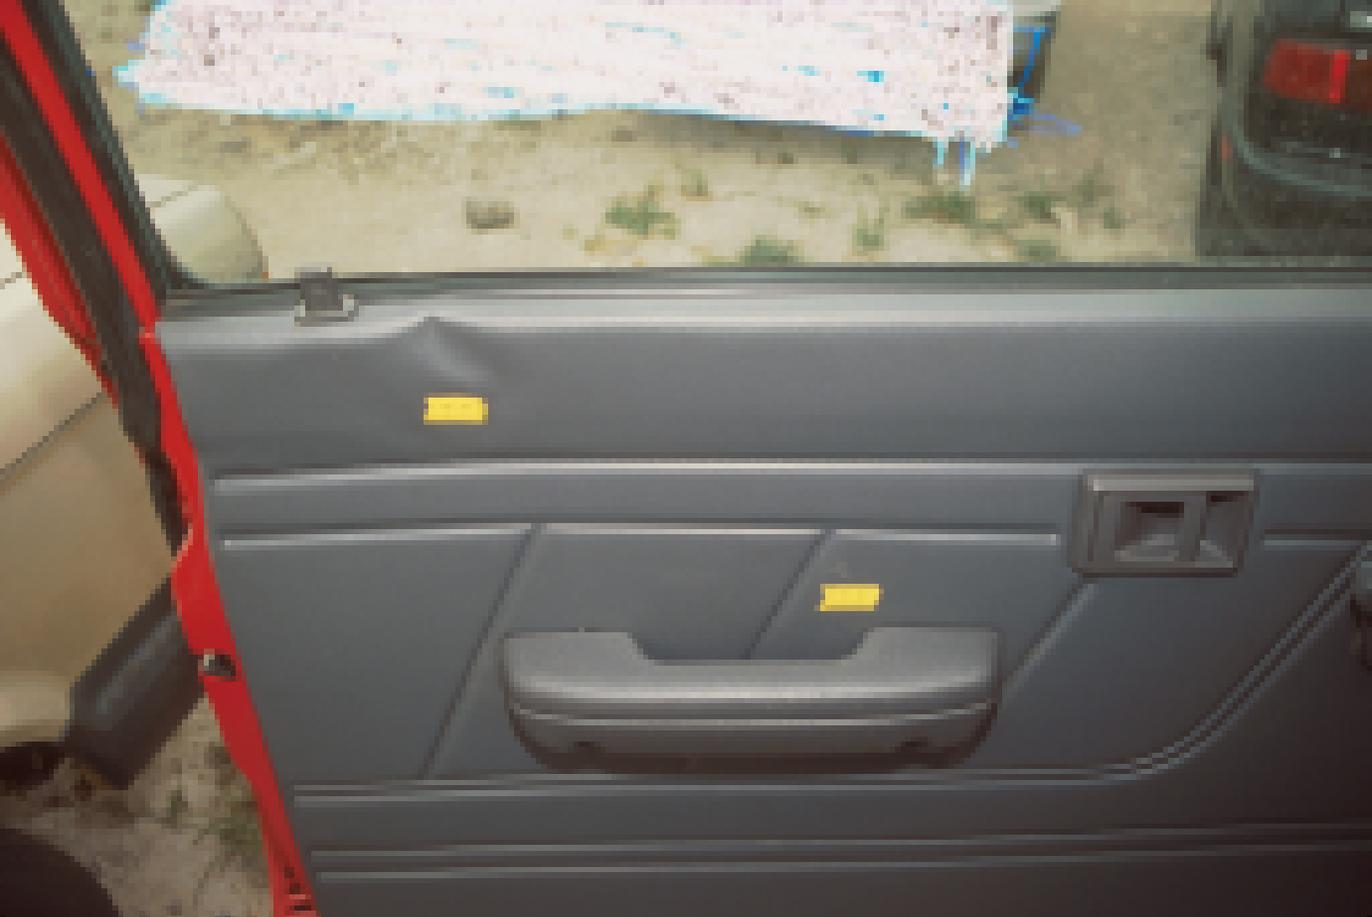
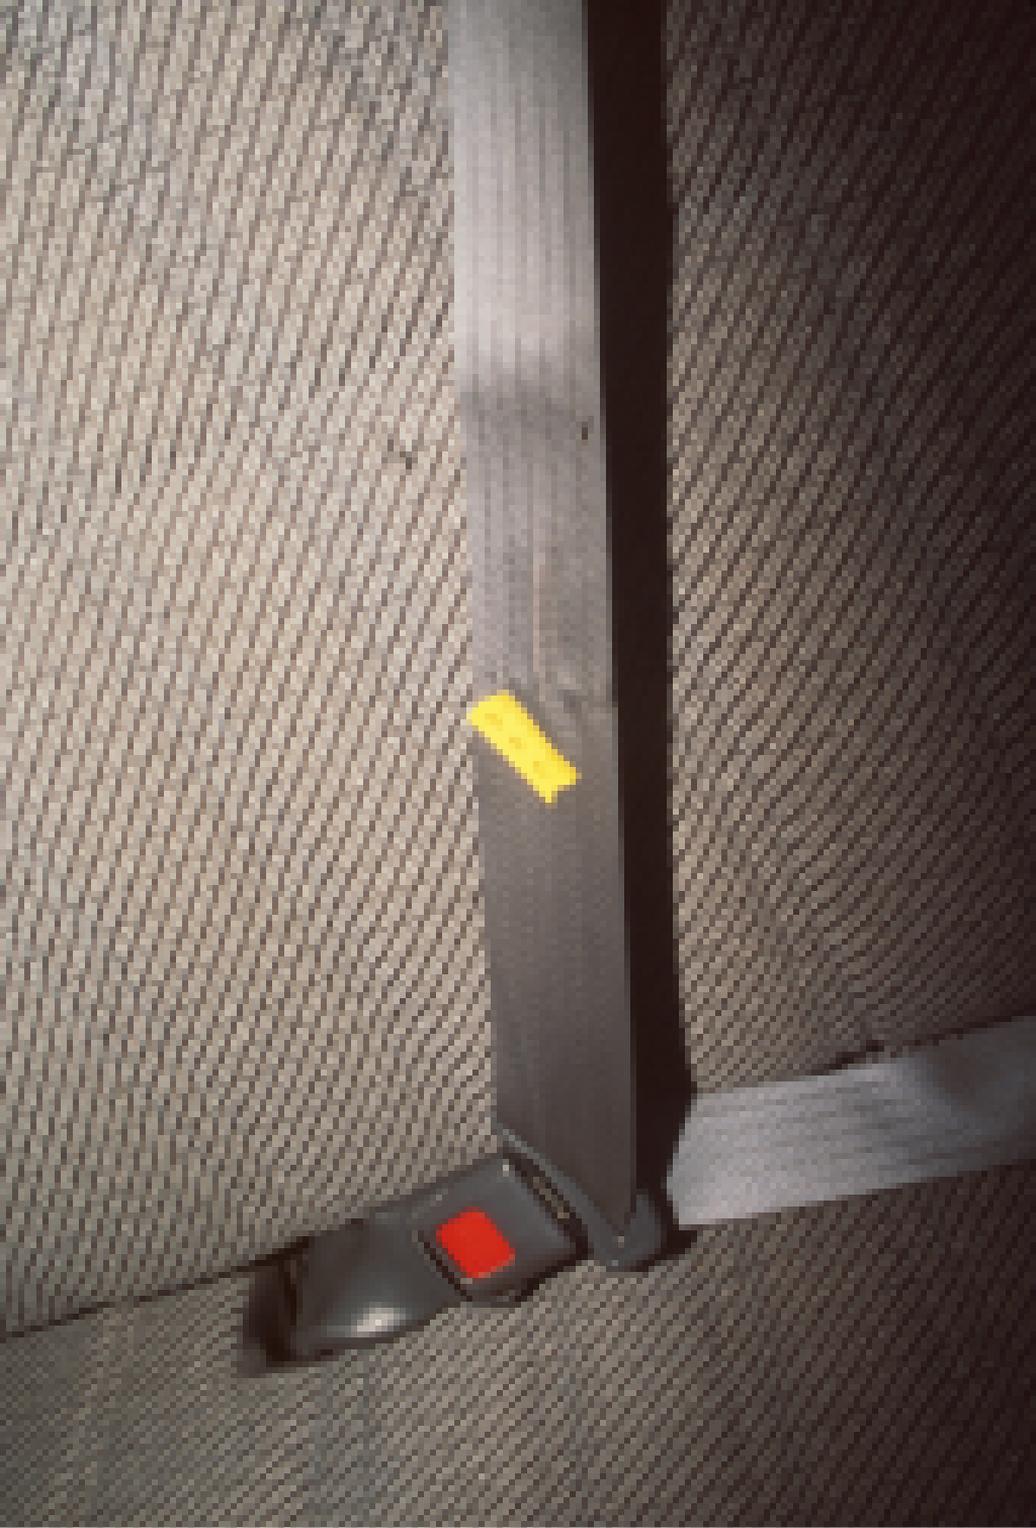
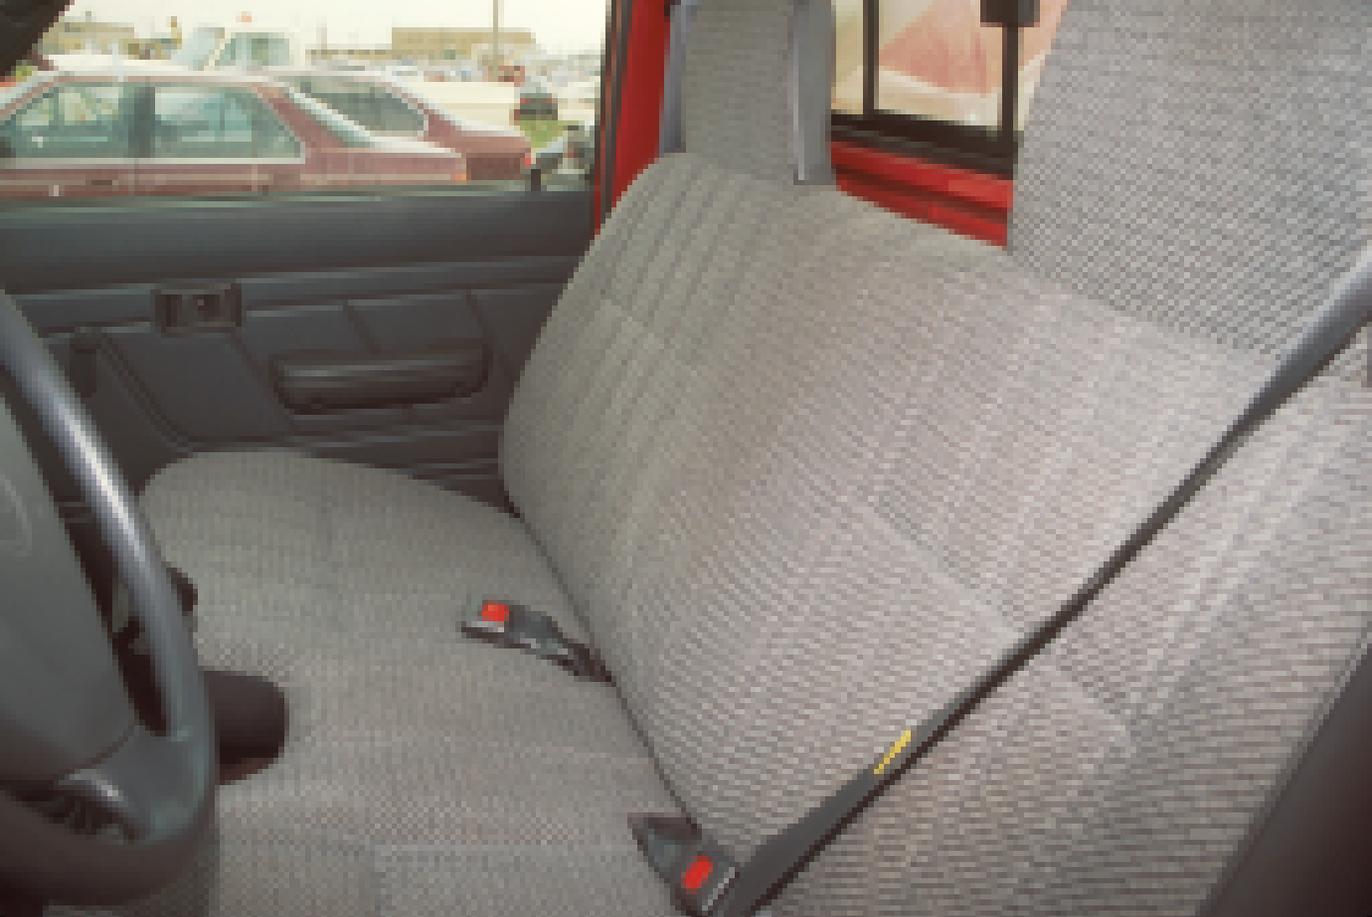
51-66	1		Interior views
67-90	2		Exterior views showing damage to the left side from impact with V1 and right side from rollover
91-104	2		Interior views showing possible occupant contact points
105-109	3		Exterior views - under repair
110-125	3		Interior views
