**National Highway  
Traffic Safety  
Administration**

# CASE SUMMARY

PSU 49 CASE NO. 075E TYPE OF ACCIDENT Car/Light truck - Angle (Multiple impacts)

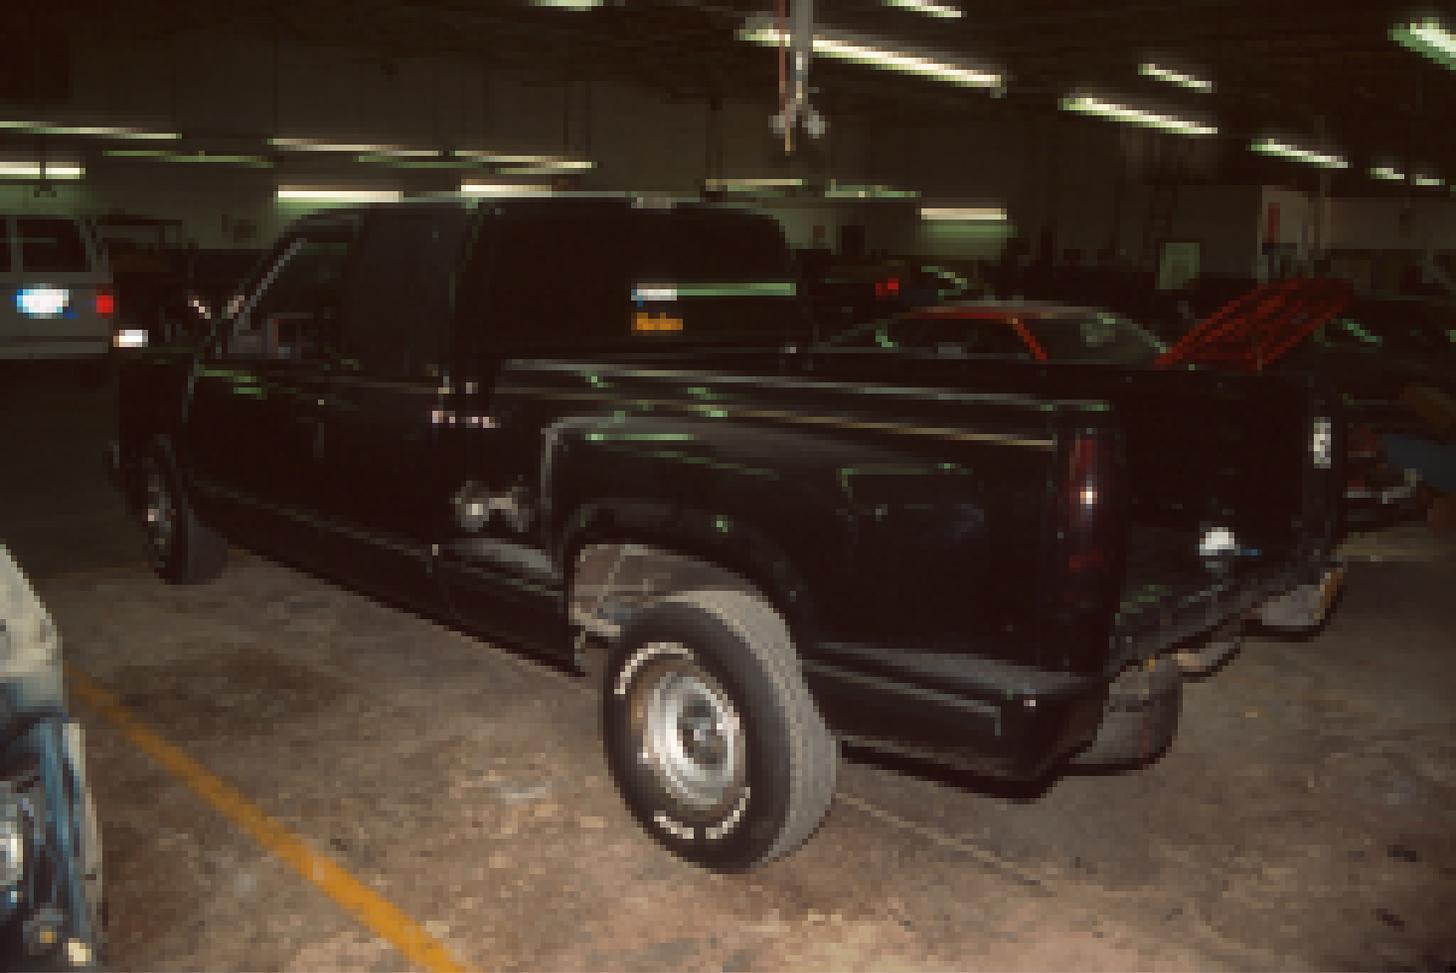
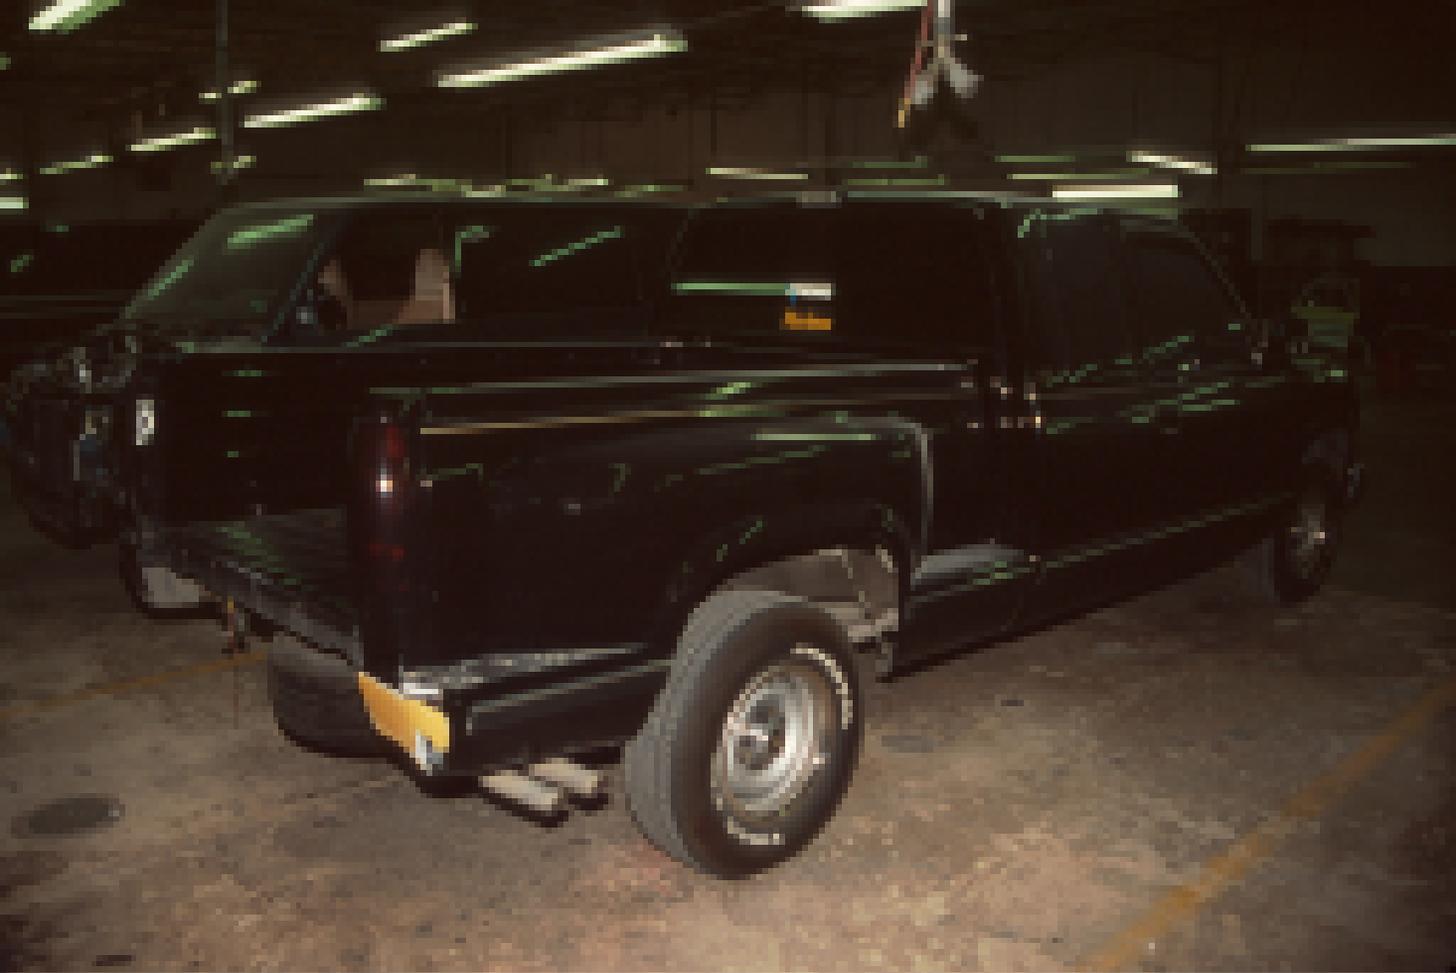
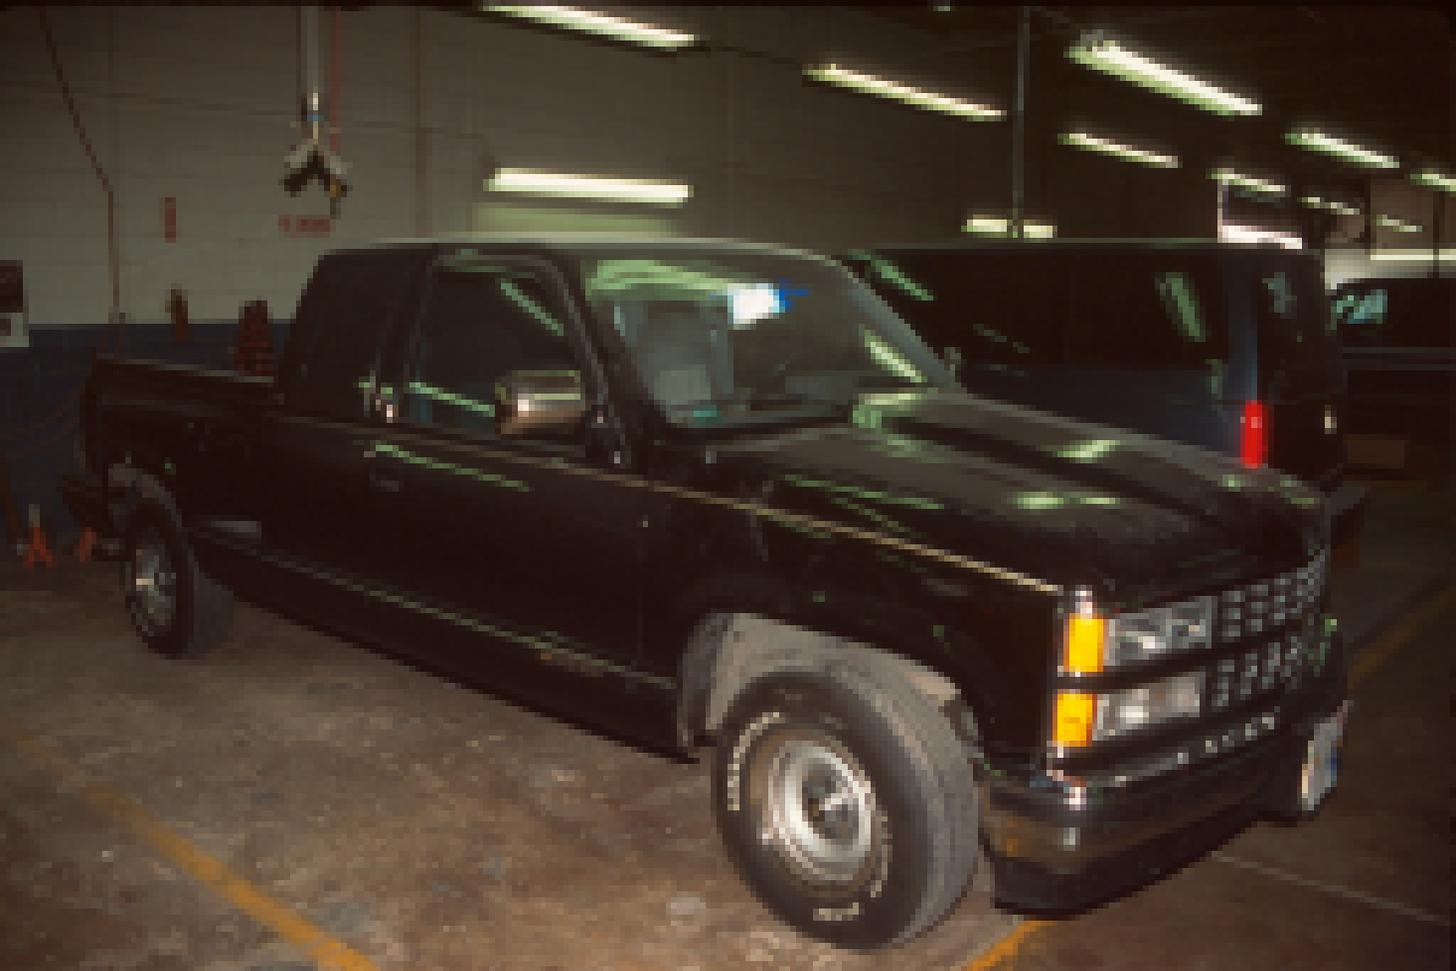
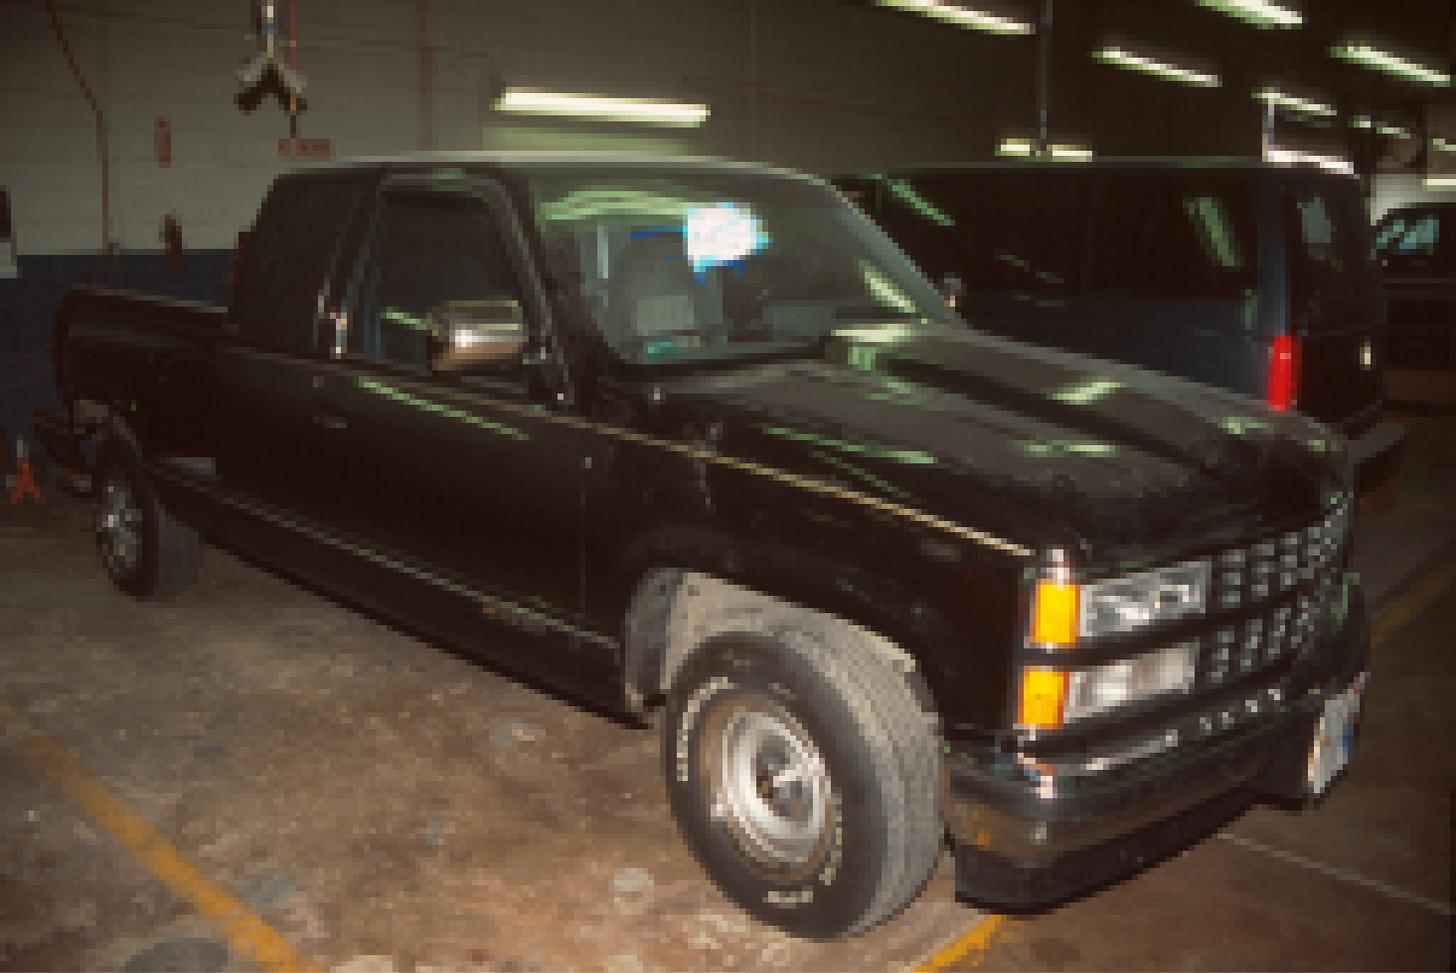
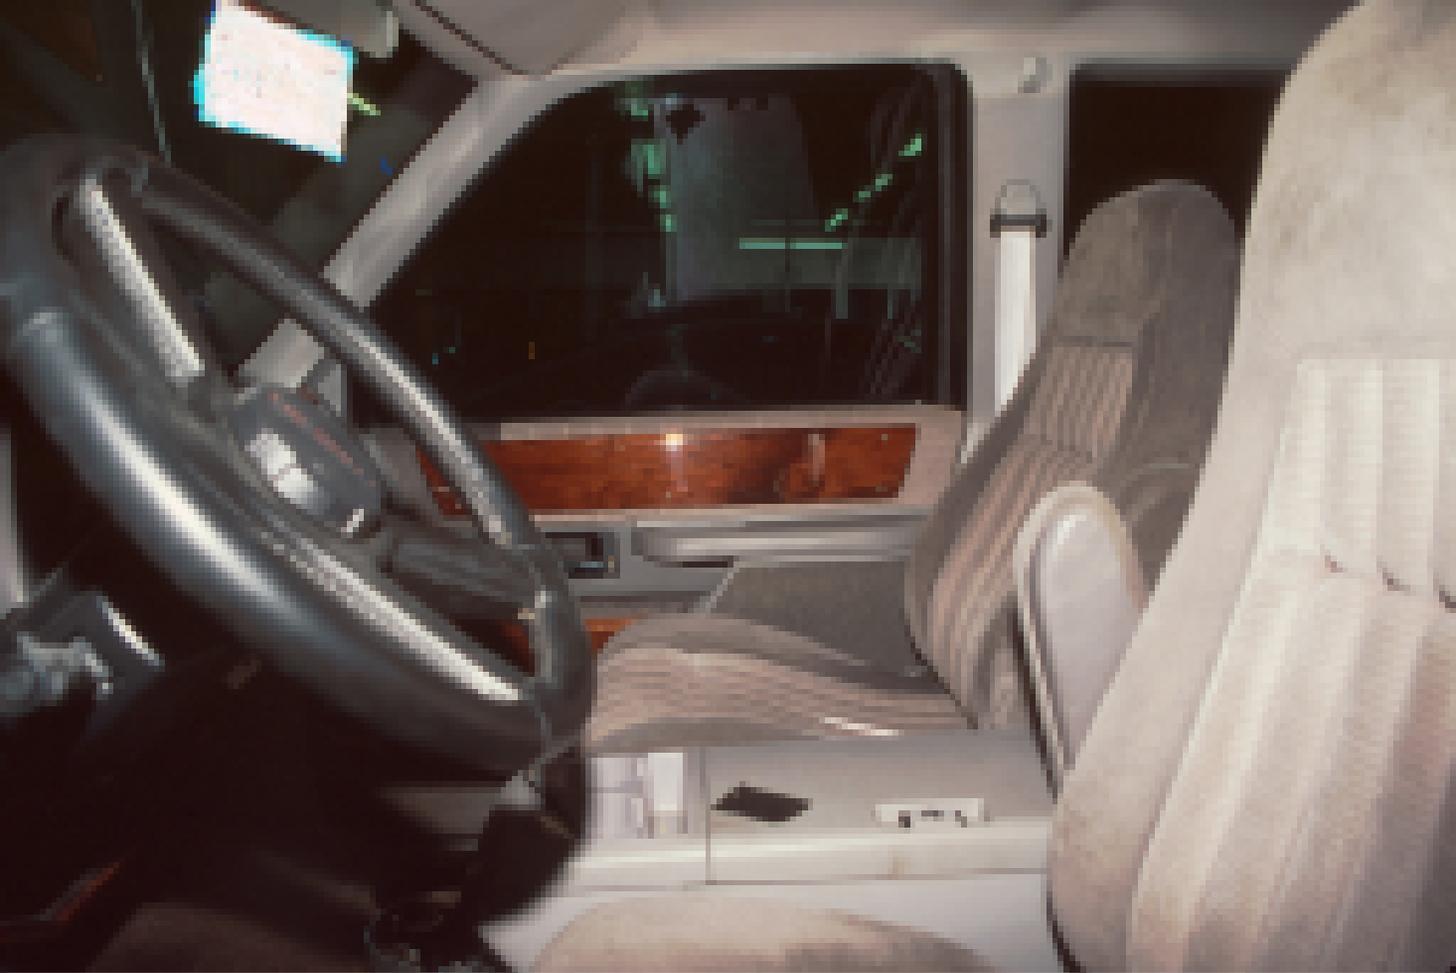
51-66	1		Interior views
67-90	2		Exterior views showing damage to the left side from impact with V1 and right side from rollover
91-104	2		Interior views showing possible occupant contact points
105-109	3		Exterior views - under repair
110-125	3		Interior views
