CASE SUMMARY

PSU 13 CASE NO. 208A TYPE OF ACCIDENT Car/Tree

V e h. No	Class of Vehicle	Year/Make/ Model	Damage Plane	Severity Descr.	Component Failure
1 01	INTERMEDIATE	1995/NISSIAN/MAXIMA	FRONT	SEVERE	NONE

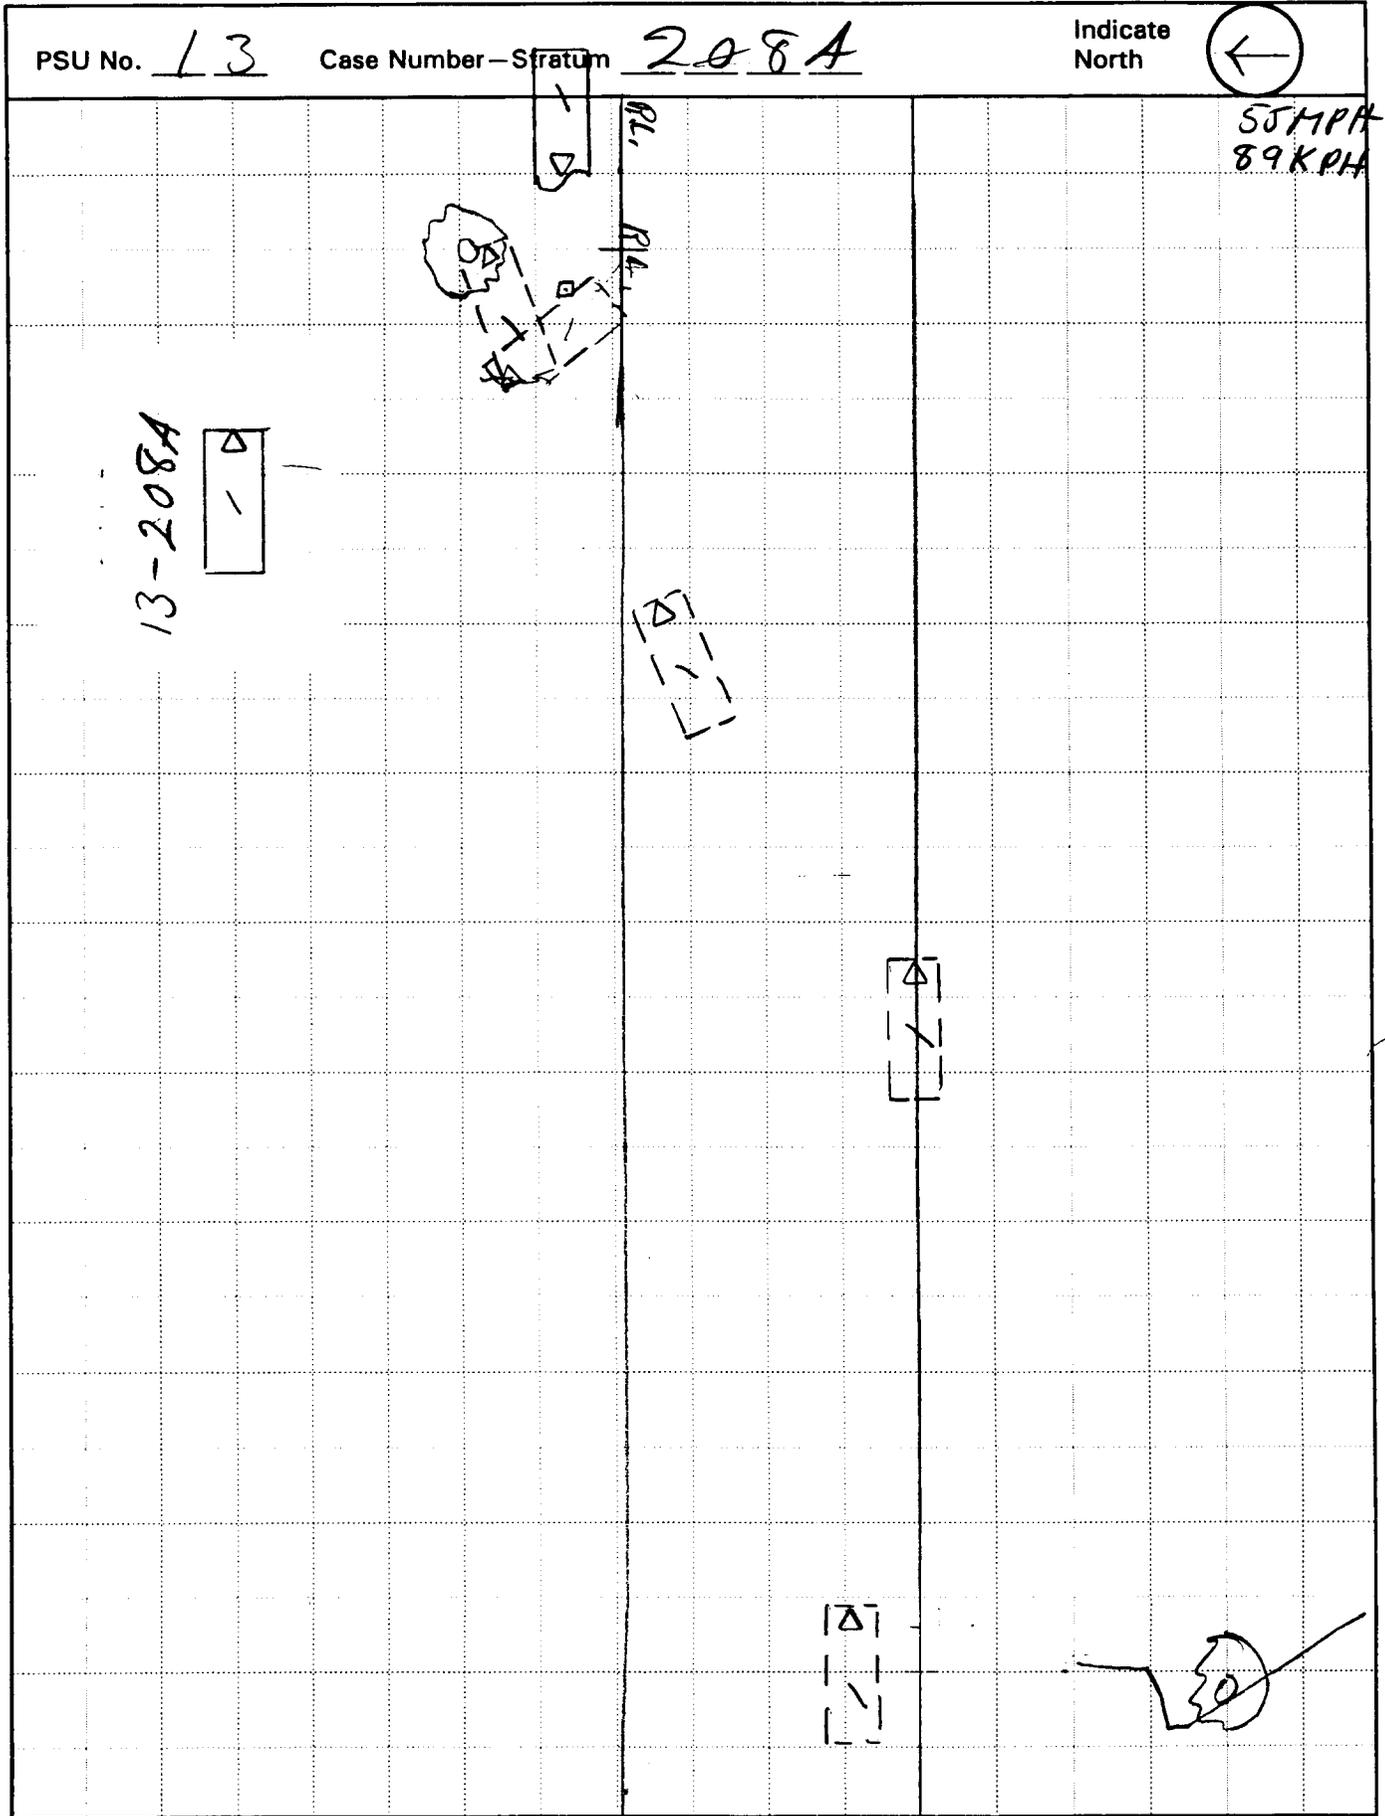
ACCIDENT COLLISION DIAGRAM

NOTE: PAR TIME IS 1645 (LOOK AT BACK OF PAGE 1 AT THE BOTTOM OF PAR) [TIME OF DEATH IS 1730 (FROM BOTH PAR NARRATIVE & MEDICAL)]

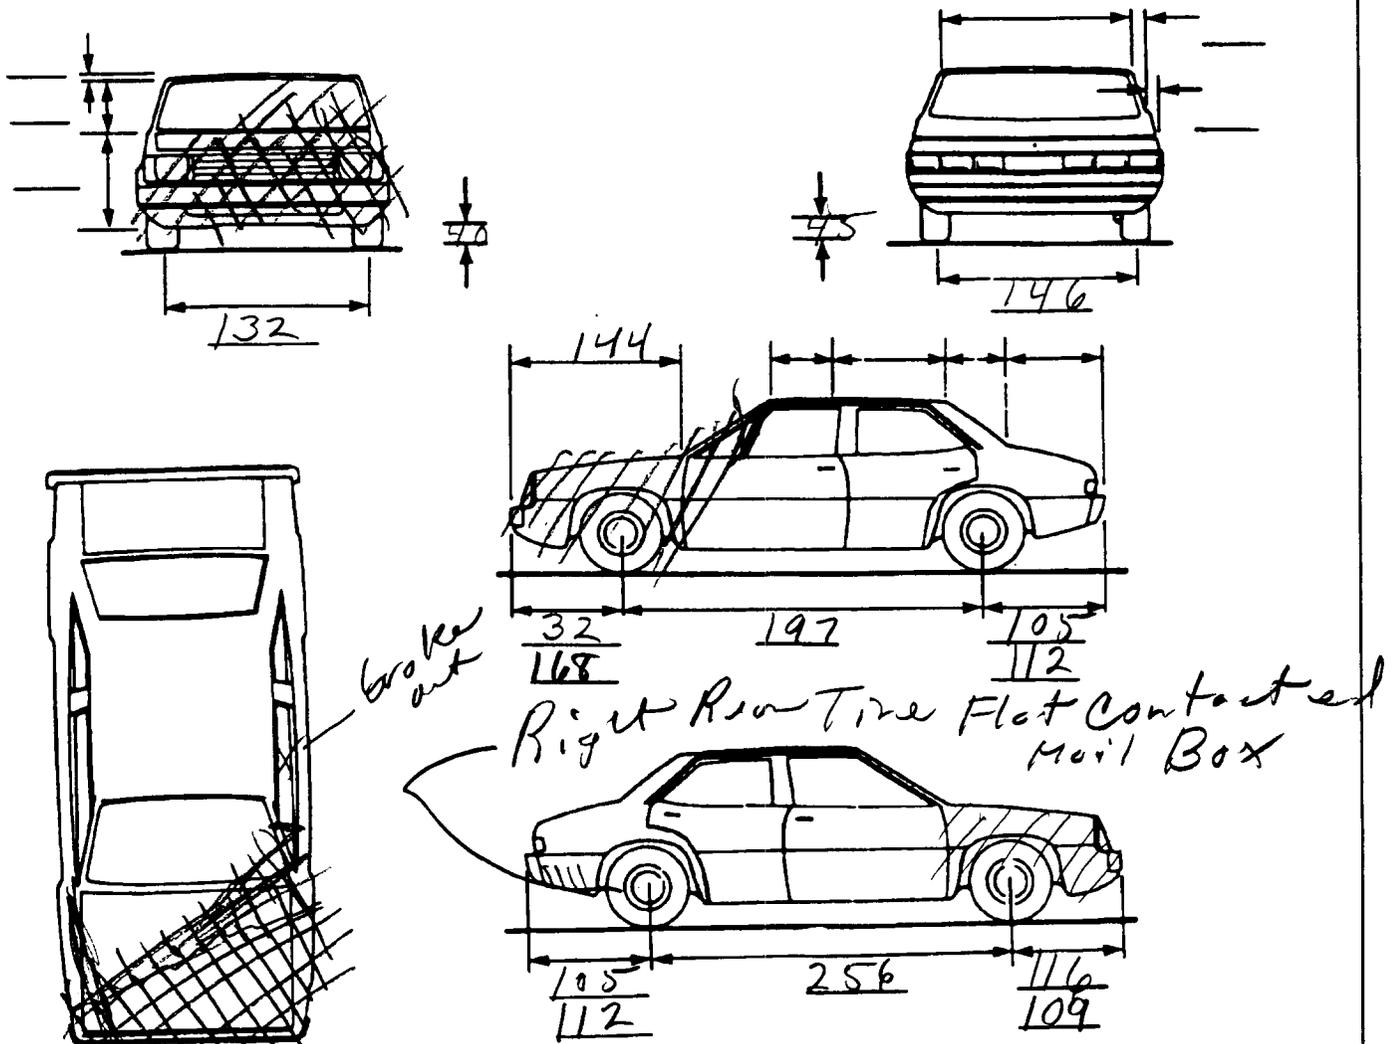
VEHICLE DAMAGE SKETCH

<p>TIRE—WHEEL DAMAGE</p> <p>a. Rotation physically restricted</p> <p>RF <u>1</u> LF <u>1</u> RR <u>2</u> LR <u>2</u></p> <p>b. Tire deflated</p> <p>RF <u>1</u> LF <u>1</u> RR <u>1</u> LR <u>2</u></p> <p>(1) Yes (2) No (8) NA (9) Unk.</p>	<p>ORIGINAL SPECIFICATIONS</p> <p>Wheelbase <u>270</u> cm</p> <p>Overall Length <u>477</u> cm</p> <p>Maximum Width <u>177</u> cm</p> <p>Curb Weight <u>1361</u> kg</p> <p>Average Track <u>152</u> cm</p> <p>Front Overhang <u>101</u> cm</p> <p>Rear Overhang <u>111</u> cm</p> <p>Undeformed End Width <u>150</u> cm</p> <p>Engine Size: cyl./displ. <u>4/3.0</u> L</p>	<p>WHEEL STEER ANGLES (For locked front wheels or displaced rear axles only)</p> <p>RF ± <u> </u> ° LF ± <u> </u> ° RR ± <u> </u> ° LR ± <u> </u> °</p> <p>Within ± 5 degrees</p> <hr/> <p>DRIVE WHEELS</p> <p><input checked="" type="checkbox"/> FWD <input type="checkbox"/> RWD <input type="checkbox"/> 4WD</p> <hr/> <p>Approximate Cargo Weight <u>0</u> kg</p>

Accident Event Sequence Number	Object Contacted	(1) (2) Direction of Force	(3) Deformation Location	(4) Longitudinal or Lateral Location	(5) Vertical or Lateral Location	(6) Type of Damage Distribution	(7) Deformation Extent
4. <u>61</u>	5. <u>42</u>	6. <u>12</u>	7. <u>F</u>	8. <u>L</u>	9. <u>A</u>	10. <u>W</u>	11. <u>26</u>

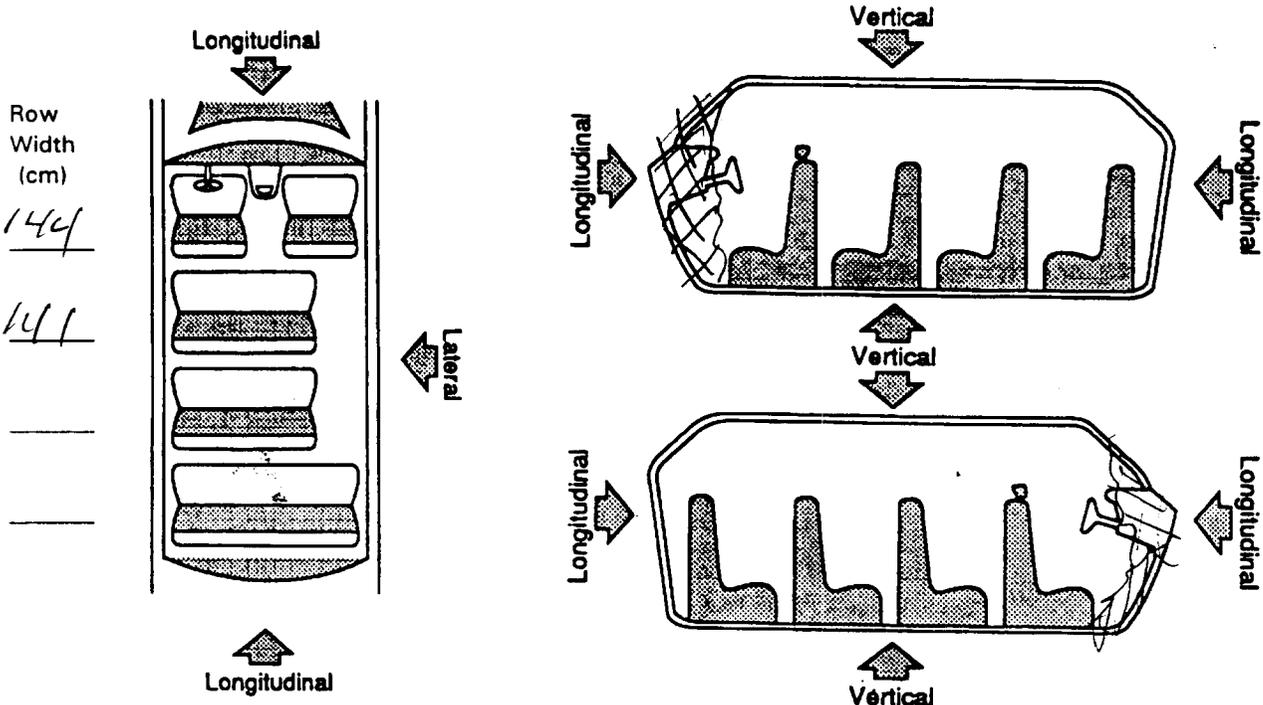
INTRUSION WORKSHEET

LOCATION OF INTRUSION	INTRUDED COMPONENT	(All Measurements Are In Centimeters)				DOMINANT CRUSH DIRECTION	
		COMPARISON VALUE	-	INTRUDED VALUE	=		INTRUSION
11	Apillar 06	88	-	66	=	22	Long
11	Back 02	63	-	47	=	16	Long
12	Back 03	62	-	43	=	19	Long
11	Floorpan 8	90	-	52	=	48	Long
12	Floor 3	0	-	25	=	25	Long
11	Windshield 5	99	-	71	=	28	Long
			-		=		
			-		=		
			-		=		
			-		=		
			-		=		
			-		=		
			-		=		
			-		=		
			-		=

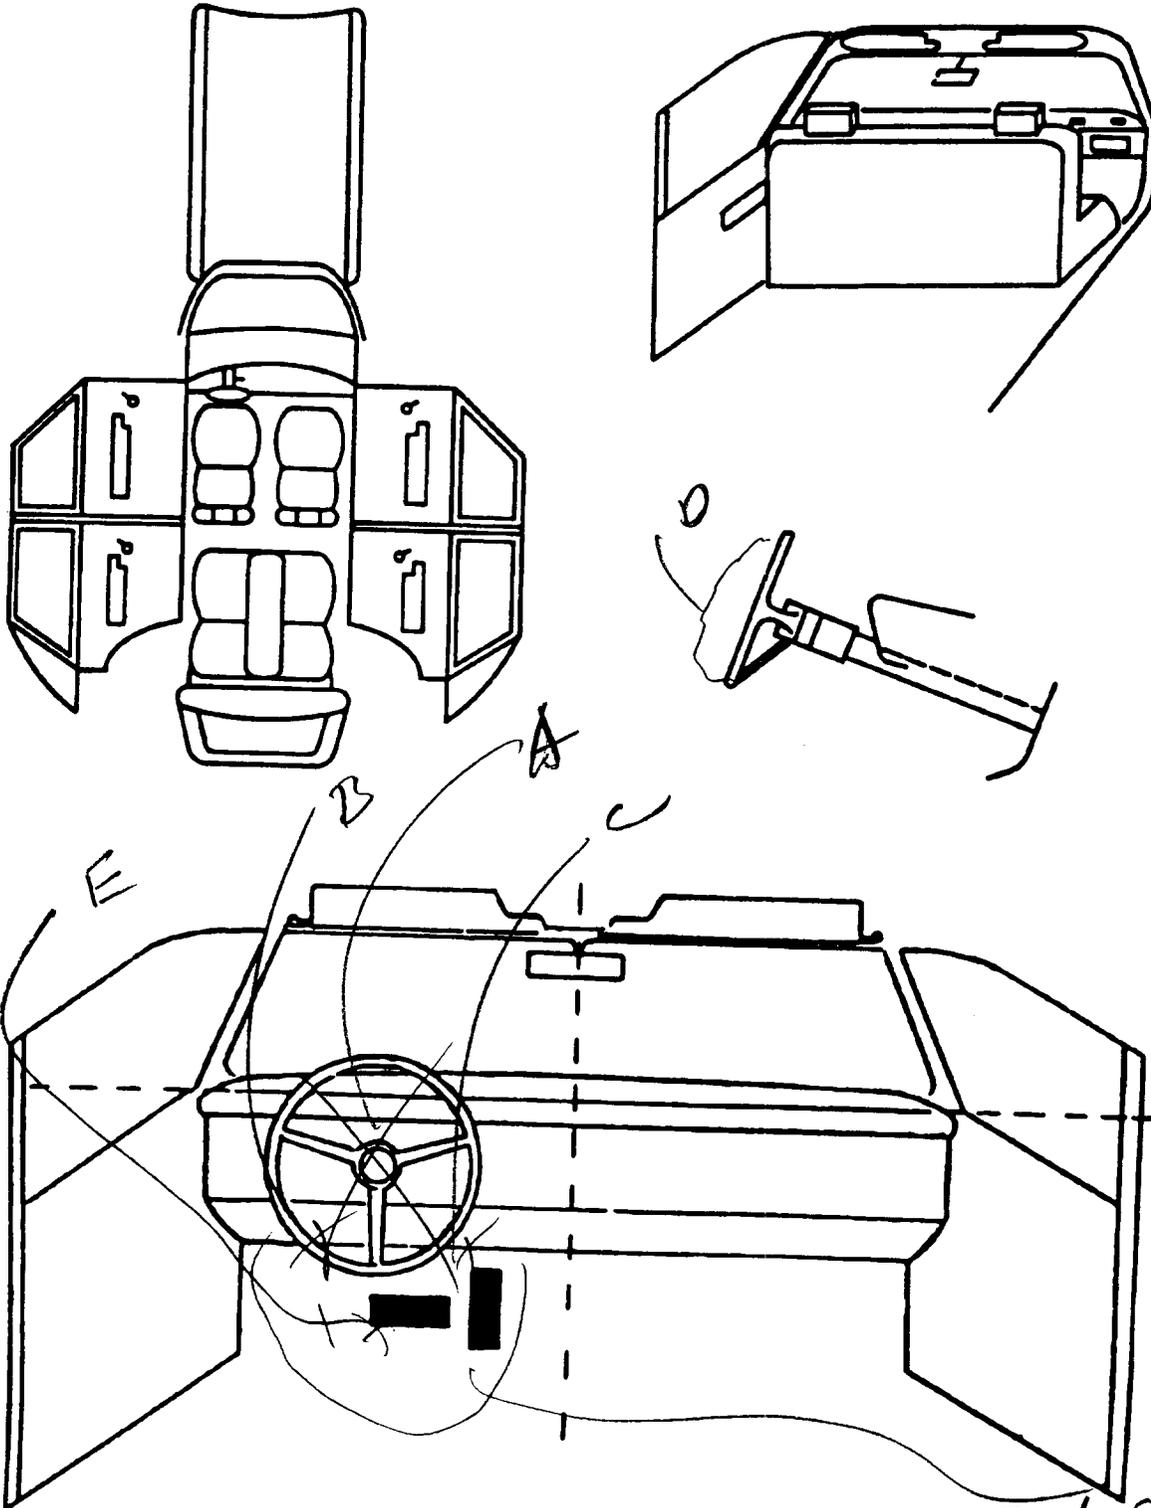
VEHICLE INTERIOR SKETCHES

90. Steering Rim/Spoke Deformation 15
16 Code actual measured deformation to the nearest centimeter
 (00) No steering rim deformation
 (01-14) Actual measured value in centimeters
 (15) 15 centimeters or more
 (98) Observed deformation cannot be measured
 (99) Unknown

93. Instrument Panel Damage from Occupant Contact? 1
 (0) No
 (1) Yes
 (9) Unknown

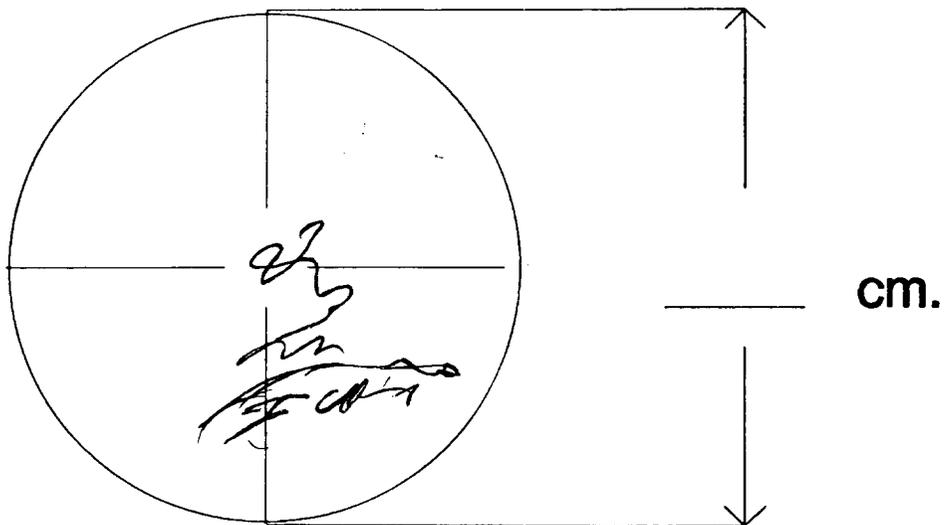
1. SKETCH DAMAGE AND CONTACT EVIDENCE ON DRIVER AIR BAG (Front)

Driver	Passenger
Type of air bag?	1	1
Flaps open at tear points?	2	2
Flaps damaged?	1	1
Air bag damaged?	03	01
Source of air bag damage	02	01
Air bag tethered?	2	1
Air bag have vent ports?	2	2
Other occupant contact air bag?	0	0
Occupant wearing eyewear?		1

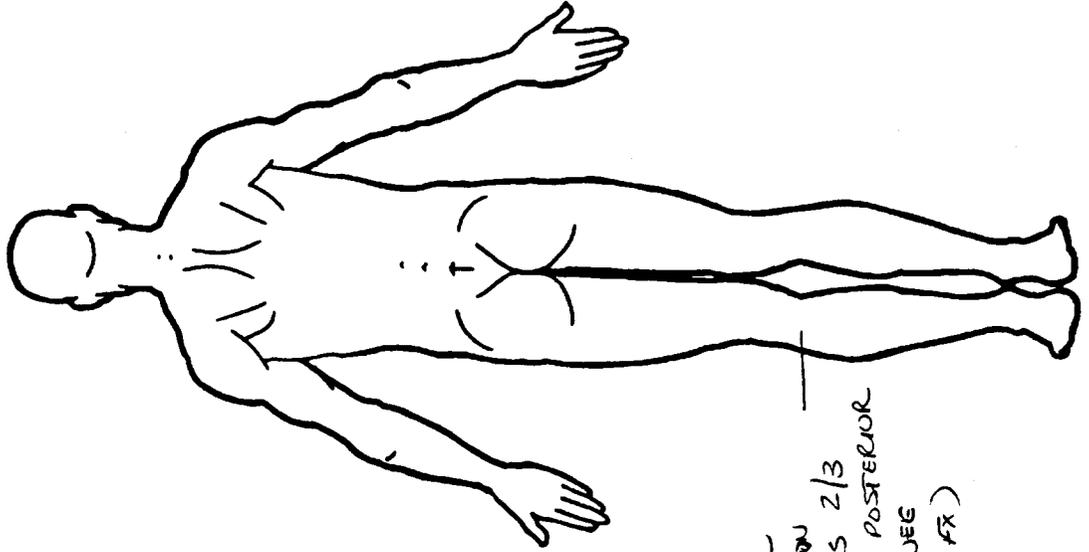
AUT: 3x1cm FOREHEAD BRUISE
 AUT: LFT SUBSCALP 7x4cm HEMORRHAGE

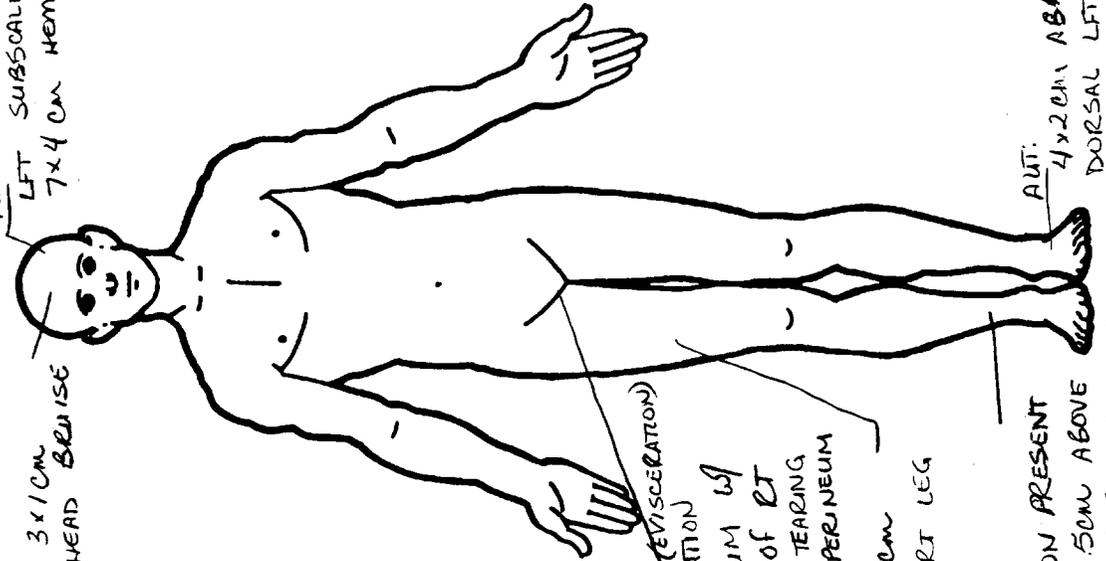
AUT: 17x5cm LACERATION MEASURES 2/3 AROUND POSTERIOR LFT KNEE (DUE TO FX)

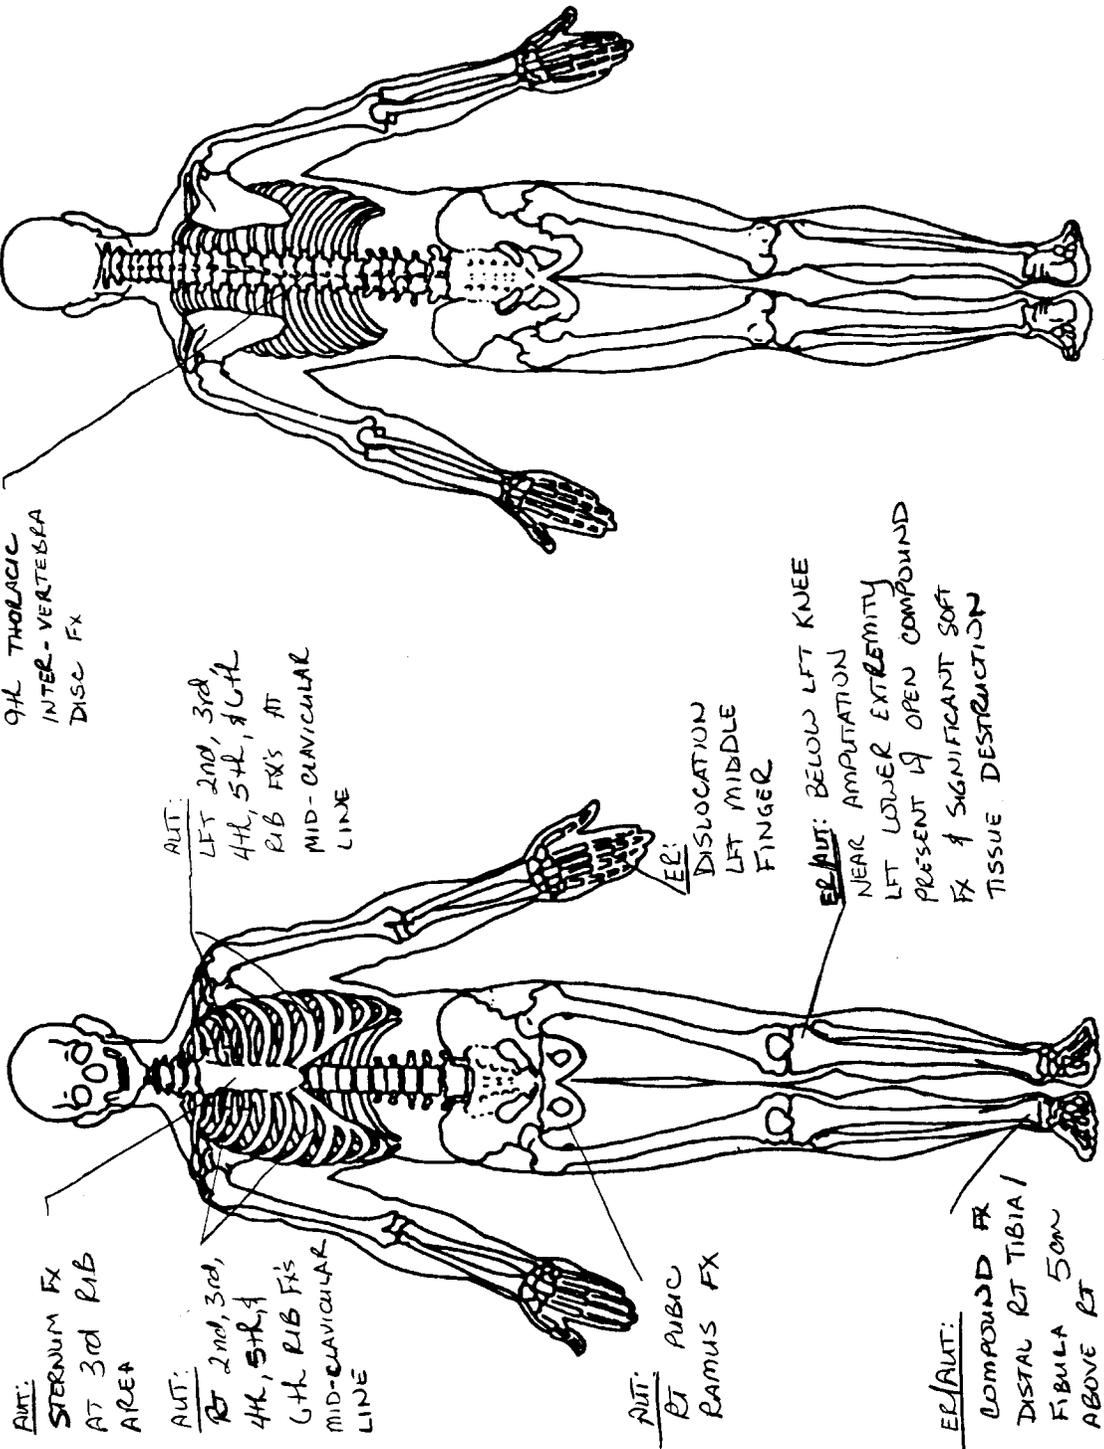
OFFICIAL INJURY DATA - SKELETAL INJURIES

Indicate the Location, Specific Anatomic Structure, Detail (size, depth, fracture type, fracture type, head injury clinical signs and neurological deficits), and Source of all injuries indicated by official sources (or from PAR or other unofficial sources if medical records and interviewee data are unavailable.)
ER: MULTIPLE FXS
