CASE SUMMARY

PSU 43 CASE NO. 877A TYPE OF ACCIDENT CAR - RAN - OFF - ROAD

NATIONAL ACCIDENT SAMPLING SYSTEM
CRASHWORTHINESS DATA SYSTEM

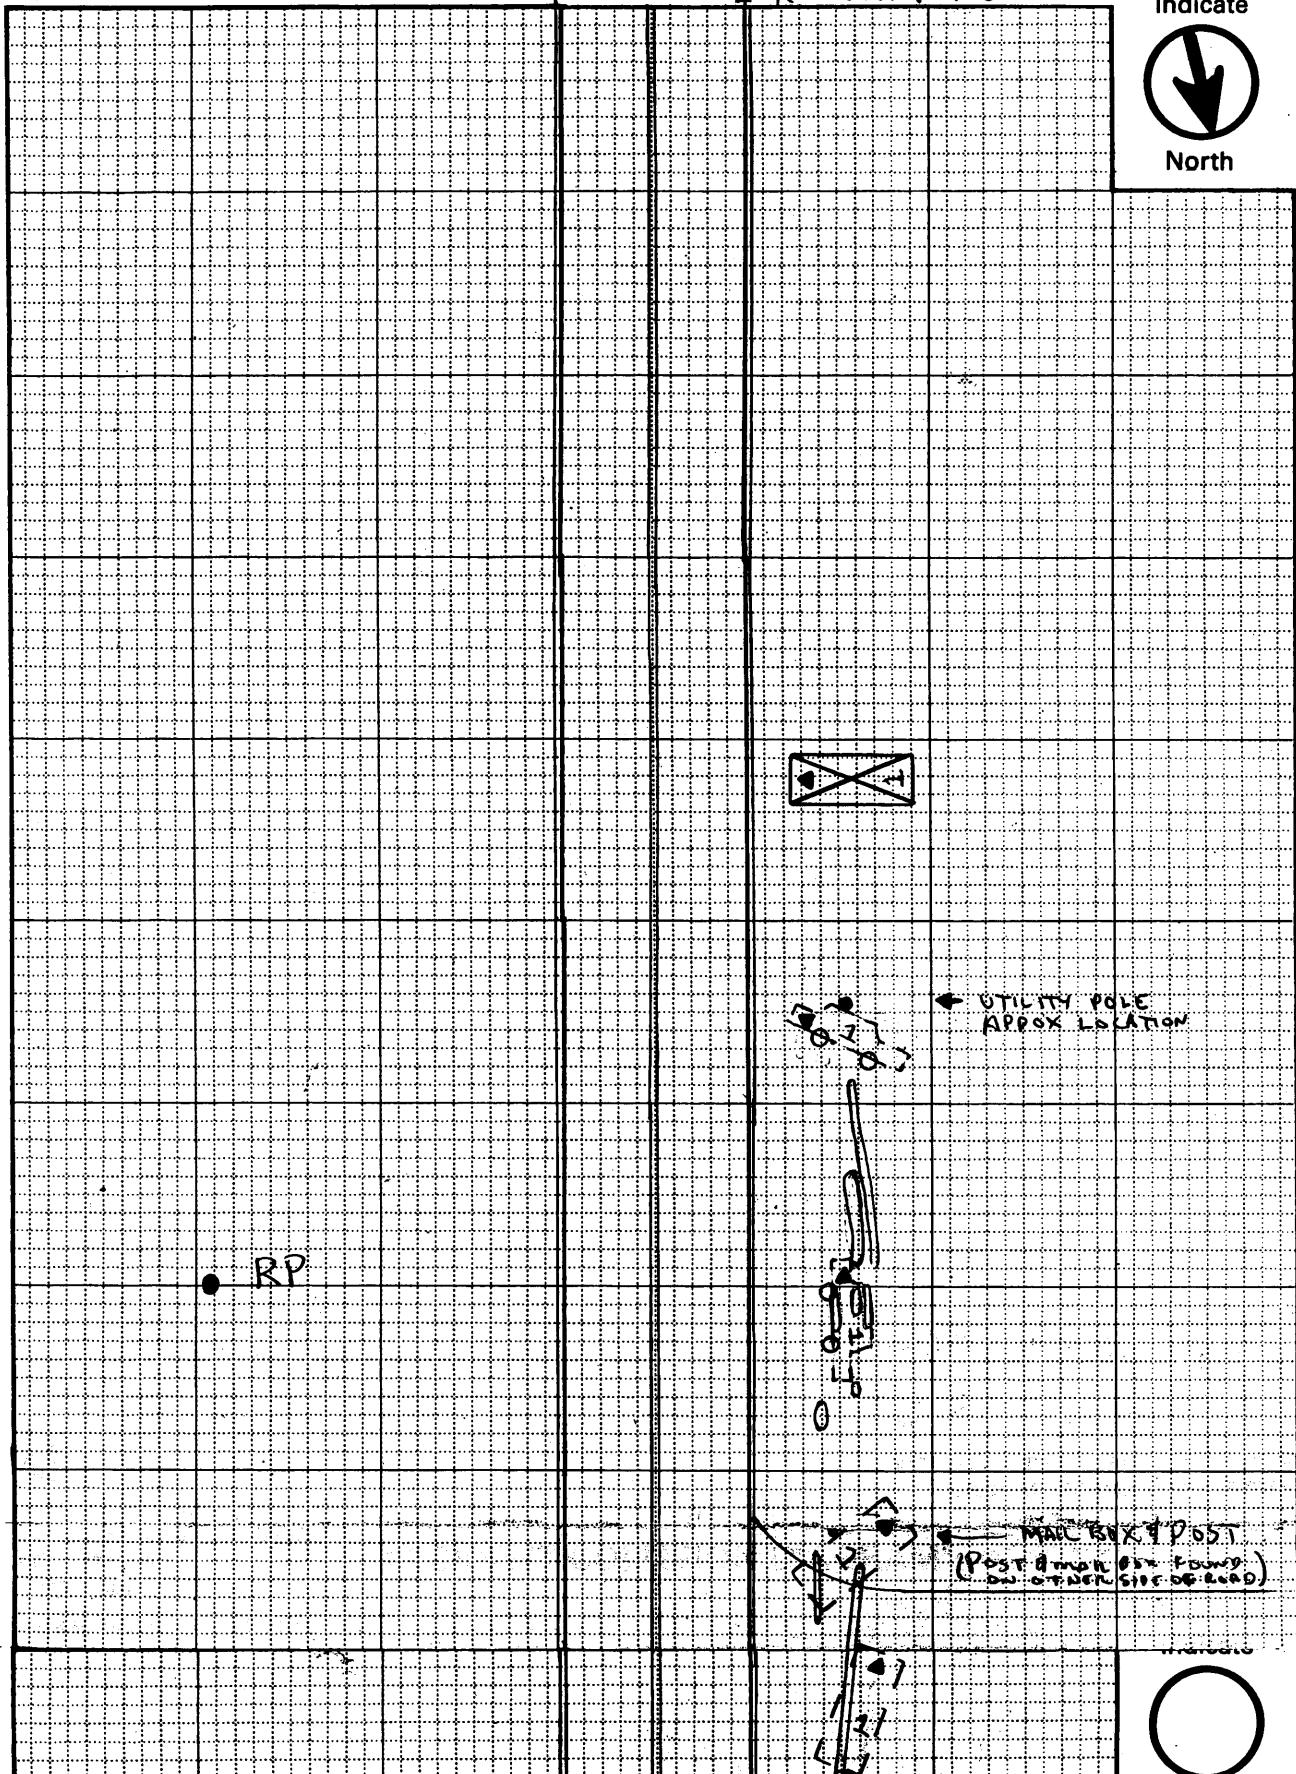
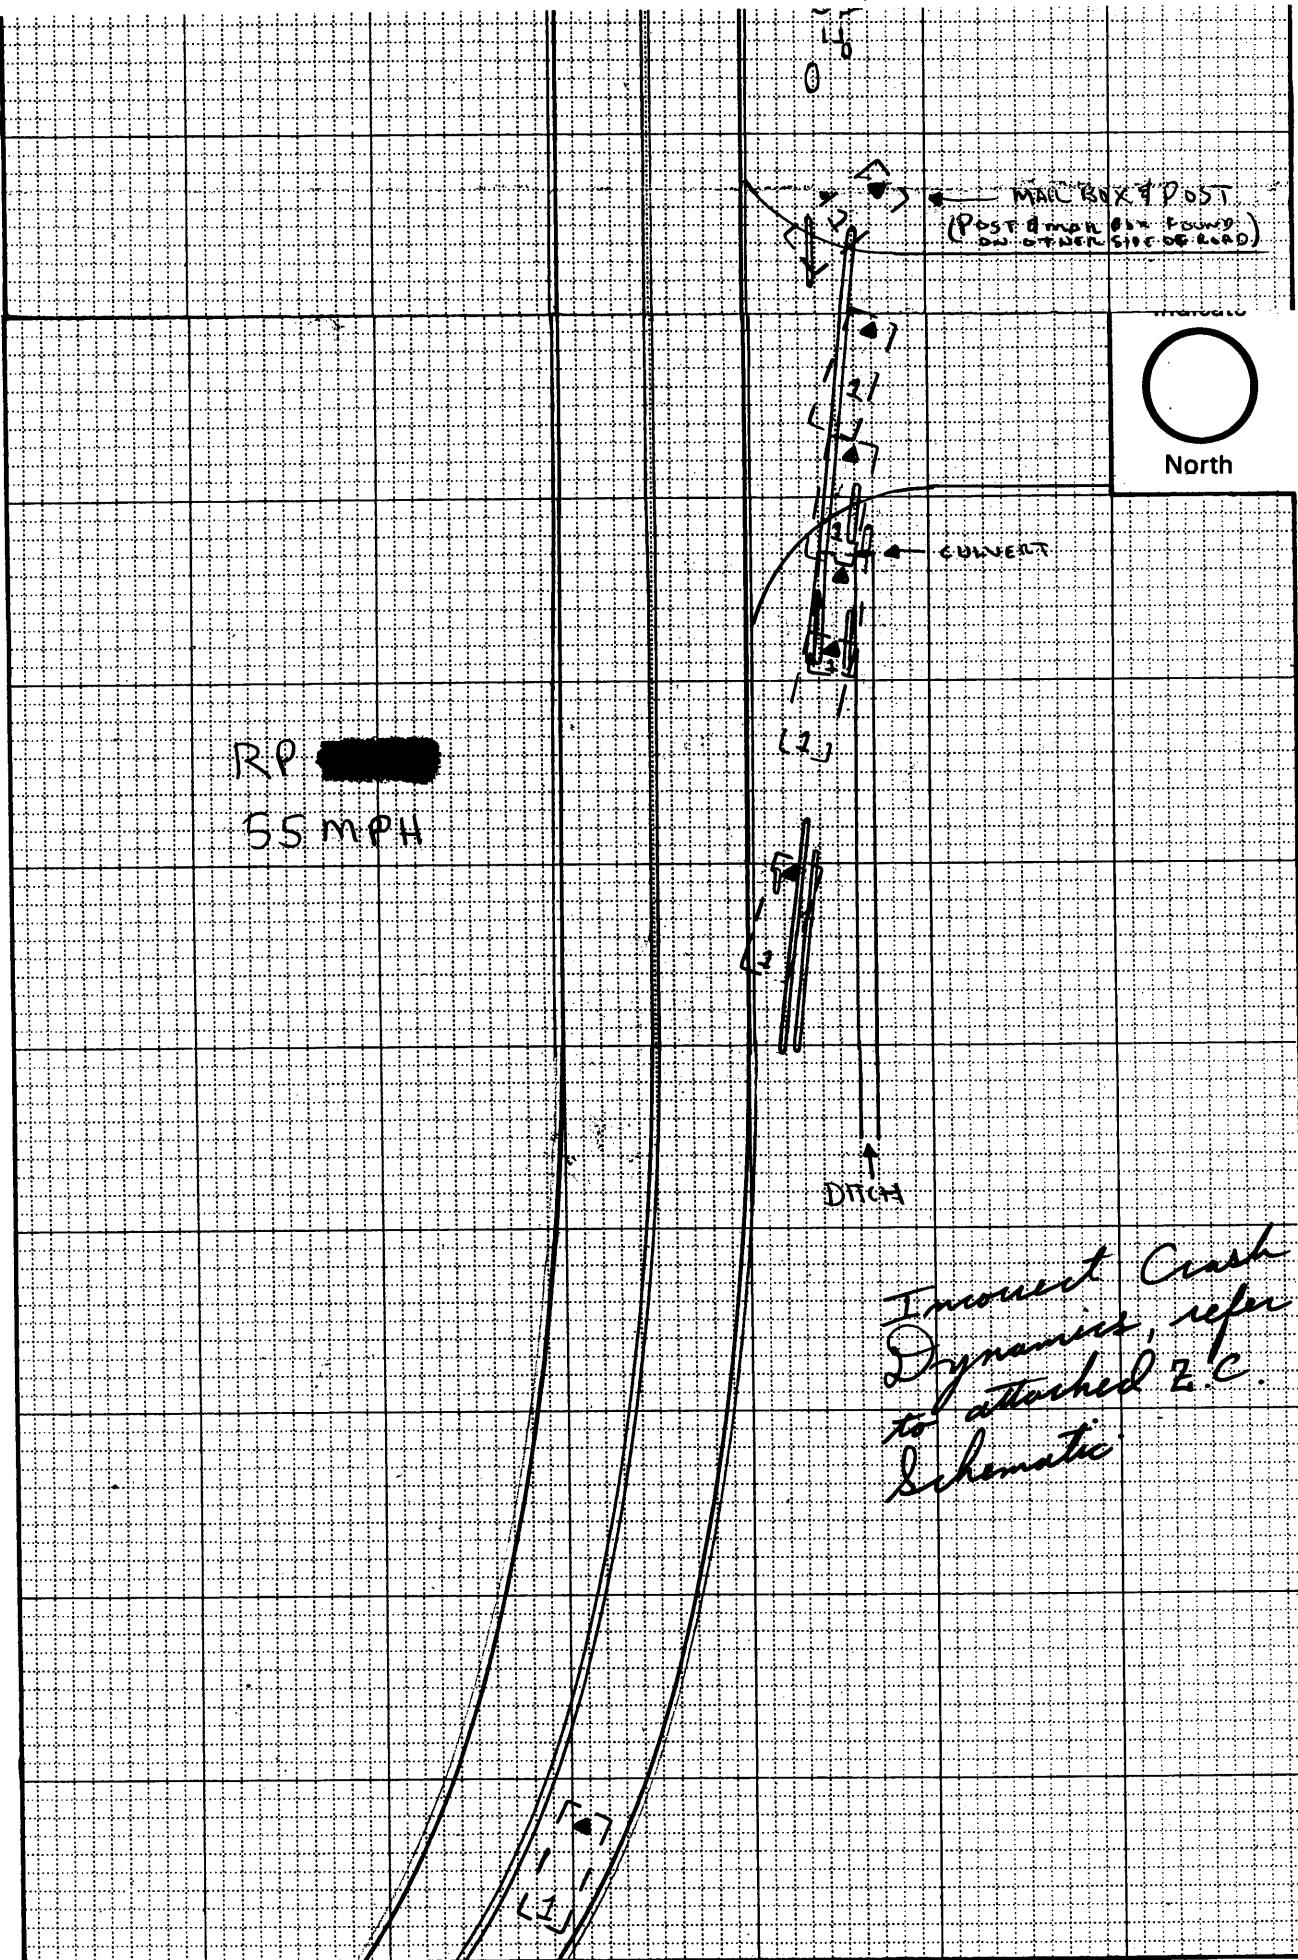
ACCIDENT COLLISION DIAGRAM

Event #4 & 5
(rollover & Fire)

← UTILITY POLE
FIRE FOX LOCATION
Event #3

Event #2

(POST & MAIL BOXES LOCATED
ON THE LEFT SIDE OF THE ROAD)

CURRENT
Event #1

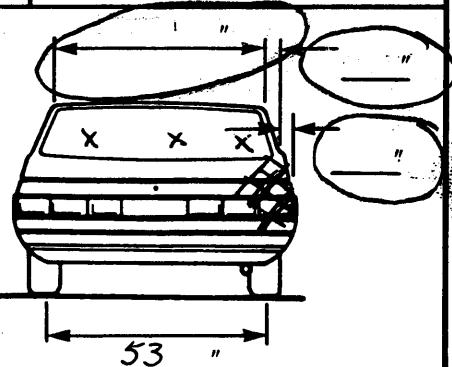
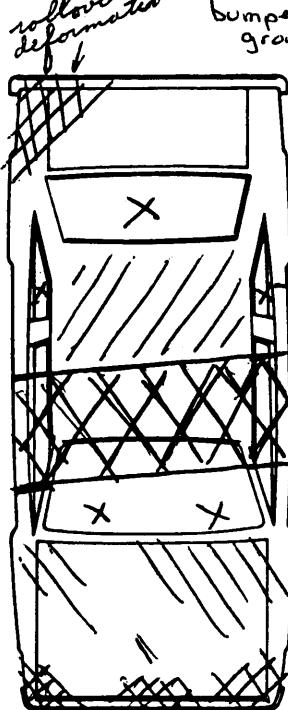
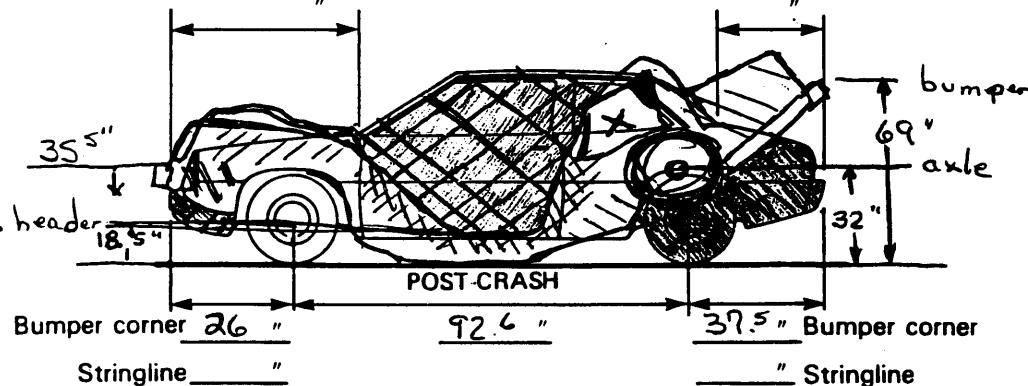
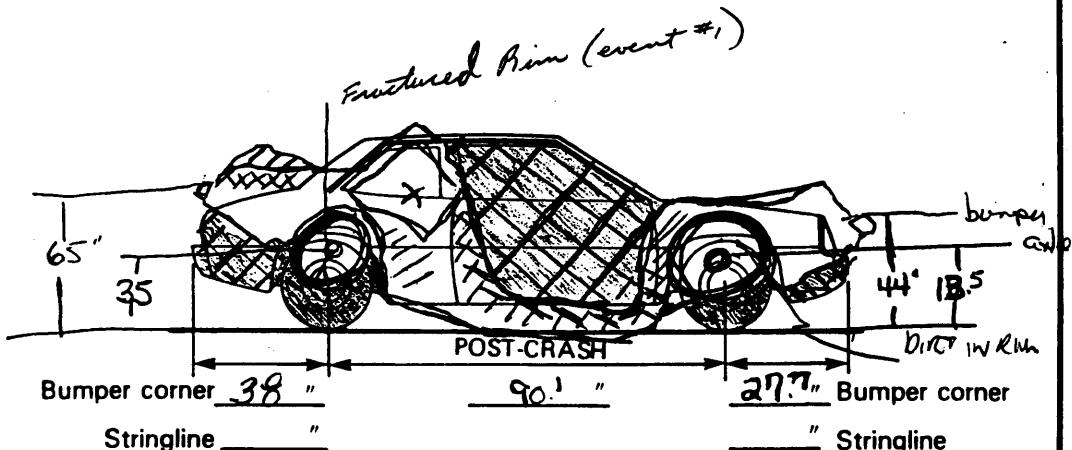
VEHICLE DAMAGE SKETCH

Entire Body DESTROYED BY FIRE

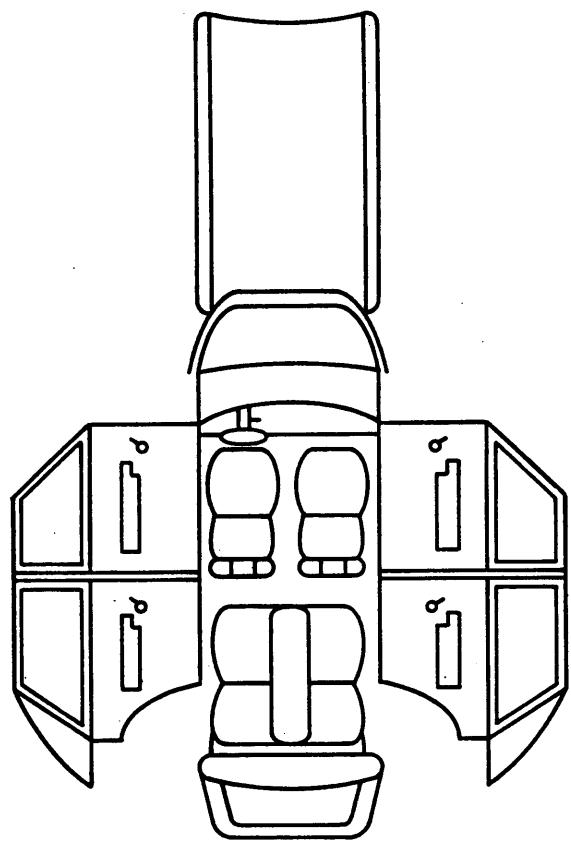
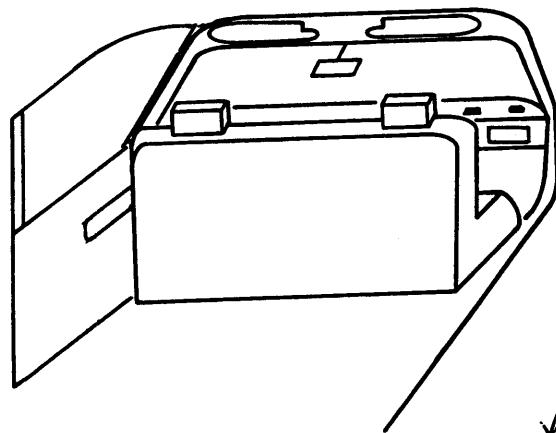
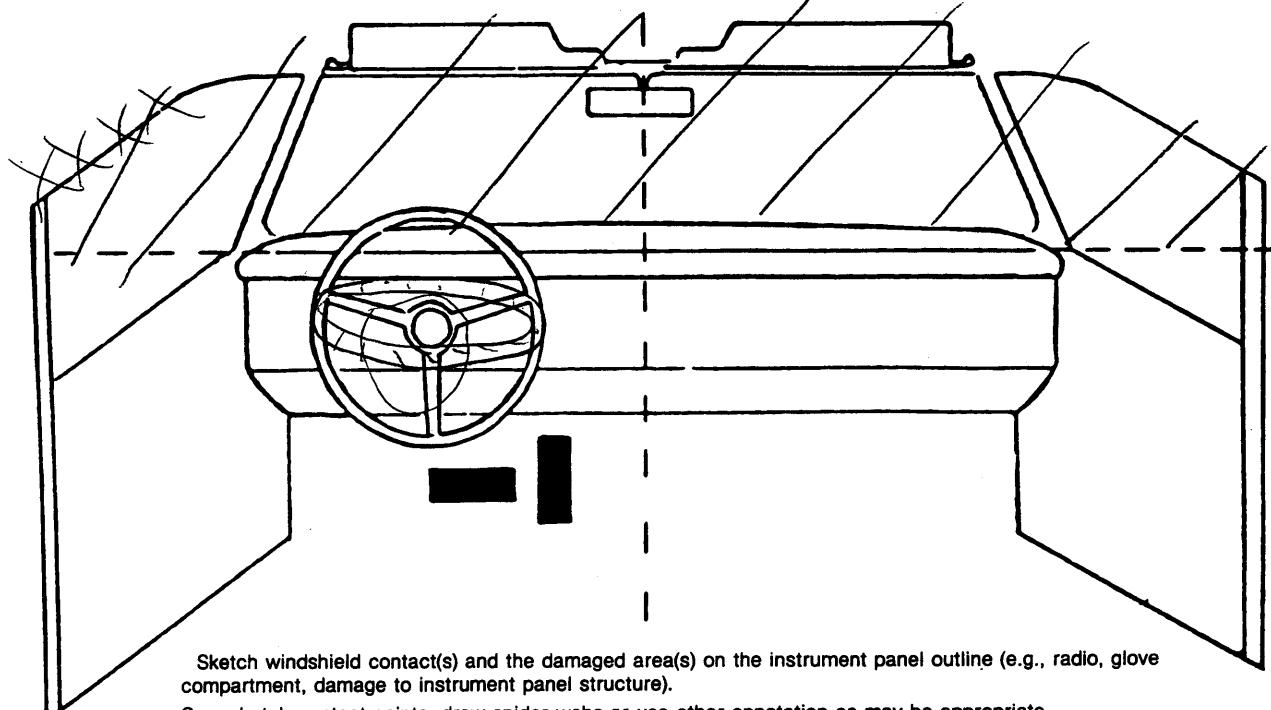
VEHICLE INTERIOR SKETCHES

STEERING WHEEL COLLAPSE due
AIR BAG DEPLOYED to
roof impact

TOTAL COLLAPSE OF ROOF STRUCTURE

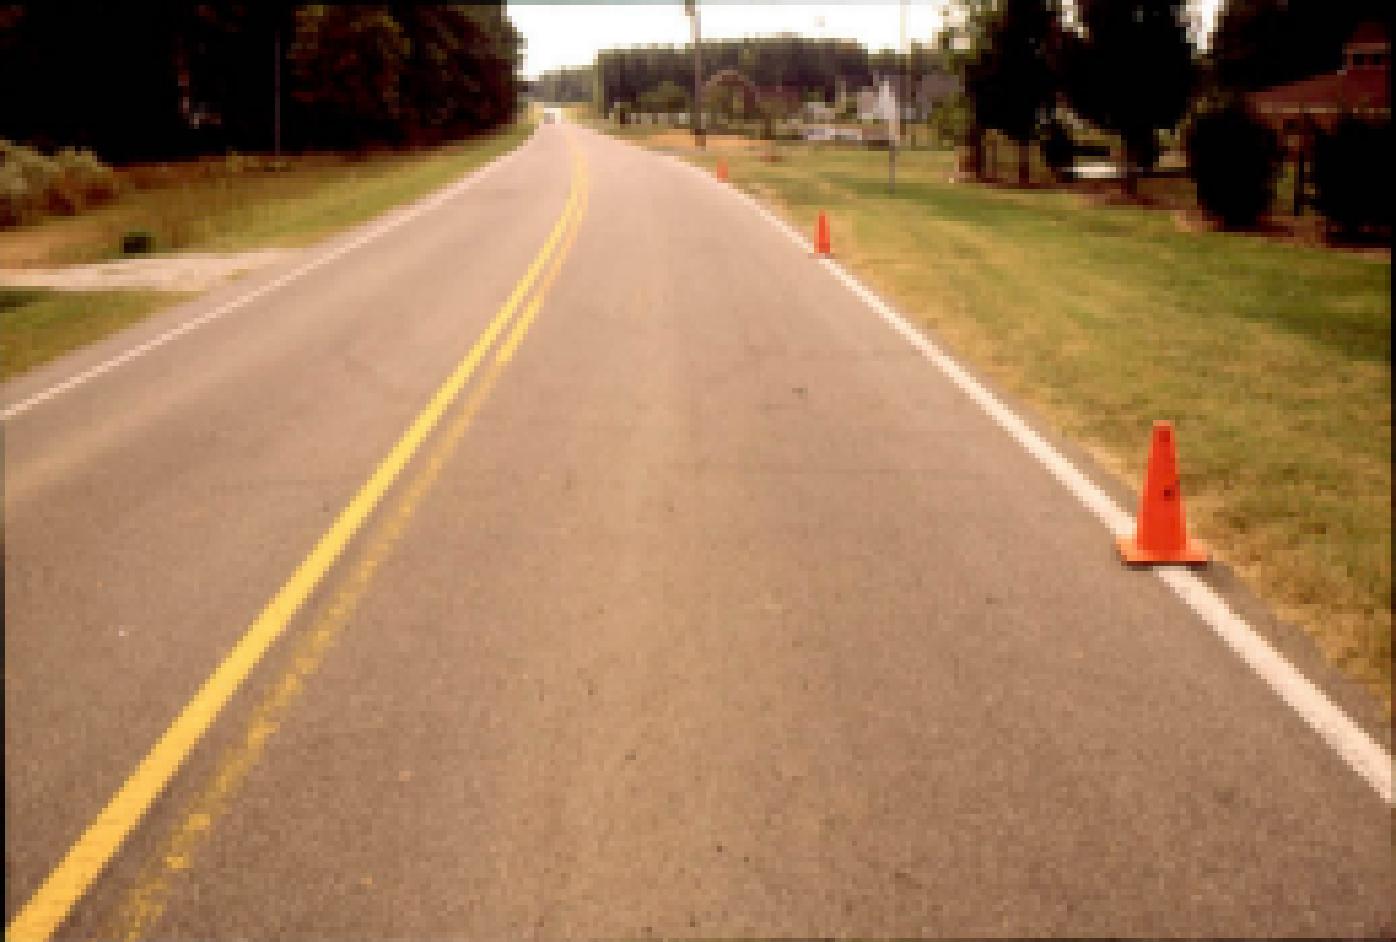
PSU 43-077A (1991) #1

Primary Sampling Unit Number <u>43</u>			Case Number—Stratum <u>877A</u>
Slide No.	Vehicle No.	Direction of Picture	Description of Slide Subject Matter
1-2	1	SW	APPROACH
3	"	"	ROAD DEPARTURE
4-8	"	"	APPROACH TO IMPACT #1
9	"	"	IMPACT #1
10-13	"	"	APPROACH TO IMPACT #2
14	"	"	IMPACT #2
15	N/A	"	DAMAGED MAIL BOX - ORIGINAL (POST DIFFERENT)
16	N/A	"	ORIGINAL DAMAGED POST FOR MAIL BOX
17	1	"	APPROACH IMPACT #3
18	"	"	IMPACT #3 (GROUND)
19-21	"	"	IMPACT #3 / APPROACH IMPACT #5
22	"	"	IMPACT #4
23	"	"	POLE REPLACED (UTILITY POLE KNOCKED OUT OF GROUND)
24	"	"	IMPACT #5 (GROUND)
25	"	NN	FINAL REST
26	"	NE	LOOK BACK FINAL REST
27	"	"	" " IMPACT #4
28	"	"	" " IMPACT #3
29	"	"	" " " " #2
30	"	"	" " " " " " #1
31	"	"	" " ROAD DEPARTURE
32	"	"	" " APPROACH
33-53	"		EXTERIOR SHOTS

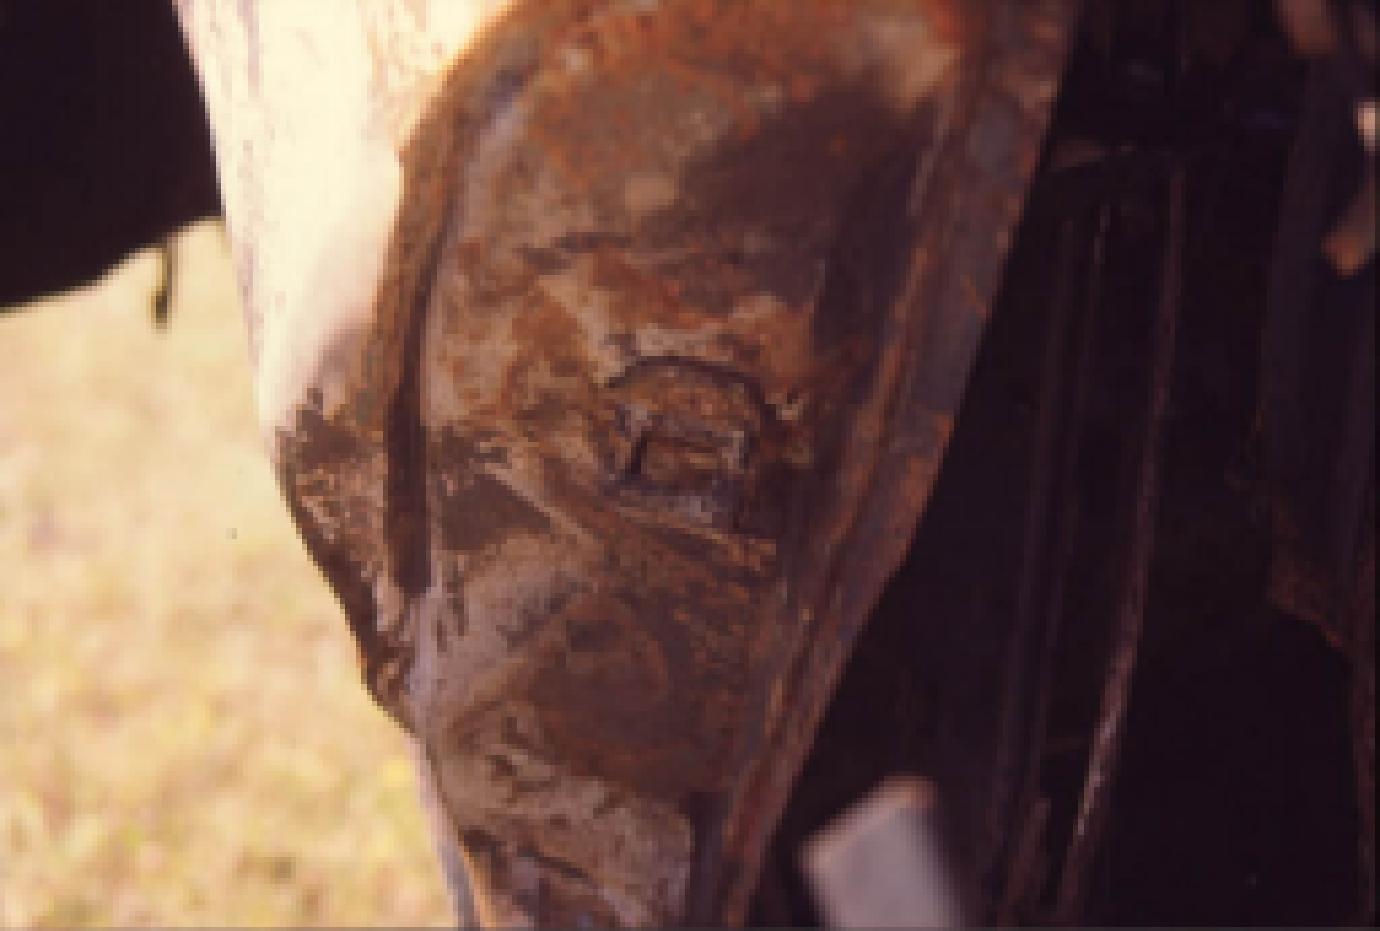
PSU 43-077A (1991) #50

#50 - CLOSE UP RF DOOR STRIKER
			#51 - " " " " LATCH
54-57	"		CLOSE UPS STEERING WHEEL & AIR BAG
			#55 - NOTE SEAT BELT SERED ONTO AIRBAG
